National Transportation Safety Board

Railroad Accident Brief

Accident No.: DCA-05-FR-007
Location: Glencoe, Kentucky
Date: January 5, 2005
Time: 3:04 a.m. eastern standard time¹
Railroad: CSX Transportation
Property Damage: \$185,000
Injuries: 2
Fatalities: None
Type of Accident: Derailment (tunnel collapse)

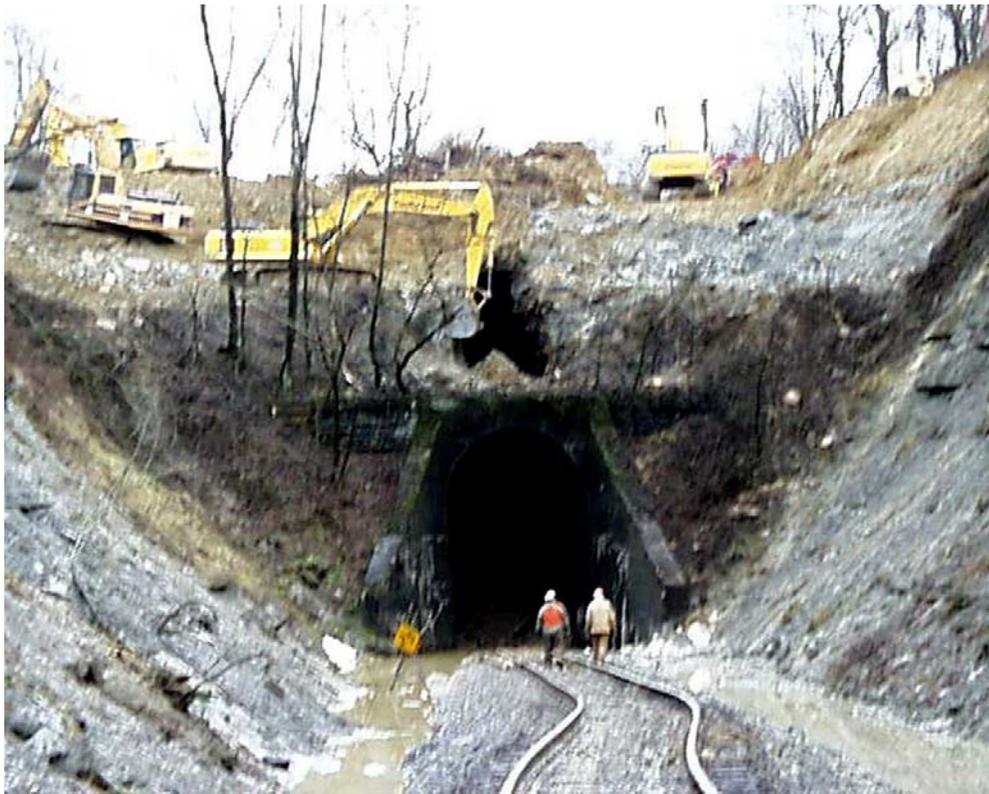
the tunnel that was approximately 27 feet long and 15 feet wide. The hole was about 48 feet from the tunnel's north entrance. (See figure 1.) The tunnel was at milepost T 73.6.

Figure 1. Excavation of Eagle Tunnel No. 3. (Track misalignment caused by derailment.)

Measurements made before and after the collapse indicate that erosion had undermined some foundation stones by 18 inches or more. This undermining allowed the sand from the brick and mortar foundation to erode into the drainage ditch, which could have easily transported the sand downstream. As the foundation eroded, the brick wall settled and cracked. According to CSX, its tunnel inspectors thought the west wall foundation was 36 inches wide. Based on this assumption, CSX thought that the 18 inches of undermining was not yet critical. However, CSX had failed to discover that the footer was actually only 18 inches wide. An examination of the remnants of the tunnel wall by investigators after the accident indicated that water had flowed beneath the foundation and undermined its footing. Because of the undermining, the west wall had settled, separated, and rotated inward.

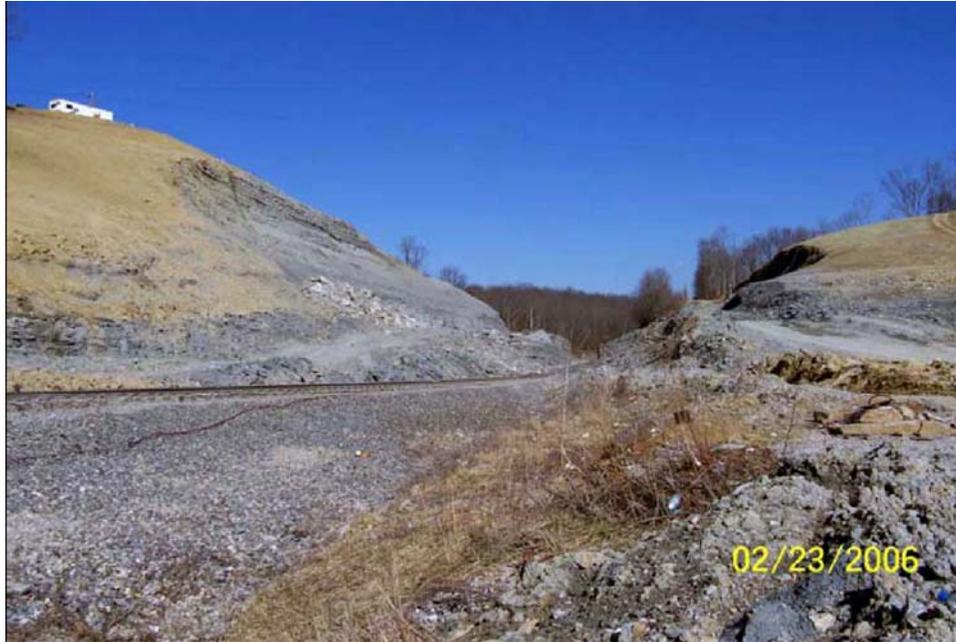
Figure 2. The track after removal of hill and Eagle Tunnel No. 3.

After the accident, CSX eliminated the entire tunnel by excavating the land above it. (See figure 2.) Before the accident, CSX had retained tunnel inspection and maintenance records for 1 year. CSX reported that it has changed its records retention policy, effective January 2007, to include "ACTIVE plus six years" of records related to the testing and inspection, design, construction, and maintenance of bridges, tunnels, culverts, piers, and related structures. CSX also has created an electronic database of inspection records of its active tunnels.
