National Transportation Safety Board

Railroad Accident Brief

Accident No.: DCA-08-FR-002
Location: Bertram, California
Date: November 10, 2007
Time: 12:03 p.m., Pacific standard time¹
Railroad: Union Pacific Railroad
Property Damage: \$2 million
Injuries: 0
Fatalities: 2
Type of Accident: Rear-end collision

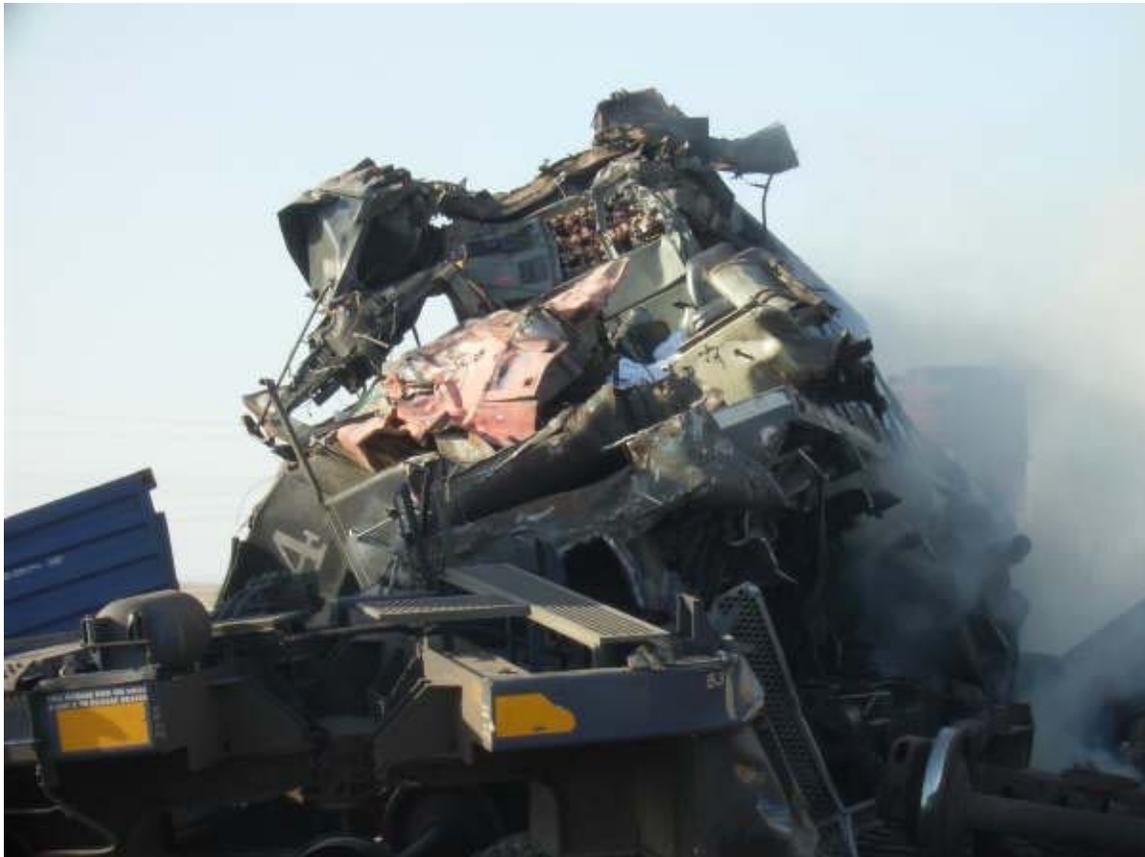
UP train IGSMN-10 was stopped on the main track for a *stop* signal indication at the east end of Bertram siding control point to meet a westbound UP train entering into the siding at Bertram. Before the striking train struck the stopped train, it traveled past a mainline *advanced approach* signal, an *approach* signal, and a *stop* signal. The maximum authorized speed near the accident was 65 mph for freight trains. The train failed to comply with the *approach* signals and passed the *stop* signal at 37 mph. The striking train was about 1,037 feet beyond the *stop* signal, traveling about 28 mph, when it struck the stopped train. (See figure 1.)

Figure 1. Lead locomotive of striking train.

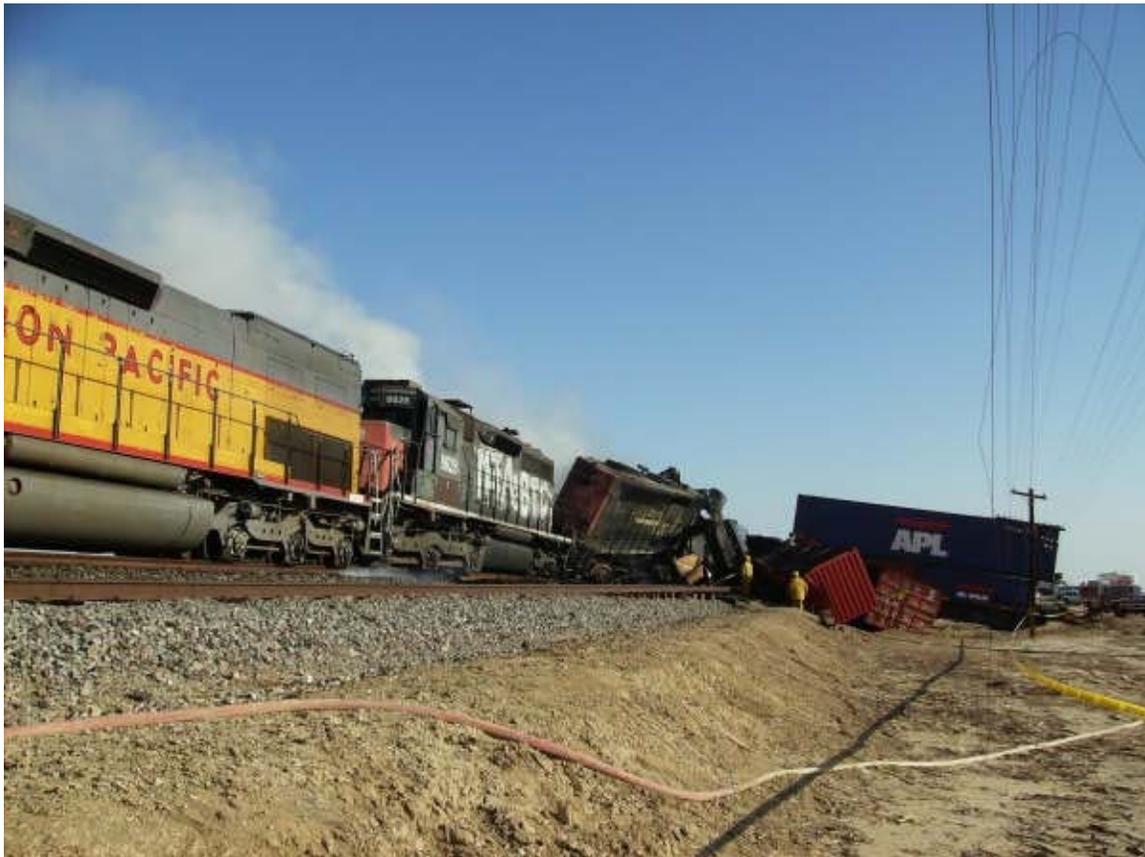
The train had slowed to about 37 mph as it passed a *stop* signal at MP 646.1, and it was still moving about 28 mph when it struck the stopped train at MP 646.3. (See figures 2 and 3.) The striking train was placed into emergency braking about 32 seconds before the collision.

Figure 2. Collision of freight trains.

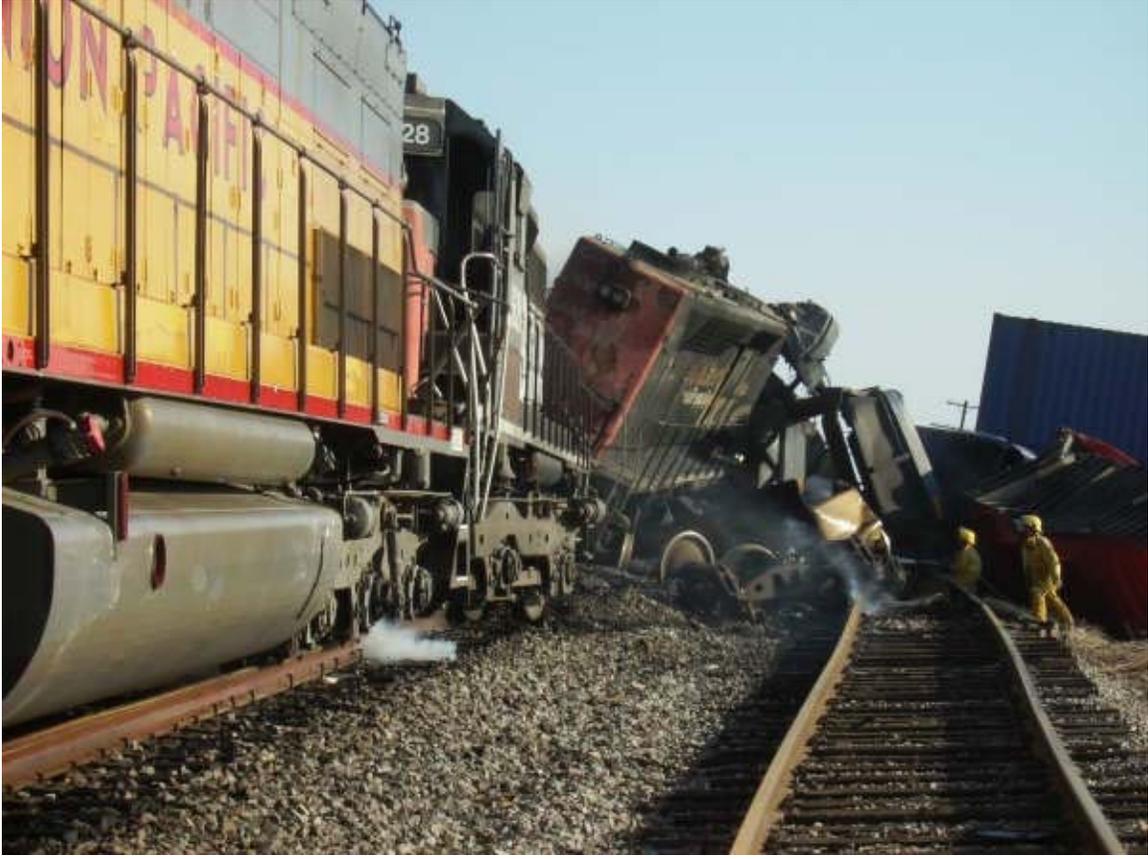
Figure 3. Wreckage of freight trains.
