# National Transportation Safety Board

## Railroad Accident Brief

**Accident No.:** DCA-08-FR-006  
**Location:** Chicago, Illinois  
**Date:** May 28, 2008  
**Time:** 10:05 a.m., central daylight time<sup>1</sup>  
**Railroad:** Chicago Transit Authority  
**Property Damage:** \$338,000  
**Fatalities:** 0  
**Injuries:** 14  
**Type of Accident:** Derailment

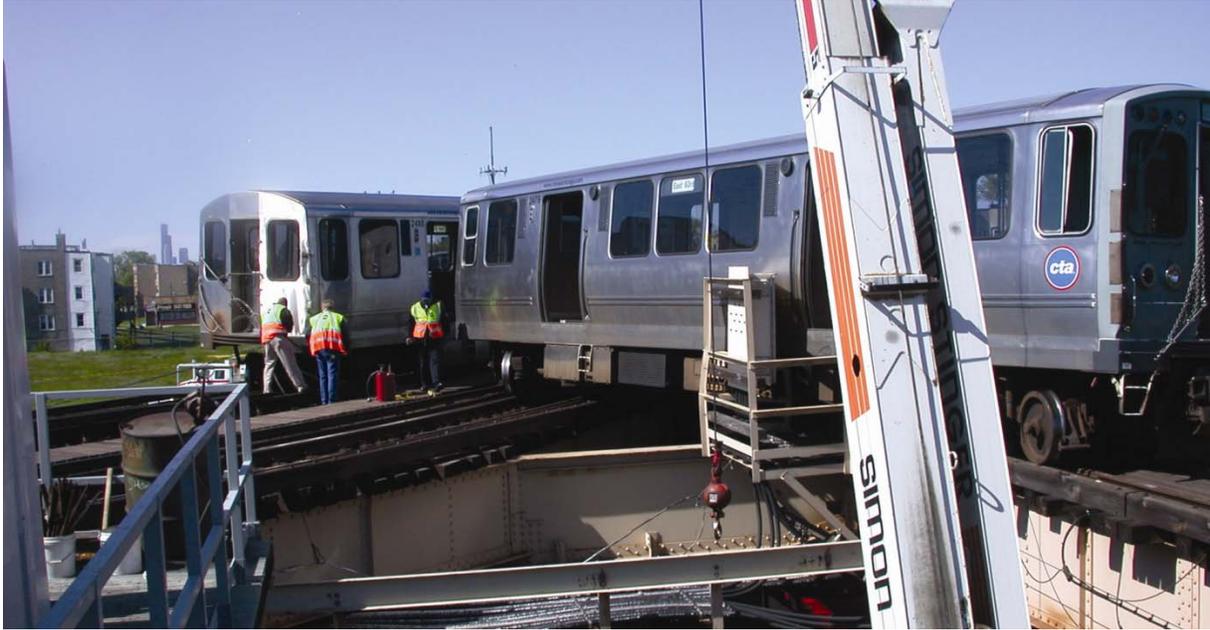
On May 28, 2008, about 10:05 a.m., southbound Chicago Transit Authority (CTA) Green Line train 003 traveling on elevated track between Harlem/Lake Avenue station and Cottage Grove derailed after crossing switch 85A, which was lined against the direction of the train at south main track marker 338 in Chicago, Illinois. (See figure 1.) Train 003 consisted of four passenger cars coupled in sets of two. There were 24 passengers onboard. Fourteen passengers sustained minor injuries and were transported to area hospitals, where they were treated and released; the other 10 passengers declined medical attention. The total property damage to track, cars, and signal equipment was about \$338,000. At the time of the derailment, the winds were variable at 11 mph, visibility was 10 miles, and the temperature was 52° F.

Figure 1. Derailed lead cars of train 003.

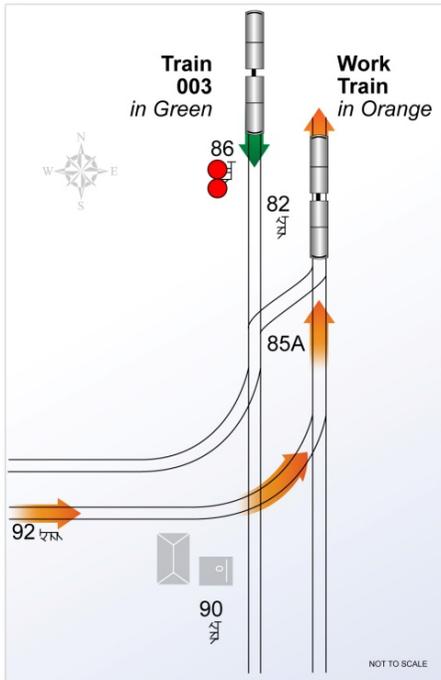
At the same time, an eastbound work train approached the 59th Street interlocking,<sup>3</sup> which was operating in automatic mode, meaning that all routes were initiated either by track circuit occupancy or by a train operator using wayside route selectors. The work train entered the interlocking and proceeded onto the northbound main track. (See figure 3.) It then stopped to make a reverse move southbound toward Cottage Grove. The work train operator used the signal 82 wayside route selector to select a reverse route from the northbound main track to the southbound main track. (See figure 4.)

**Figure 3.** Positions of work train and train 003 before derailment. Orange arrows indicate work train movement to northbound main track. Green arrows indicate train 003 southbound movement. Signal 86 displays a *stop* (red) signal indication for train 003.

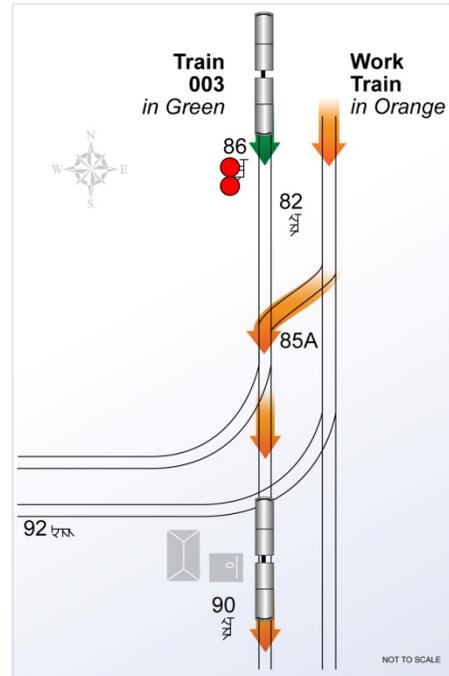
**Figure 4.** Reverse movement of work train and position of train 003 before derailment. Orange arrows indicate work train turn-back move to southbound main track. Green arrows indicate train 003 southbound movement. Signal 86 displays a *stop* (red) signal indication for train 003.

Before the work train crossed over to the southbound track, train 003 approached the 59th Street interlocking, where signal 86 was displaying a *stop* (red) signal indication<sup>4</sup> and the corresponding track trip<sup>5</sup> was raised. The work train then proceeded from the northbound track to the southbound track. Instead of stopping at the No. 86 signal, the train 003 operator continued past the signal. Because the track trip was in the raised position, when the lead car (2479) of the first pair of cars passed over the track trip, an emergency brake application was initiated. After train 003 came to a stop, the operator moved the train forward. When the lead car (2476) of the second pair of cars passed over the track trip, a second emergency brake application was initiated. After train 003 again came to a stop, the operator continued southbound, moving his train over switch 85A, which was still lined for the work train's reverse movement from the northbound track to the southbound track. Because the switch was lined reverse, or against train 003, the wheel did not have a path forward; it climbed the rail, damaged the switch, and began to derail the train.

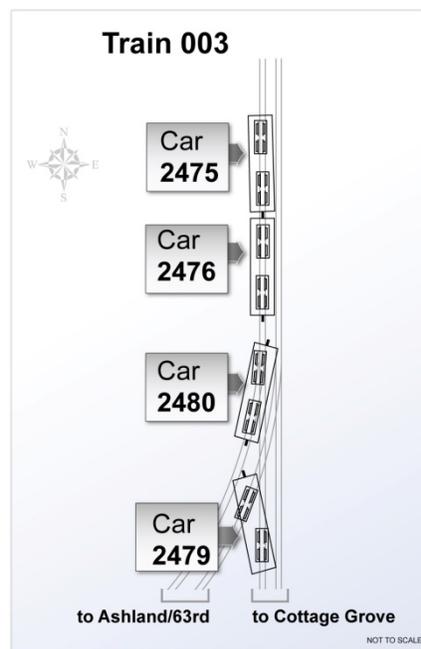
The first and the fourth cars (2479 and 2475) of train 003 derailed heading in a straight direction toward Cottage Grove. The second car (2480) derailed heading in the direction of the curve. The third car (2476) did not derail. (See figure 5.) As the derailment occurred, the work train continued moving toward Cottage Grove on the southbound main track.

**Figure 5.** Cars of train 003 shown with wheel sets indicating resting positions after derailment.
