National Transportation Safety Board

Railroad Accident Brief

Accident No.: DCA-10-FR-004
Location: Washington, D.C.
Date: February 12, 2010
Time: 10:16 a.m., eastern standard time¹
Railroad: Washington Metropolitan Area Transit Authority
Property Damage: \$174,000
Injuries: 3
Fatalities: 0
Type of Accident: Derailment

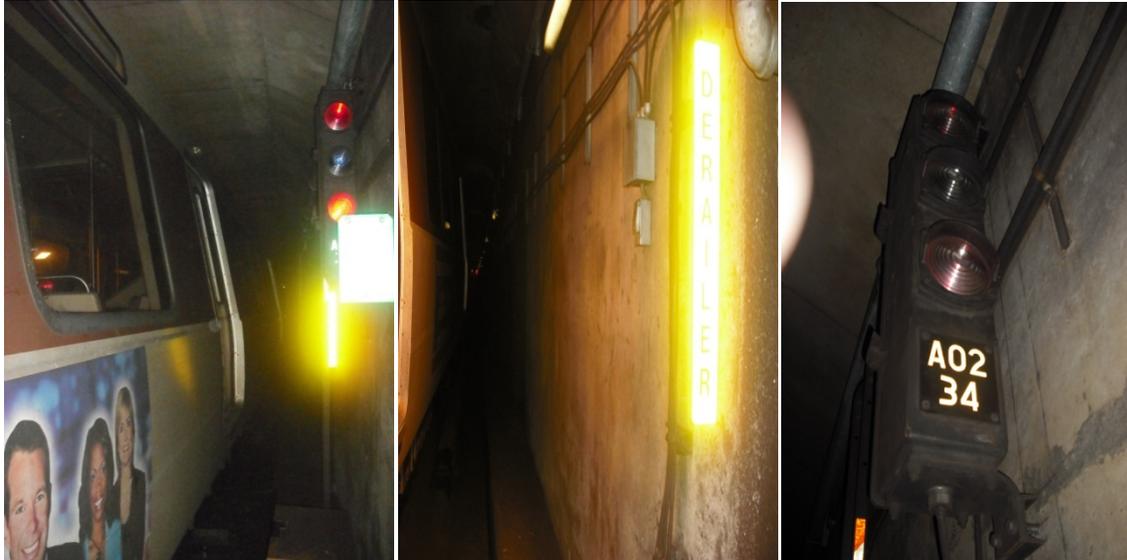
The operator of train 156 initiated a movement forward at about 7 mph toward the north end of the pocket track, past the red signal, and over a derail. The front wheel set of the lead car derailed onto the ground. The train operator reported that she was not looking for a derail and did not see one. (See figures 2 and 3.) The front set of wheels of the derailed car traveled 27.9 feet north of the point of derailment, where the train stopped.

Figure 2. Three views, facing north, of the signal and reflective warning sign for the derail.

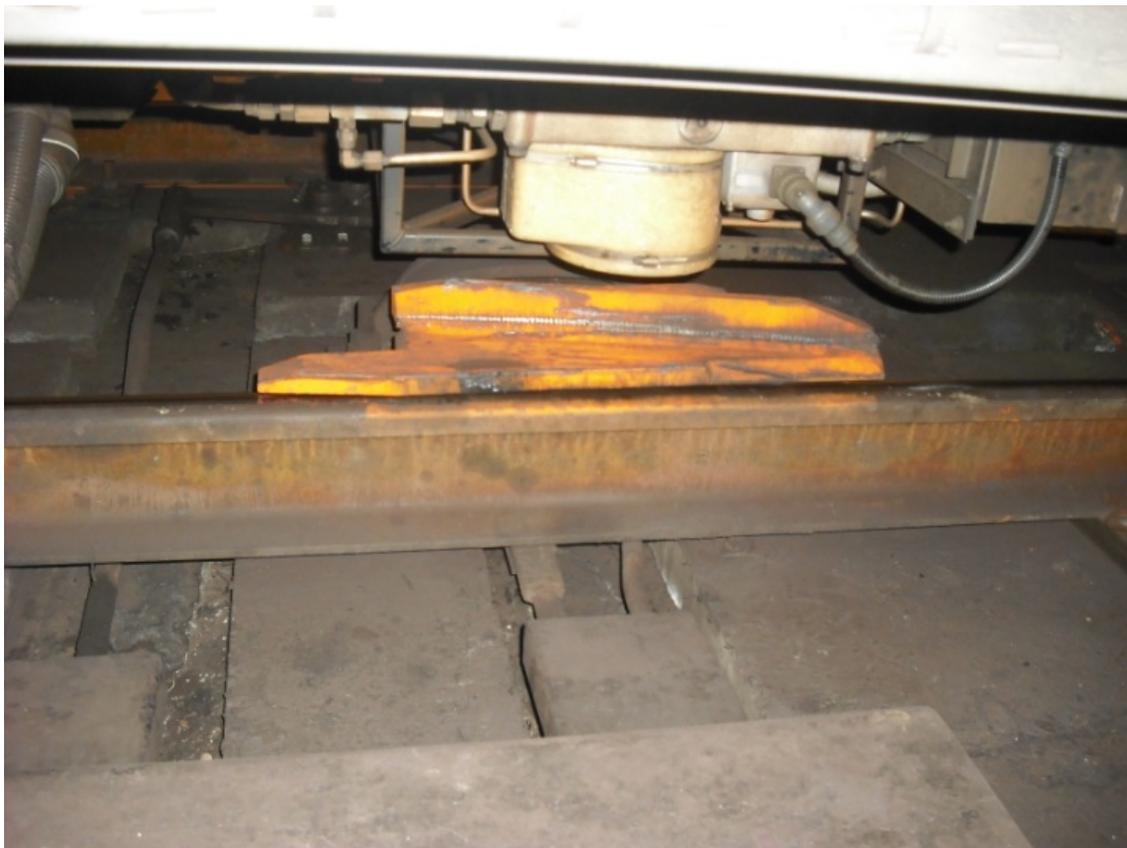
Figure 3. Derail in the normal position for a red signal.

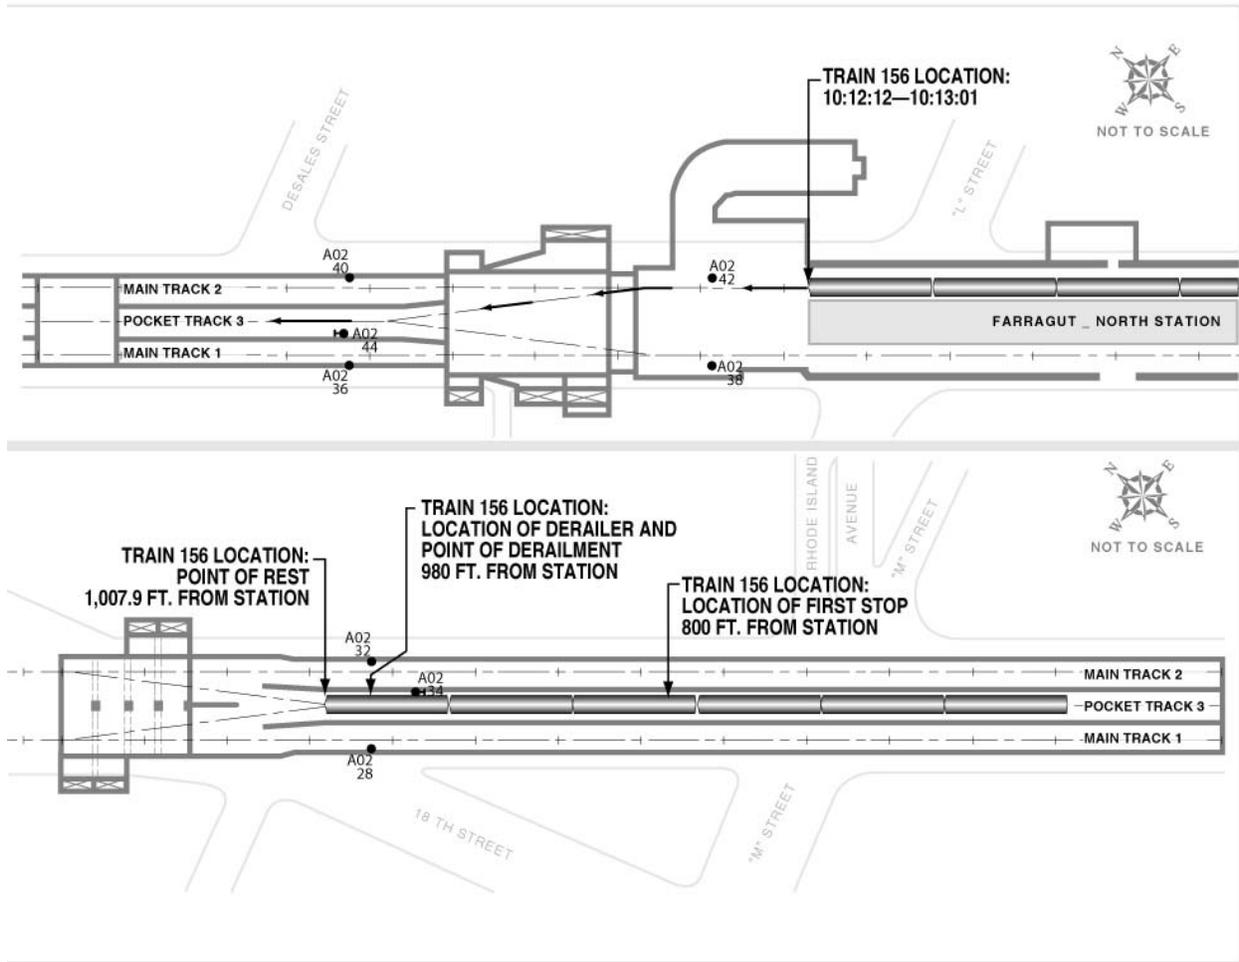
The event recorder data were downloaded following the accident. A data plot was compiled for the 4 minutes before the derailment of the lead car. The data showed that train 156 stopped at the Farragut North station at 10:12:12. At 10:13:01, the master controller was advanced to the P3 position, and the train began moving. The train traveled about 800 feet and reached a speed of about 15 mph before stopping. The train remained stopped for about 1 minute 15 seconds. Then, the master controller was advanced to the P4 position and the train started moving again. Over the subsequent 3-second period, the master controller was reduced gradually to the coast position. The train continued moving at about 7 mph until the operator applied the emergency brake. The distance traveled during the second movement was about 180 feet. (See figure 4.)

Figure 4. Schematic of track and signal locations at the Farragut North station showing the movement of train 156 from the No. 2 main track into the No. 3 pocket track.
