National Transportation Safety Board

Railroad Accident Brief

Accident No.: DCA-11-FR-004
Location: Mineral Springs, North Carolina
Date: May 24, 2011
Time: 3:35 a.m. eastern daylight time
Railroad: CSX Transportation
Property Damage: \$1.6 million
Injuries: 2
Fatalities: 2
Type of Accident: Rear-end collision

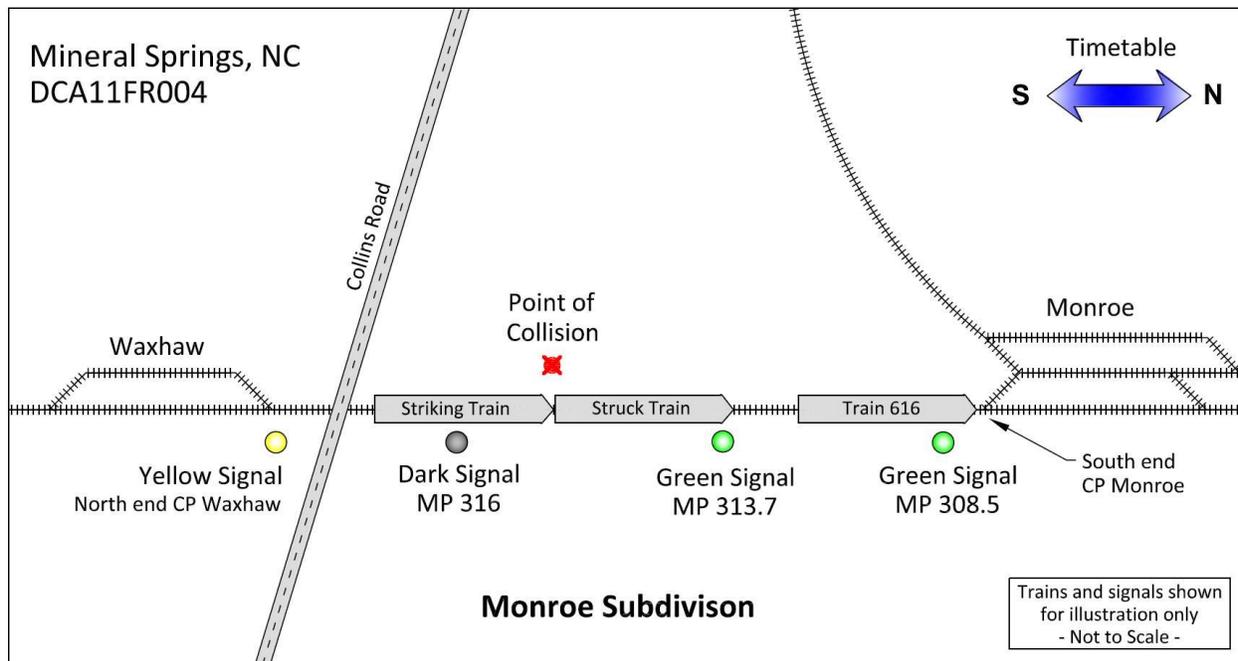
After stopping at the signal for about 10 minutes, train 616 began to move northward after receiving a green signal. Then the crew of the struck train received a green signal to proceed, and their train was struck by the striking train. (See figure 2.)

Figure 2. Diagram of accident area.

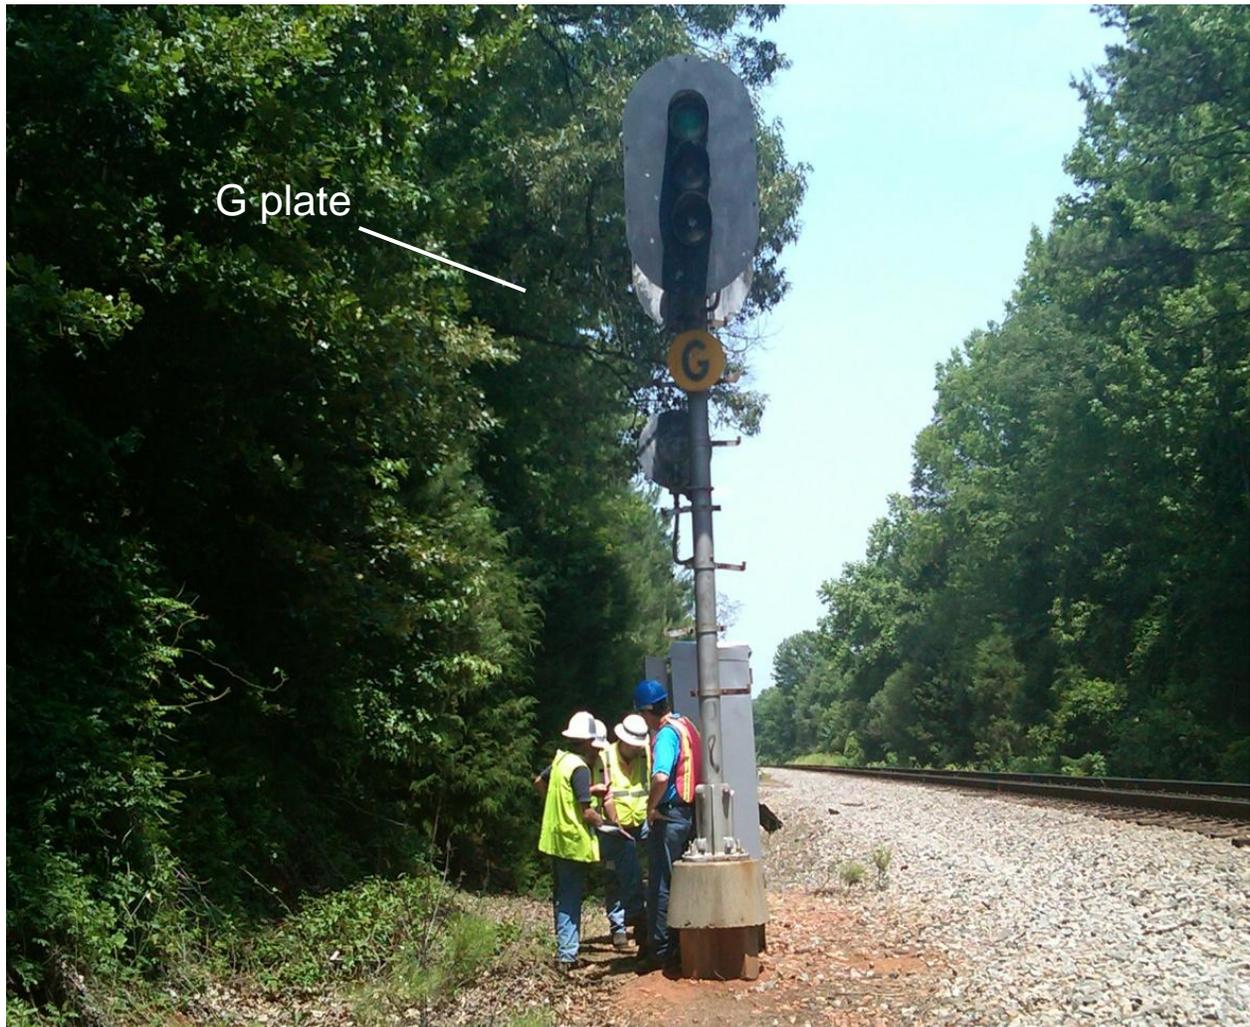
National Transportation Safety Board (NTSB) investigators examined data from the forward-facing video camera on the striking train’s locomotive. The data showed that when the striking train reached the signal at MP 316, the signal was dark (that is, not illuminated). This dark signal also was verified by investigators during postaccident signal testing. According to the CSX operating rules, a dark signal requires train crews to reduce train speed to the most restrictive indication the signal can convey and to contact the train dispatcher promptly. A G plate,⁴ which was attached to the signal mast, allowed the train to pass the dark signal without stopping, but at a restricted speed of no more than 15 mph.⁵ (See figure 3.) However, the striking train proceeded at 31 mph past the dark signal. The train accelerated and was traveling about

Figure 3. NTSB signal investigators inspecting signal at MP 316 with attached G plate.

Testing of the signal at MP 316 revealed that the red aspect⁶ of the signal was not illuminated. Further testing found that the signal lamp for the red aspect was burned out.

During the on-scene investigation, CSX representatives recognized a fault in the CSX signal incident reporting procedures. The CSX implemented a corrective change, and reporting procedures now allow only one signal incident to be reported on each trouble ticket. To close a ticket, signal personnel must enter a specific remedy for the reported incident.
