National Transportation Safety Board

Railroad Accident Brief

Accident No.: DCA-11-FR-001
Location: Tiskilwa, Illinois
Date: October 7, 2011
Time: 2:14 a.m. central daylight time
Railroad: Iowa Interstate Railroad
Property Damage: \$1.6 million
Injuries: 0
Fatalities: 0
Type of Accident: Derailment and hazardous materials release and fire

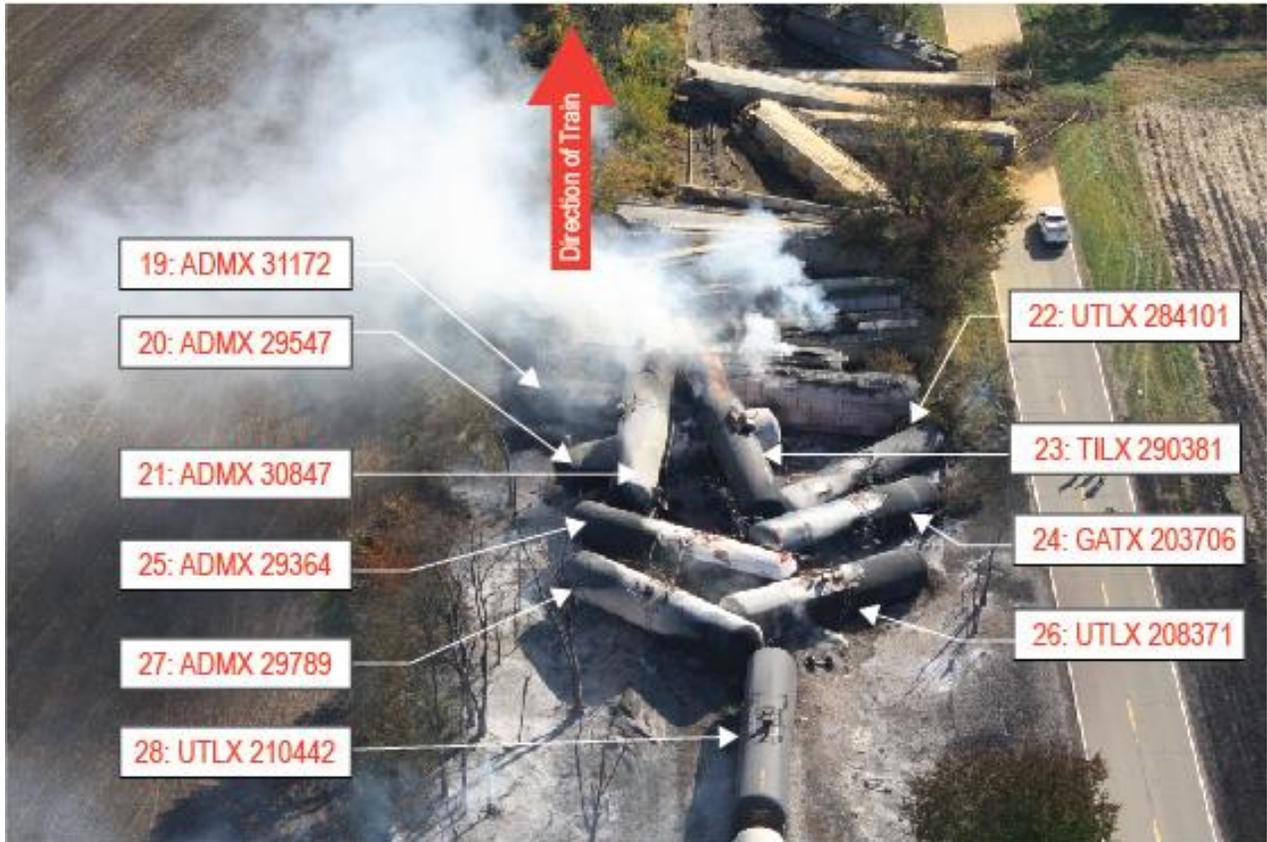
Figure 1. Aerial photograph of derailment looking east.

The first 26 cars behind the locomotives had derailed. The first 15 derailed cars were covered hopper cars carrying corn mash followed by a hopper car carrying sand and 10 tank cars carrying ethanol. Nine of the derailed ethanol cars were damaged and lost product, which burned. (See figure 2.) The intense fire caused three of the tank cars to fail and erupt in massive fireballs.

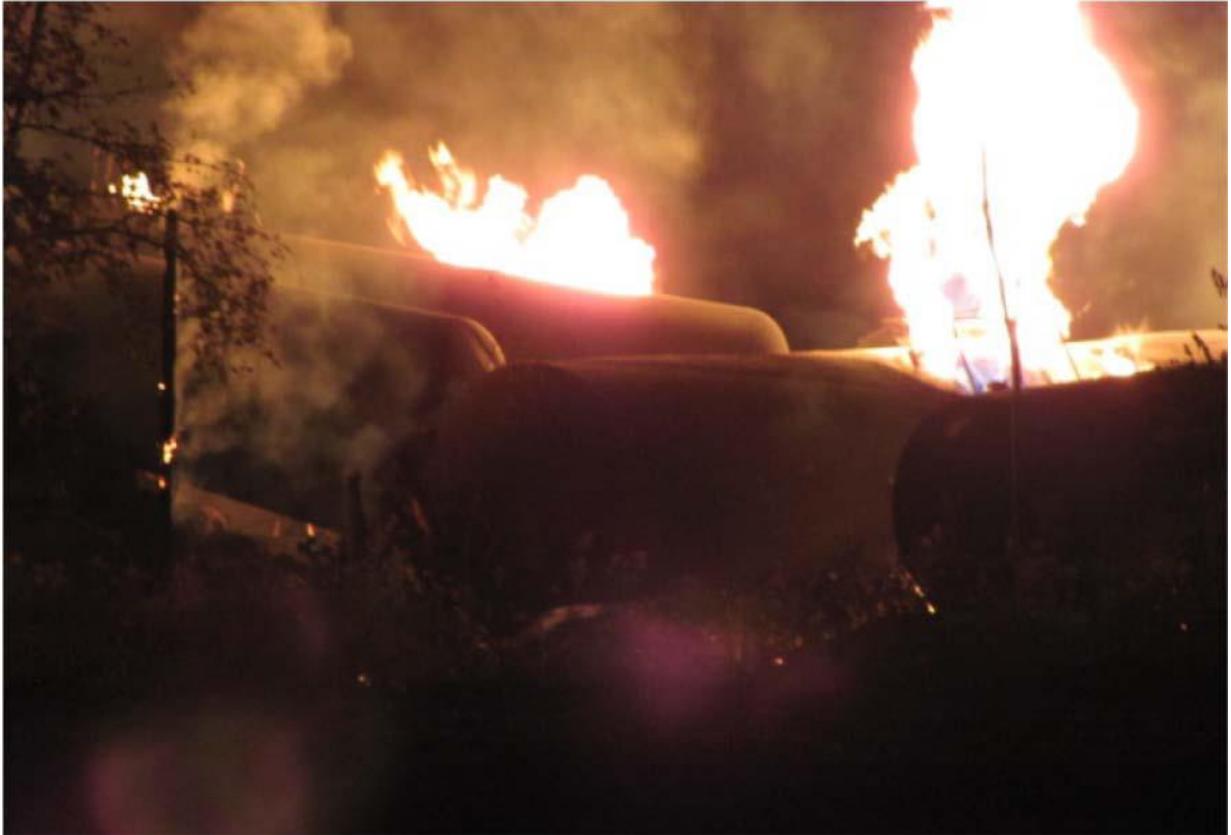
Figure 2. Intense ethanol-fueled fires from several derailed tank cars.

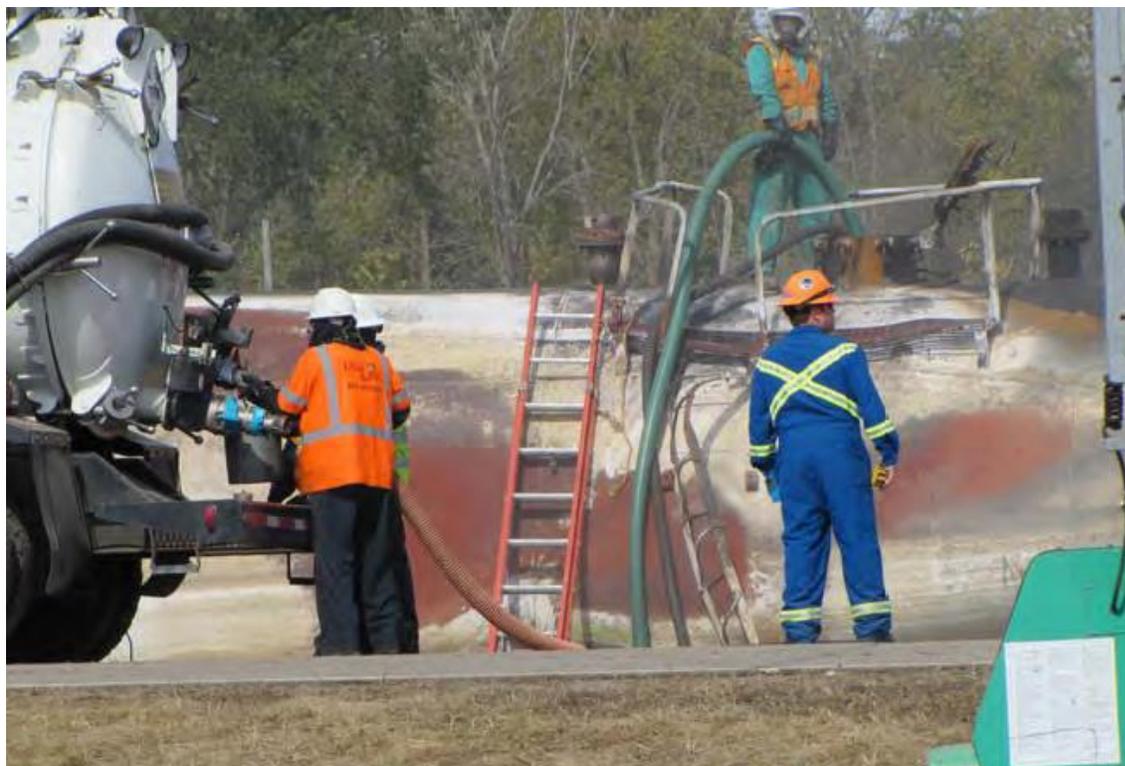
After the fires were extinguished and the equipment cooled, transloading of the tank car contents began. (See figure 3.) This process took several days and mitigated the release of ethanol into the surrounding environment.

Figure 3. Crews pumping remaining ethanol from derailed tank car.

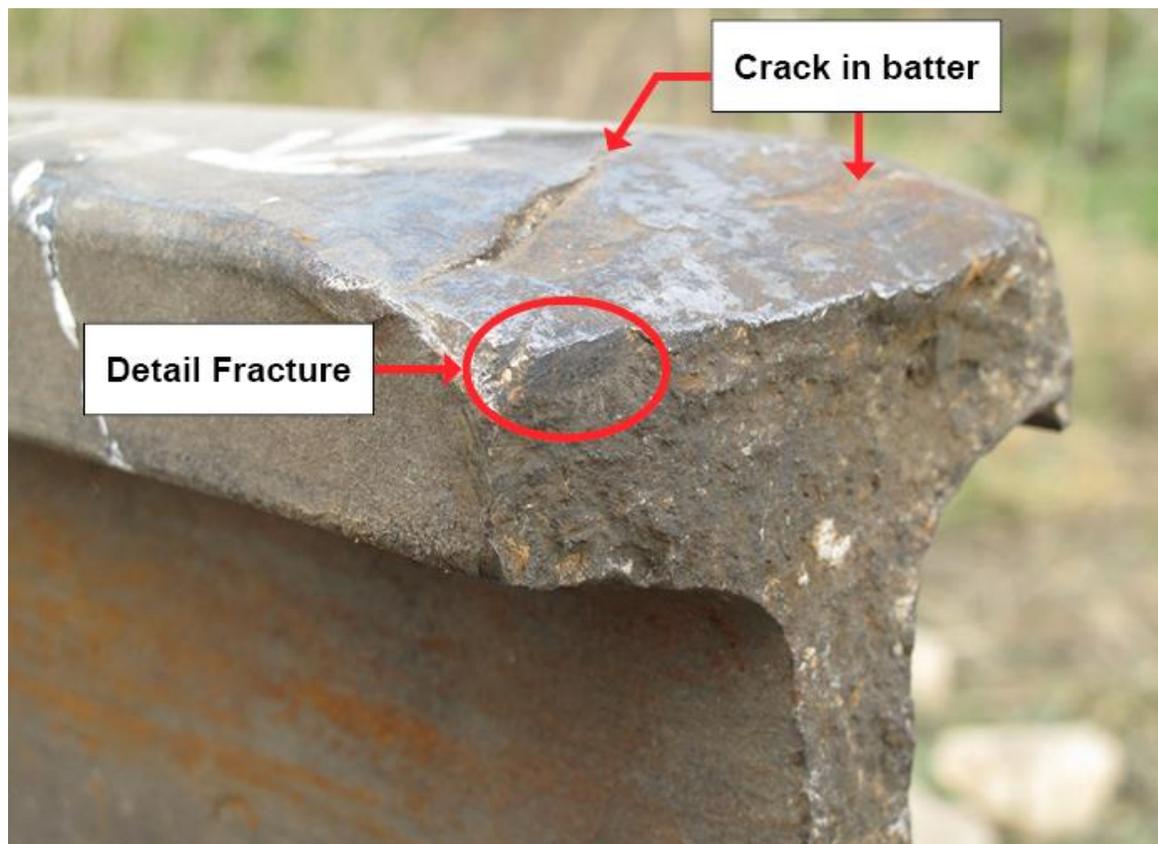
Rail pieces adjacent to the severely battered rail end about 100 feet into the derailment area were sent to the NTSB Materials Laboratory in Washington, DC, for detailed documentation, examination, and analysis. The running surface adjacent to the severely battered fracture face was flattened and deformed downward, and the upper portion of the fracture in the rail head had been obliterated by receiving rail end batter. (See figure 4.) The field side⁷ of the head had an overall downward deformation near the fracture face. No evidence of preexisting cracks was observed.

Figure 4. Rail head at east end of west rail fracture showing severe rail end batter and detail fracture.

Investigators found a detail fracture⁸ that measured about 3 percent of the original head area. Because a small section of the rail in the POD area was missing, investigators could not determine whether this rail defect caused the derailment; however, the other physical evidence points to a broken rail as the initiating factor. Also, it is unlikely that a detail fracture of only 3 percent of the original head area would cause a derailment.

The train crew's experience of a severe impact under the lead locomotive wheels, the locomotive recordings, the physical evidence of lateral markings on the lead locomotive wheels, and the presence of severely battered rail all indicate that the rail broke prior to the derailment.
