# National Transportation Safety Board

## Railroad Accident Brief

### The Belt Railway Company of Chicago Employee Fatality

<b>Accident No.:</b>	DCA11FR005
<b>Location:</b>	Bedford Park, Illinois
<b>Date:</b>	July 25, 2011
<b>Time:</b>	12:33 a.m., central daylight time
<b>Railroad:</b>	The Belt Railway Company of Chicago
<b>Property Damage:</b>	\$120
<b>Injuries:</b>	0
<b>Fatalities:</b>	1
<b>Type of accident:</b>	Employee Fatality

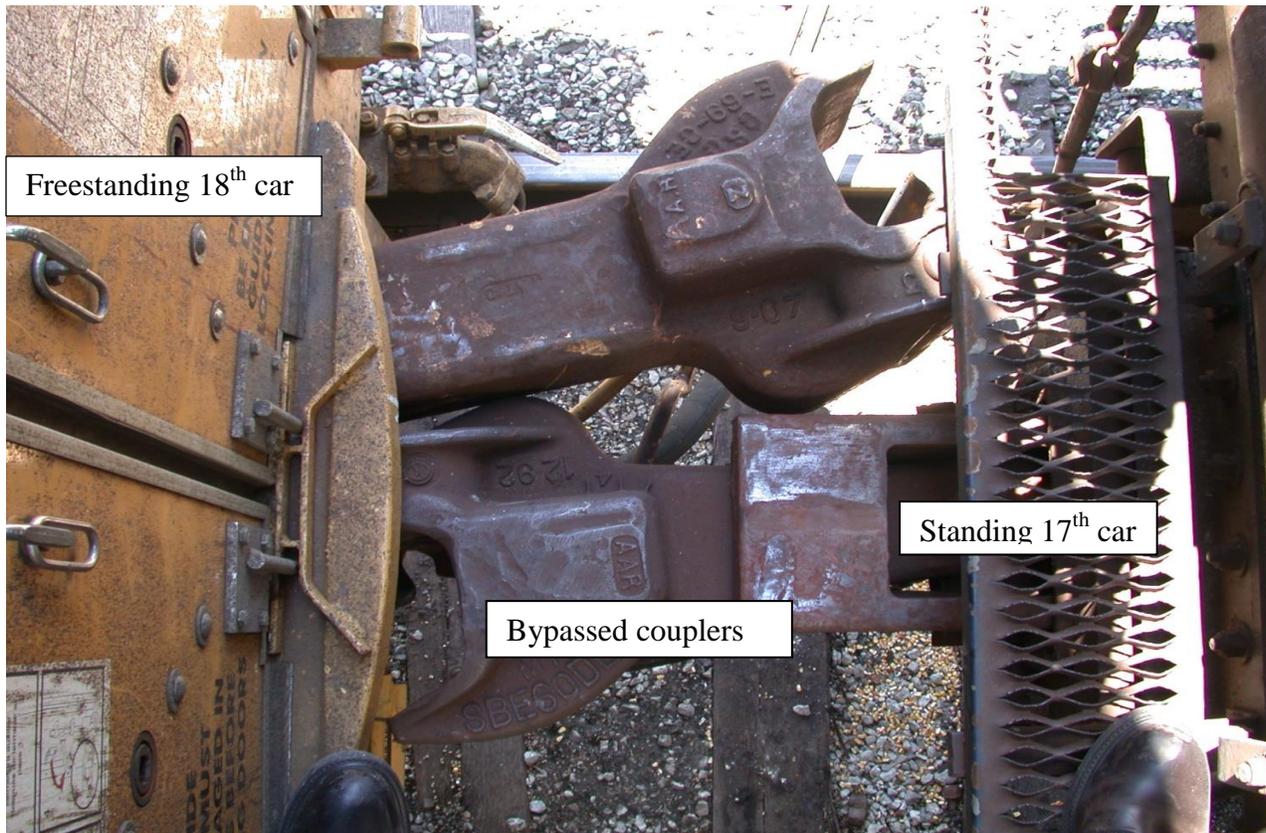
The conductor was found on the ground between the 17th railcar (CSXT box car 140182), which was the last railcar coupled to the lead end of the train, and the 18th railcar (TTUX auto carrier 891054), which was a freestanding railcar. The NTSB found the couplers

were by-passed or crossed between these two cars (see figure 1) and noted that the handbrake of the 18th railcar had not been set.

**Figure 1.** By-passed couplers on the 17th and 18th cars.

The BRC safety rules 31.14.1 and 31.14.2 mandate, in hump bowl tracks and other yard tracks where cars are likely to roll together, cars must be separated at least 100 feet with sufficient handbrakes applied, but not less than one handbrake, on the unattached cars to prevent movement before going between cars to perform work on cars. In addition, the controlling Remote Control Operator (RCO) must apply a “three-point protection,” which means the RCO must apply the locomotive air brakes, center the reverser, and apply the train air brakes, when necessary. These actions required 2 to 4 minutes per coupling. Recorded data indicated that the conductor did not apply three-point protection, and equipment inspection showed that the handbrakes were not set on the free rolling car.

The National Transportation Safety Board determines that the probable cause of the accident was the failure of the conductor to apply the necessary protections before he stepped between the cars to adjust the drawbars. Contributing to the cause of the accident was the BRC’s lack of an effective efficiency testing program to periodically observe and enforce its safety and operating rules for switching movements.

Within 2 months of the fatal accident, the BRC General Manager and a Federal Railroad Administration (FRA) Operating Practice Inspector observed instances in which BRC Safety Rule 31.14.1, *Coupling / Uncoupling Cars*, was violated by switchmen. As a result of these observations, the BRC identified General Code of Operating Rules (GCOR) 7.4, *Precautions for Coupling or Moving Cars or Engines* and 7.6, *Securing Cars or Engines*, and BRC 31.14.1 as critical rules which, if violated, escalated the discipline policy by one step.<sup>5</sup> In October 2011, BRC modified its computer program that tracks efficiency testing so every employee is tested at least every 365 days on critical rules.
