National Transportation Safety Board

Railroad Accident Brief

CSX Transportation Coal Train Derailment Killed Two Individuals

Accident No.:	DCA12MR009
Location:	Ellicott City, Maryland
Date:	August 20, 2012
Time:	11:54 p.m. eastern daylight time
Train:	CSX Transportation coal train U81318
Railroad:	CSX Transportation
Property Damage:	\$1.9 million
Injuries:	0
Fatalities:	2
Type of Accident:	Derailment

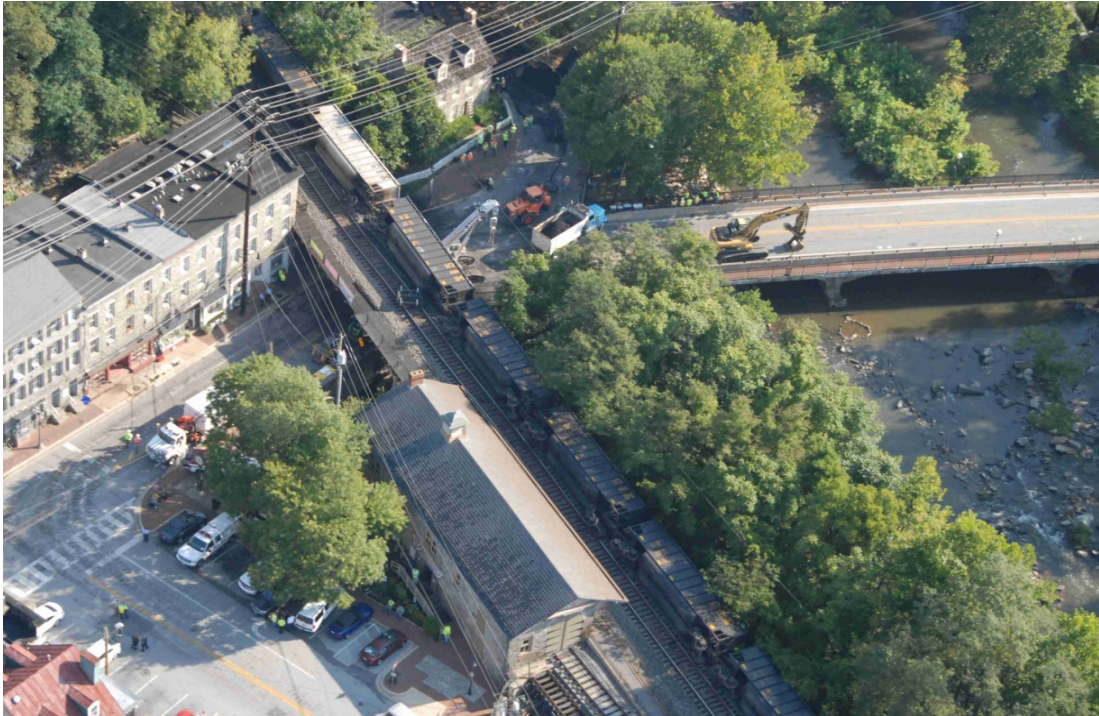
On August 20, 2012, about 11:54 p.m. eastern daylight time, an eastbound CSX Transportation (CSXT) coal train, U81318, derailed the first 21 cars at milepost (MP) 12.9 while crossing the railroad bridge over Main Street on the Old Main Line (OML) Subdivision in Ellicott City, Maryland.^{1,2} The train consisted of two locomotives and 80 loaded coal cars; the train length was 4,227 feet and the weight was 9,873 trailing tons. Seven of the derailed cars fell into a public parking area that was below and north of the tracks. The remainder of the derailed cars overturned and spilled coal along the north side of the tracks. (See figure 1.)

Figure 1. Derailed train on the railroad bridge. (Photo by the Howard County Police Department)

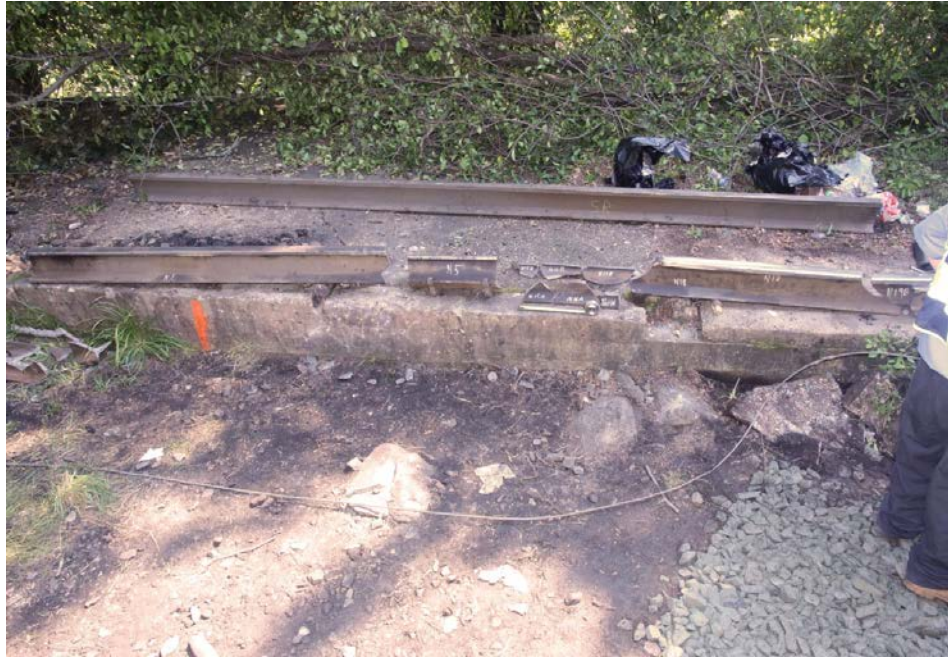
Investigators pieced together and examined the recovered rail. The entire south rail was reconstructed. While reconstructing the west portion of the north rail, investigators found that about 5 inches of rail were missing (and could not be located in the derailment debris). Based on the inspection data for July and August 2012, investigators estimated that the length of rail from the west end of piece N1 to the location of the repaired defect in N19 was about 17 feet 1 inch (205 inches).

Figure 3. View of rail rebuild.

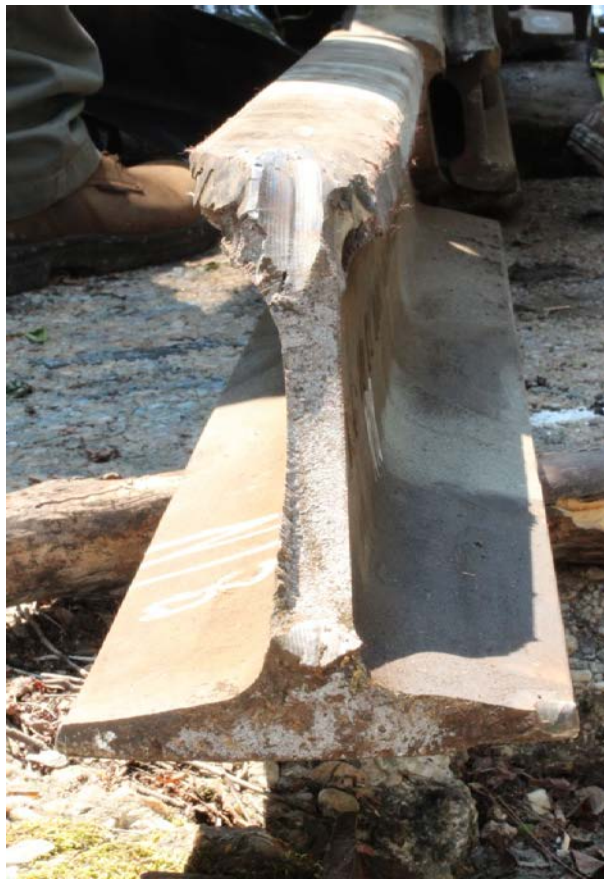
The rail under the derailed cars was destroyed. Some sections of the broken rail had indications of overstress fractures that are characterized by a shiny, granular appearance with sharp edges around the freshly exposed metal. In addition, a section of broken rail that was found under car 21, had the appearance of recent longitudinal loading at the exposed edge of the rail head that is consistent with wheel tread impacts.^{4,5}

Figure 4. Cross-sectional view of a severe wheel flange strike mark on the head of a broken rail.
