National Transportation Safety Board

Railroad Accident Brief

CSXT Petroleum Crude Oil Train Derailment and Hazardous Materials Release

Accident No.:	DCA14FR008
Location:	Lynchburg, Virginia
Date:	April 30, 2014
Time:	1:54 p.m. eastern daylight time
Train:	CSXT Train K08227
Railroad:	CSX Transportation (CSXT)
Property Damage:	\$1,224,000
Injuries:	0
Fatalities:	0
Type of Accident:	Derailment with hazardous materials and fire

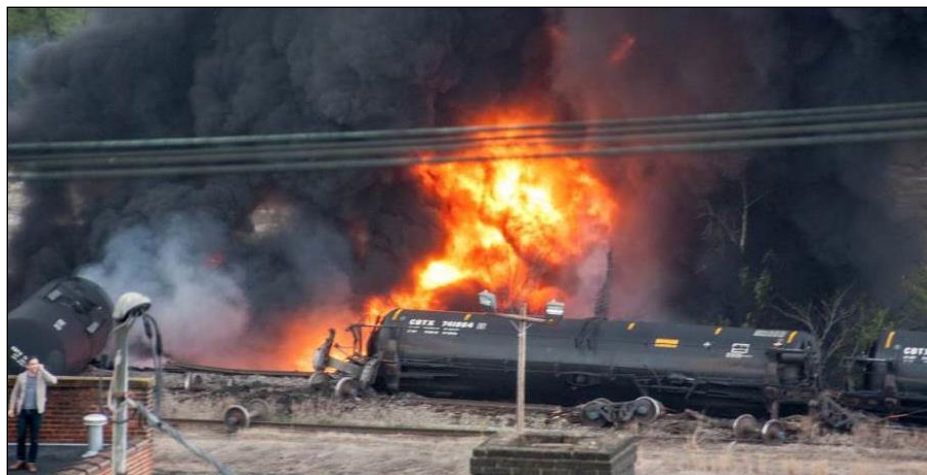
On April 30, 2014, at 1:54 p.m. eastern daylight time, 17 CSX Transportation (CSXT) tank cars on petroleum crude oil unit train K08227 derailed in Lynchburg, Virginia.¹ Three of the derailed cars were partially submerged in the James River. One was breached and released about 29,868 gallons of crude oil into the river, some of which caught fire. (See figure 1.) No injuries to the public or crew were reported. At the time of the accident, it was cloudy and raining lightly; the temperature was 53° F. The CSXT estimated the damages at \$1.2 million, not including environmental remediation.

Figure 1. Accident scene.

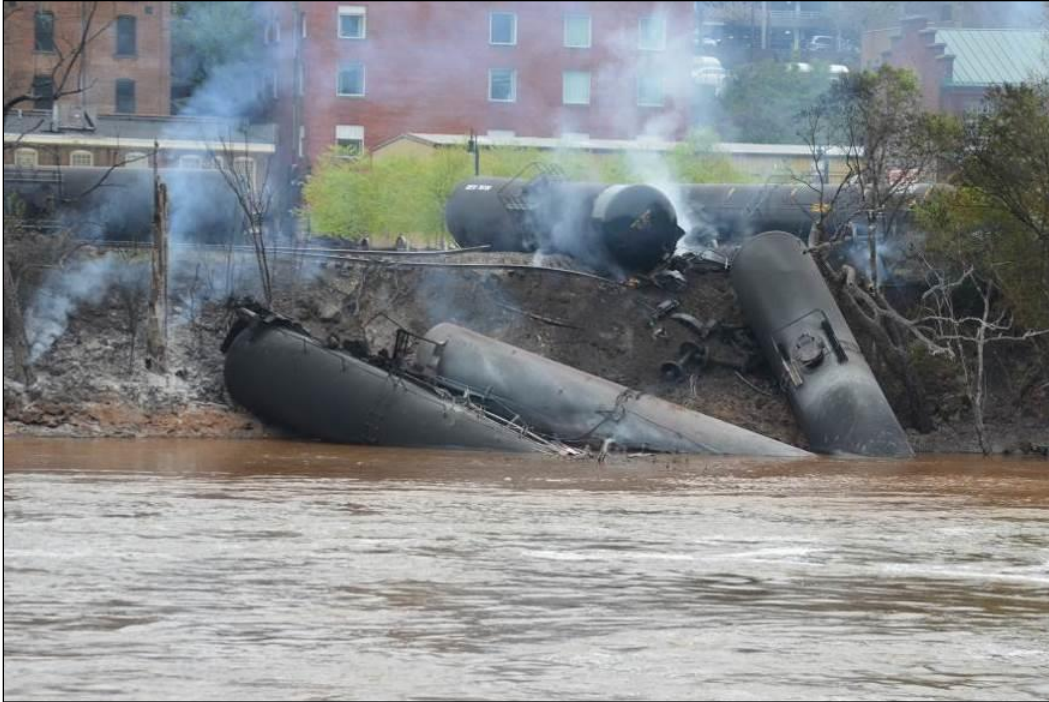
Only tank car CBTX 741712 in position 44 was breached. It released its contents, and the contents caught fire. The tank cars in positions 43 and 46 were exposed to the fire, but they were not breached. (See figure 3.) All three met the CPC 1232 standard.

Figure 3. Smoldering, derailed tanks cars on the bank of the James River.

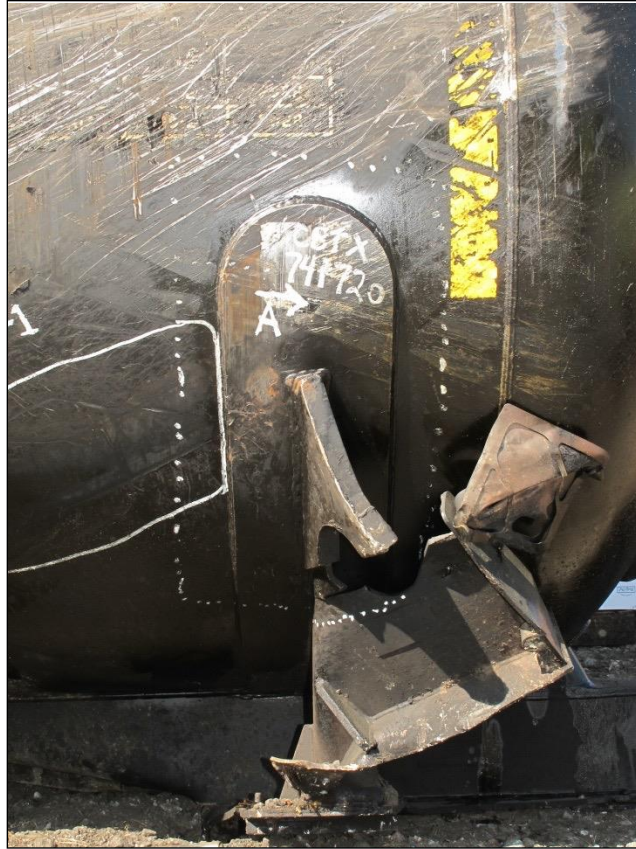
NTSB investigators inspected all derailed tank cars, and samples were cut from the car that was hanging over the riverbank (CBTX 741720) and the breached tank car and shipped them to the NTSB materials laboratory in Washington, DC, for examination. Most of the damage to the car that was hanging over the riverbank occurred on the right side of the tank, particularly to the A end of the right body bolster.⁹ The lower portion of the body bolster web was deflected toward the A end, while the upper portion—constructed out of solid, 2-inch thick steel—was partially deflected. (See figure 4.)

Figure 4. Right body bolster, A end, of CBTX 741720.

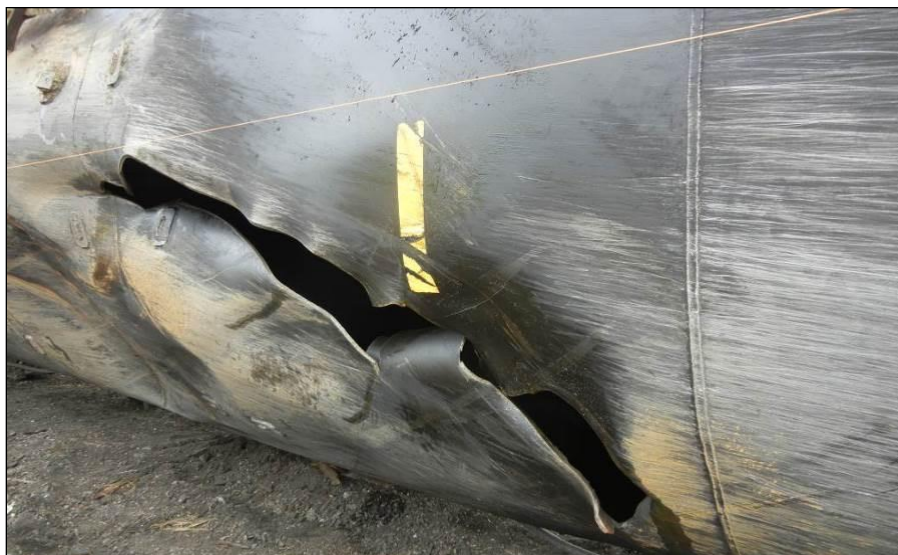
The tank car in position 44, CBTX 741712, had an approximately 95-inch long tear on the right side of its shell (tank car wall) that ran through two shell rings.¹⁰ (See figure 5.) The tear occurred below the centerline. The NTSB examination indicated that an object scraped the shell of the tank car and tore into the shell at the longitudinal seam weld between two rings, producing two coiled rolls of metal that extended into the inside of the tank.

Figure 5. Tear in shell of tank car CBTX 741712.
