# National Transportation Safety Board

## Railroad Accident Brief

Train Collision with End of Track  
Felton, California

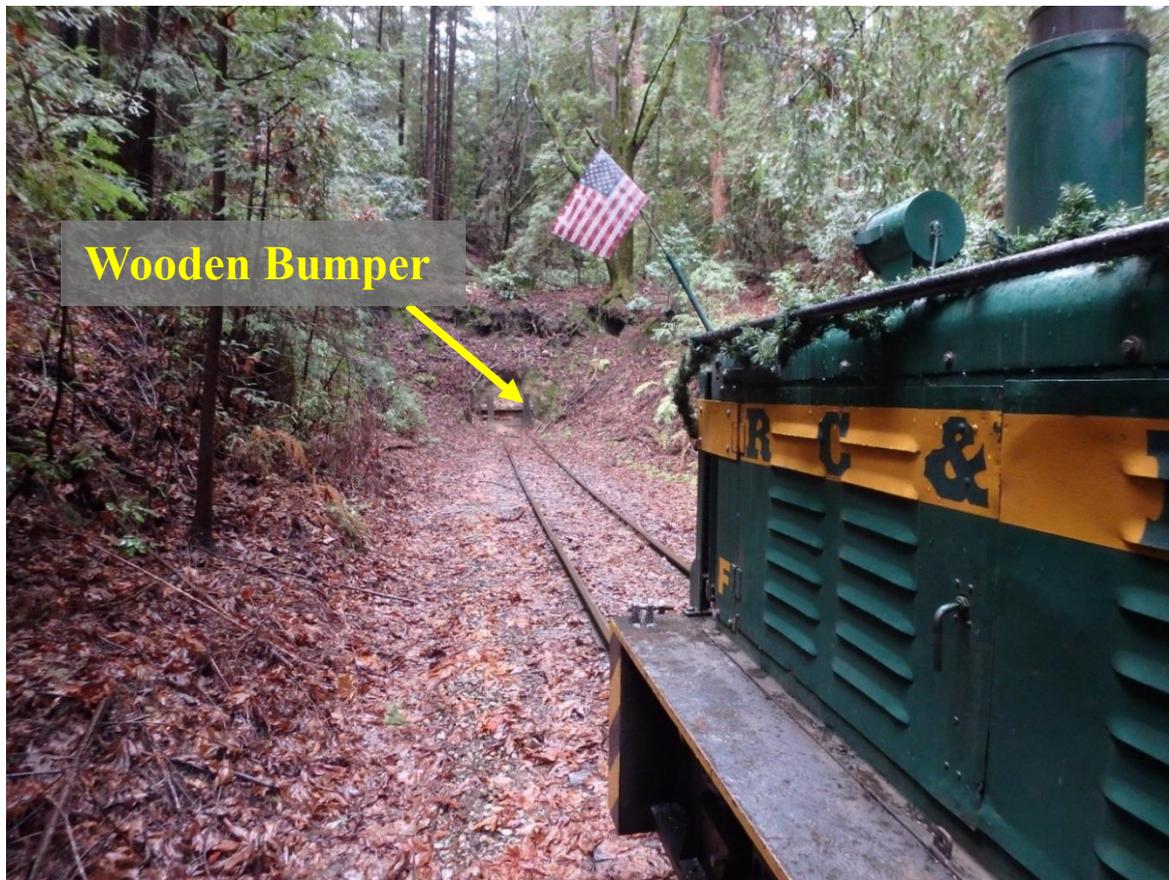
On December 28, 2015, about 11:55 a.m., Pacific standard time, a Roaring Camp & Big Trees Narrow Gauge Railroad (RCBT) tourist/excursion train struck a wooden bumper at the end of a switchback track in Felton, California.<sup>1</sup> The train had 39 passengers, six of whom received minor injuries. The weather at the time of the accident was partly sunny with the wind out of the east at 5 miles per hour (mph) and the temperature was 49°F.

**Figure 1.** Accident location at the end of the switchback.

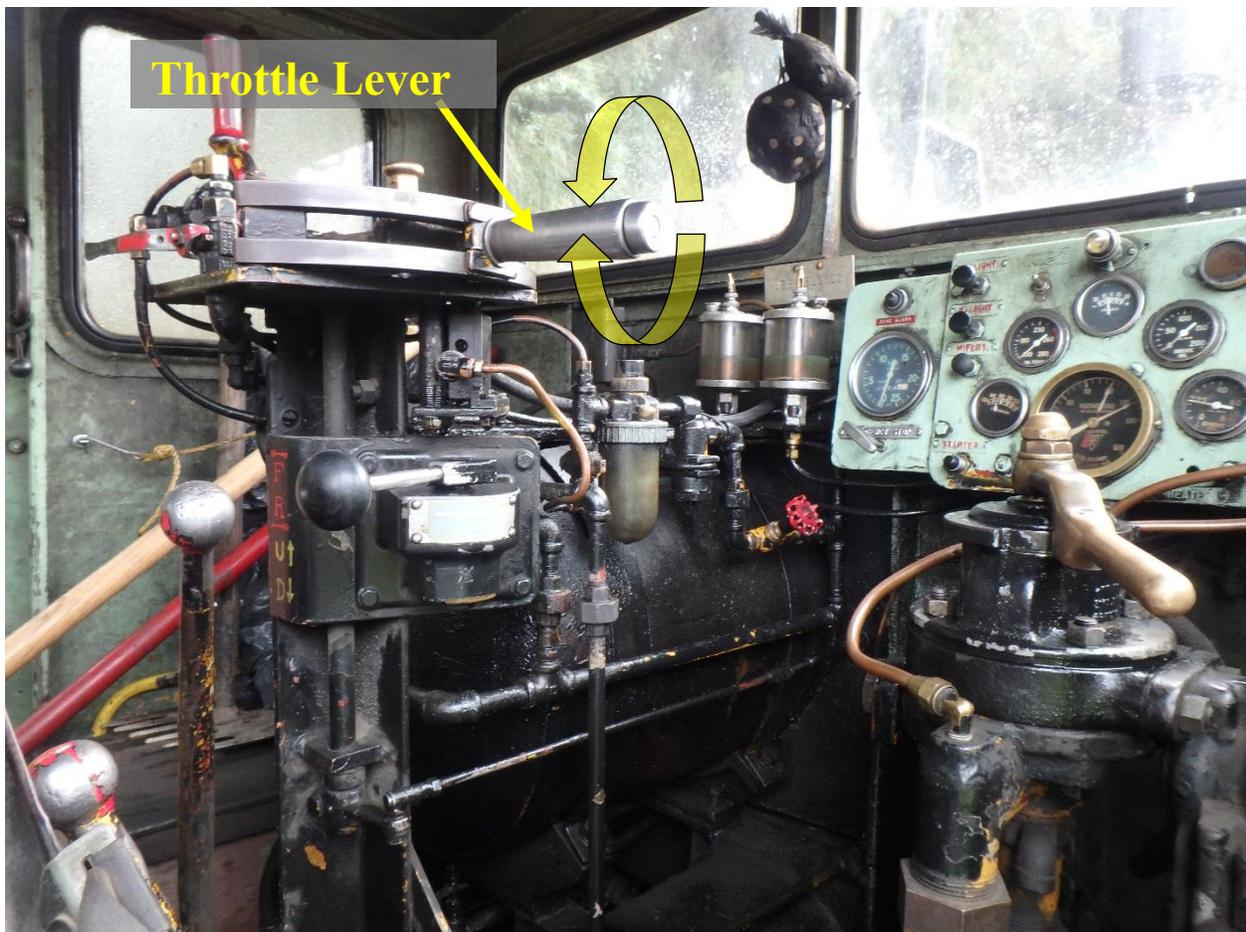
A throttle lever at the top of the control stand in the locomotive cab controlled the locomotive speed and operated the clutch ahead of the torque converter. (See figure 2.) Twisting the throttle handle would apply a friction shoe and hold the throttle lever in any desired position.

**Figure 2.** Locomotive control stand.

Postaccident testing of the control stand determined that the friction shoe prevented the throttle lever from returning to the idle position when the throttle lever was twisted, applying the friction shoe. As designed, the friction shoe would not allow placement of the throttle lever in idle while engaged. The only way to recreate the scenario from the day of the accident, as described by the engineer, was by applying the friction shoe on the throttle lever and attempting to manipulate the throttle lever back to the idle position. However, the friction shoe prevented the engineer from returning the throttle lever to the idle position. No exception to the operation of the throttle lever was noted.

During the postaccident interview, the engineer stated that when he operated the locomotive, he usually used his hand to hold the throttle lever in the desired position instead of using the friction shoe. The throttle lever did not have any indications or markings to indicate to the engineer when the friction shoe was engaged.

The National Transportation Safety Board determines that the probable cause of the accident was the engineer's application of the throttle lever friction shoe that prevented the throttle lever from being placed into the idle position and his failure to stop the train by using the emergency engine stop lever or pneumatic clutch control valves before the collision with the wooden bumper at the end of the track.

Prior to allowing the accident train engineer to return to work, RCBT provided him with remedial hands-on training on the use of the various emergency stop systems on the locomotive, including using the emergency engine stop lever, emergency brake, pneumatic clutch control valves, and throttle. Conductors received additional training on the requirement that they consistently make safety announcements reminding passengers they must remain seated during the train ride. RCBT also implemented a requirement that the train be stopped if passengers refuse to remain seated while riding the train. In addition, Roaring Camp Railroads has implemented a program of announced and unannounced (efficiency) testing for operating crewmembers which is closely based on the FRA requirements for regulated railroads found in Title 49 *Code of Federal Regulations (CFR)* Part 217. RCBT also implemented a requirement that train crews stop their trains at the switchback where this accident occurred as soon as the rear of the train is clear of the switch.
