National Transportation Safety Board

Railroad Accident Brief

BNSF Railway Crude Oil Unit Train Derailment

Heimdal, North Dakota

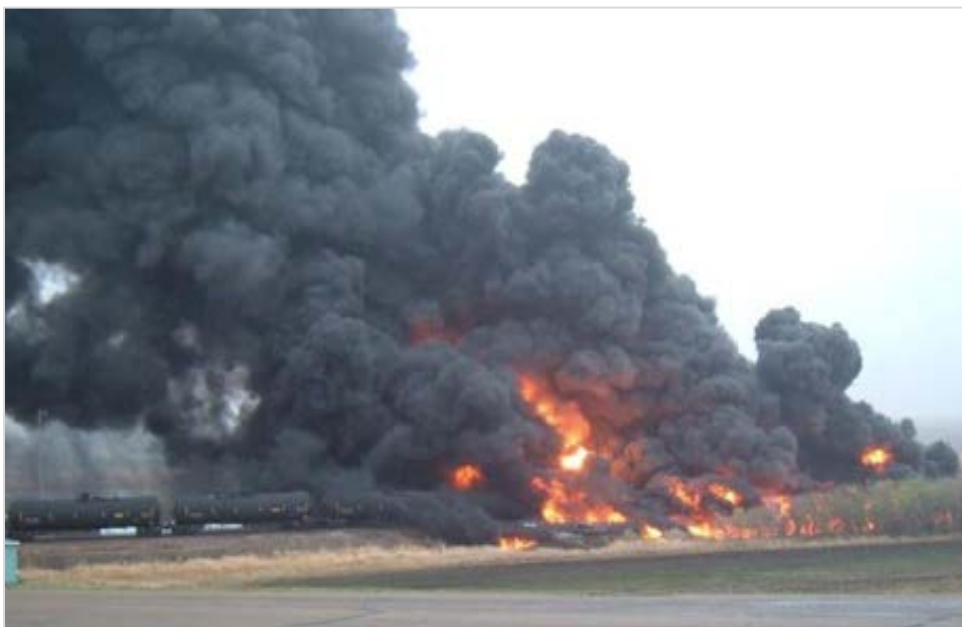
On May 6, 2015, at 7:21 a.m. central daylight time, a BNSF Railway (BNSF) crude oil unit train derailed six cars (81 through 86) near Heimdal, North Dakota.¹ The train, consisting of three locomotives, two buffer cars, and 107 loaded tank cars carrying crude oil, was operating at 45 mph when the cars derailed. The train separated after a broken wheel on the 81st car struck the leading edge of the highway-rail grade crossing at milepost 149.01. A mark on the track structure at milepost 153.87 indicated that the broken wheel could not maintain its normal position on the rail at that point and the derailment sequence began.² The momentum of the train pulled the 81st car and the following five cars off the track. Five of the derailed tank cars breached and released about 96,400 gallons of crude oil, which fueled a fire about 1 mile east of Heimdal.³ About 30 people were evacuated from Heimdal and the surrounding area due to the smoke plume that extended north. At the time of the accident, the sky was overcast and the temperature was 57°F. BNSF estimated damage at \$5 million.

Figure 1. Accident scene.

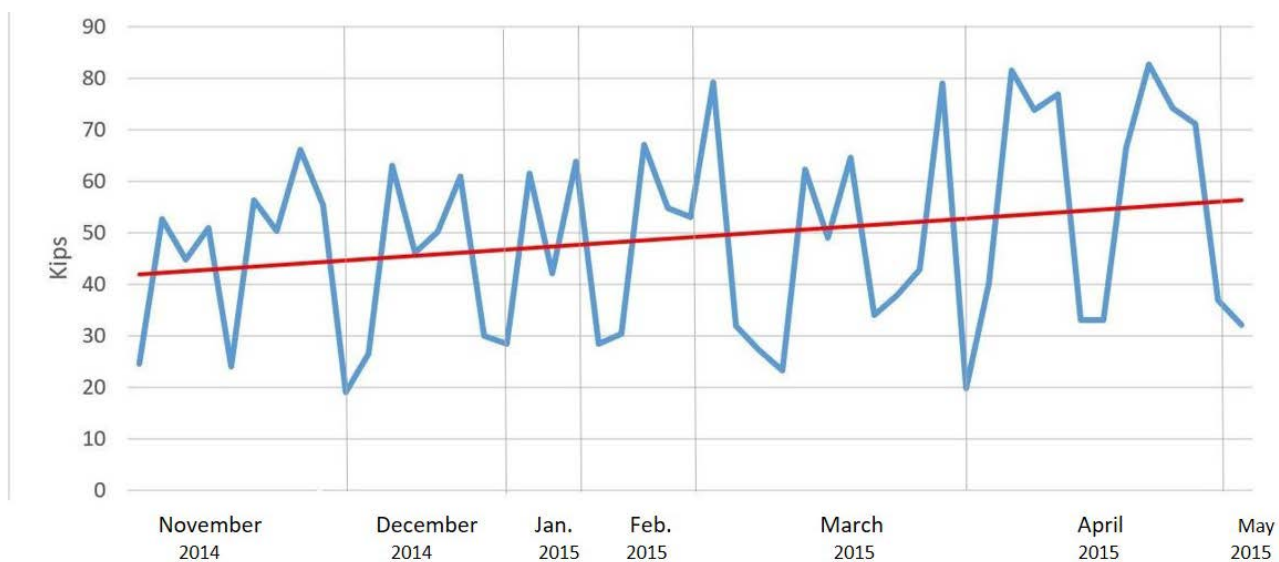
can continue to grow if the wheel is left in service; this process is called wheel shelling. The geometry of the shelled spot on the wheel does not conform to that of the rest of the wheel surface, and the spot impacts the rail with every rotation (similar to a hammer strike on the railhead). The larger the shelled spot, the harder the impact. A preemptive reduction of the high-impact forces is achieved by “truing” faulty wheels and removing damaged wheels.⁶ These actions benefit the railroads by reducing derailments, rail fatigue, bearing damage, cold weather rail fractures, car and truck damage, concrete tie cracking, and wood tie-plate cutting and by improving wheel tread life and fuel efficiency. The WILD data history of the broken wheel indicated increasing forces that exceeded 80 kips before ultimate failure of the wheel. (See figure 2.)

Figure 2. Wheel impact load of car TRFX 1224 November 5, 2014–May 3, 2015.

The impact load of car TRFX 1224 increased between November 5, 2014, and May 3, 2015, to the point where it exceeded 80 kips. In four instances before the derailment, the impact load reading for the subject wheel was near or above 80 kips: (1) March 2, 2015, 79.27 kips; (2) March 30, 2015, 79.02 kips; (3) April 19, 2015, 81.58 kips; and (4) April 24, 2015, 82.74 kips.

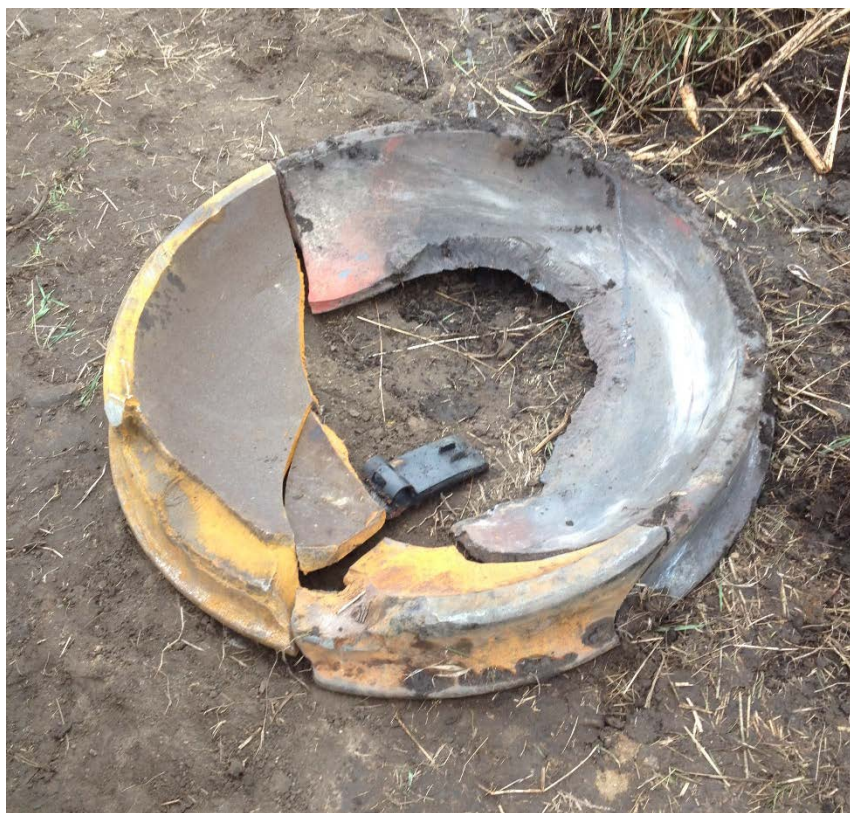
During an inspection of the six derailed cars, investigators found that the left wheel in the second position on car 81 was broken due to a vertical split rim (VSR).⁴ Two pieces of the broken wheel were found at milepost 150.7.

The fractured wheel fragments, sectioned axle halves, and an intact wheel were sent to the NTSB Materials Laboratory for examination. (See figure 3.) The fracture surface exhibited subsurface fatigue cracking parallel to the tread surface of the train wheel followed by a vertical overstress fracture perpendicular to the tread surface running inward. The wheel fracture features were consistent with VSR failure. Subsequent fatigue cracking propagated from the bottom of the VSR. Once these cracks progressed far enough into the wheel, the wheel catastrophically failed due to multiple overstress fractures, leaving a remnant of the inner wheel hub about the axle.

Figure 3. Broken accident wheel at accident site placed as if it were unbroken.

Additional examination of wheel sections found that the wheel met the prescribed chemical composition. The mechanical properties, including hardness and tensile strength, also met all requirements. There were no indications that the fractured wheel was manufactured improperly. Examination of the internal residual stress profile of the wheel found surface compressive stress followed by a subsurface tensile stress region. This residual stress profile was consistent with those of VSR failures and was also consistent with the observed fracture features.

The National Transportation Safety Board determines that the probable cause of this derailment was failure of a wheel on the 81st tank car due to a vertical split rim.
