National Transportation Safety Board

Railroad Accident Brief

Union Pacific Railroad Employee Fatality

Kansas City, Kansas

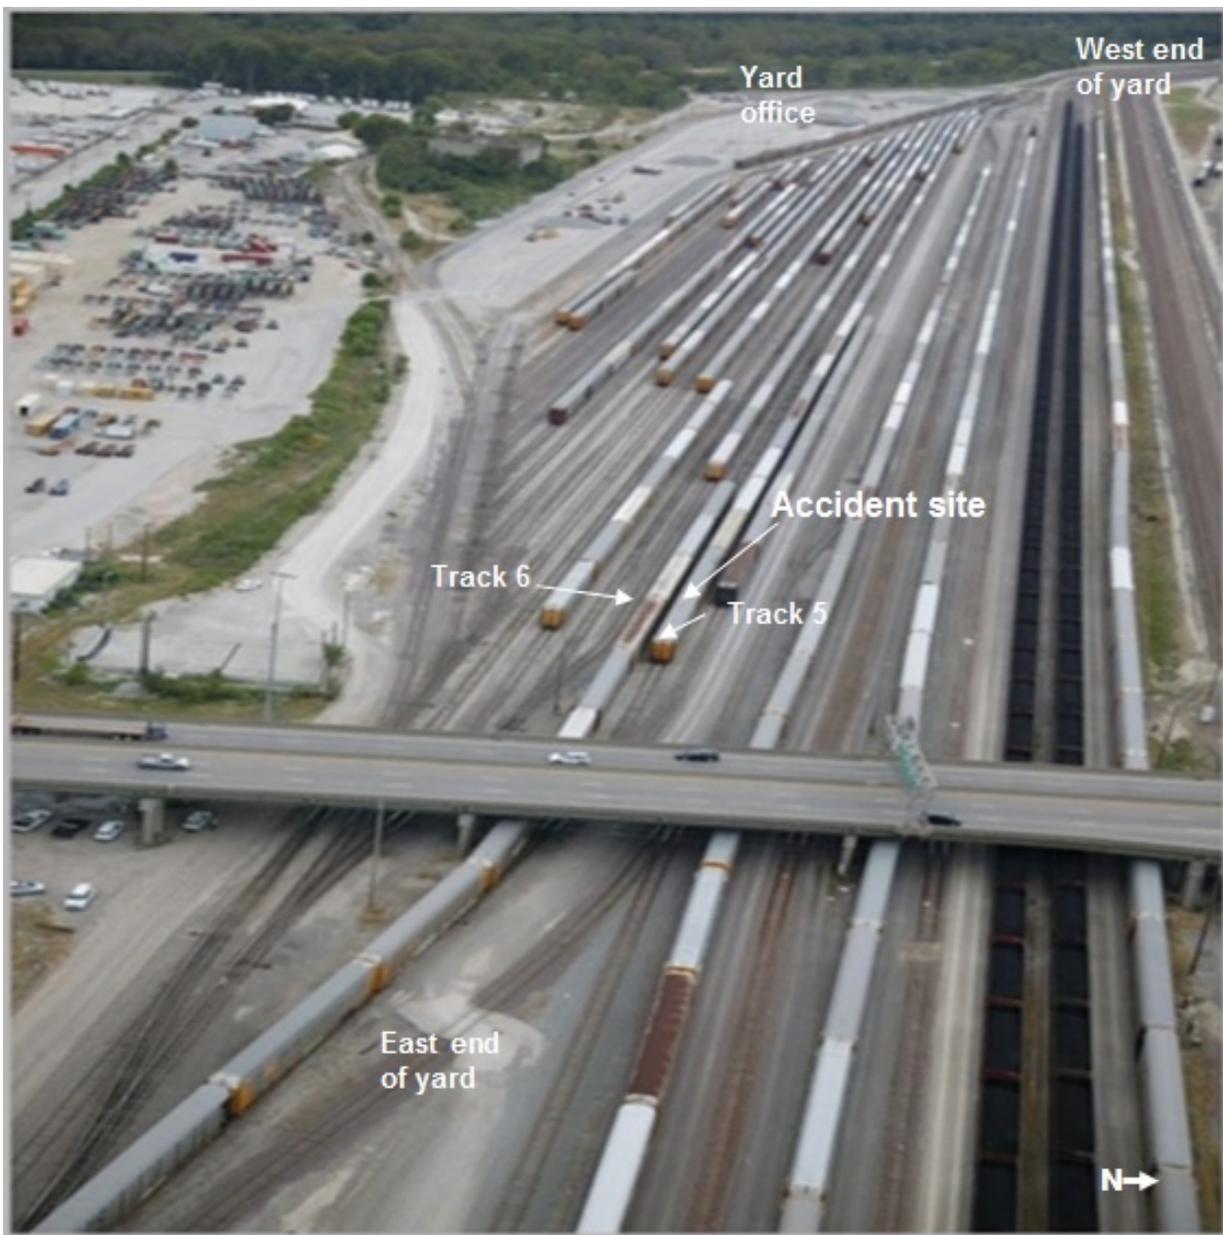
In the minutes before the accident, the east crew was pushing 61 railcars westward on track 6. The east crew foreman had ensured track 6 was clear. At the same time, the west crew was pushing 5 railcars eastward onto track 5, which already had 31 cars on it. Less than a minute after the west crew completed its switching movement on track 5, a man-down alarm was issued across all yard radio channels.⁷ All work in the yard stopped as members of the east and west crews tried to discern if they were receiving a legitimate or false man-down alarm. When the alarm did not stop, indicating a likely legitimate emergency, the crewmembers searched and found the east crew foreman dead in the gage of track 5. He was under the lead railcar of the equipment the west crew had been pushing toward the east end of the yard. (See figure.)

Figure. Aerial view of Armourdale Yard and the accident site. (Photo by UP.)
