National Transportation Safety Board

Railroad Accident Brief

Long Island Rail Road Passenger Train Strikes Platform in Atlantic Terminal

Brooklyn, New York

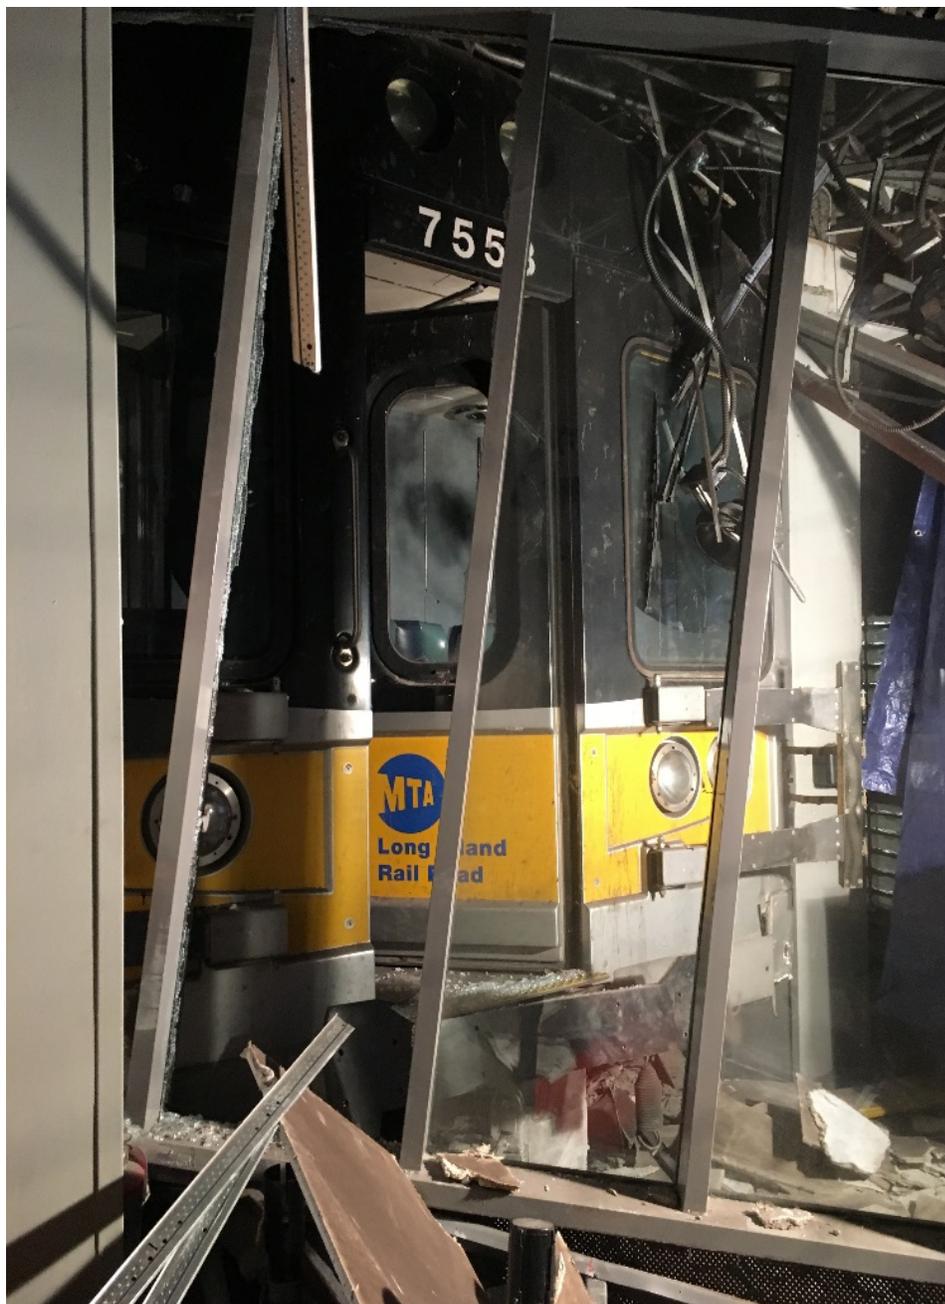
On, January 4, 2017, about 8:18 a.m. eastern standard time, Long Island Rail Road (LIRR) passenger train 2817, consisting of six cars, collided with the platform at the end of track 6 in the Atlantic Terminal in Brooklyn (a borough of New York City, New York).¹ The lead end of the lead car came to rest on top of the concrete platform at the end of the track. (See figure 1.) As result of this accident, 108 people were injured. Damage was estimated at \$5.3 million. The accident occurred inside the terminal and was not affected by the weather.

Figure 1. The accident train's lead car.

After the collision, three cars (7067, 7073, and 7074) remained upright and did not derail. The lead car (7553), which was the most damaged, derailed upright with its front end resting on the raised concrete at the end of the track.³ Its front truck disconnected from the car body and moved about 6 feet backward.

Train 2817 was traveling about 13 mph when it struck the bumping post at the west end of track 6. The lead car destroyed the bumping post. The car traveled 13 feet 6 inches after making contact with the bumping post. A segment of the rail attached to the bumping post pierced the floor of the lead car and entered the electrical closet directly behind the engineer's control cab.

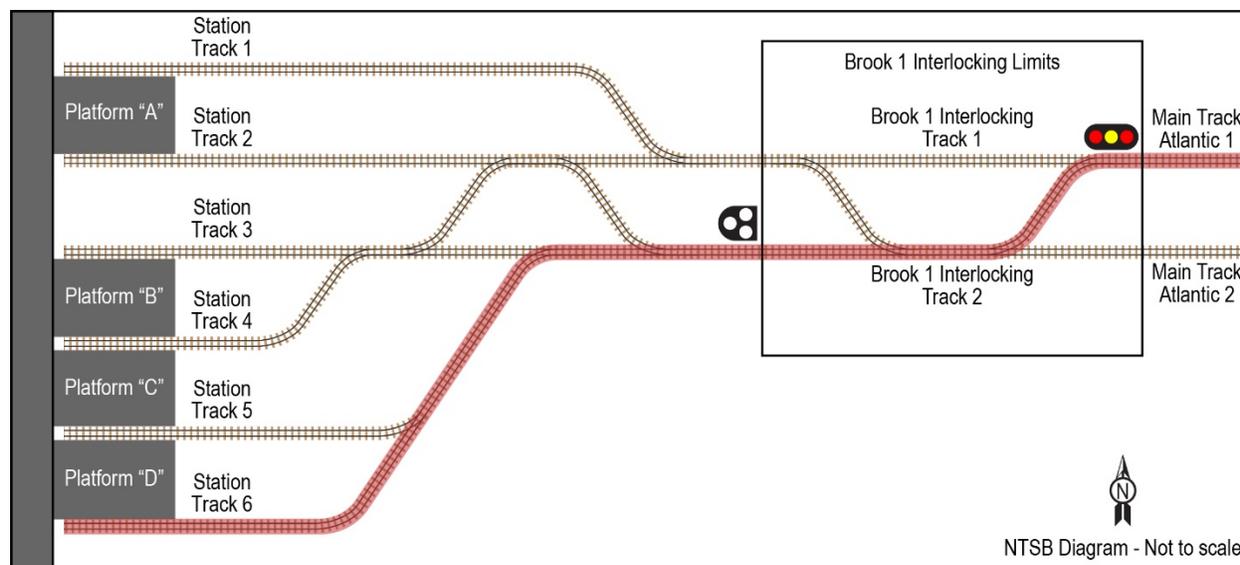
The engineer said he encountered a restricting signal at the Brook 2 Interlocking on main track 1, which required him to slow to restricted speed (not to exceed 15 mph).² (See figure 2.) The train then crossed from main track 1 to main track 2 where it encountered another restricting signal at the Brook 1 Interlocking that also required the train to travel at restricted speed. However, the maximum authorized track speed in the terminal was restricted to 5 mph. In this circumstance, the engineer must still be prepared to stop in one-half his range of vision while not exceeding 5 mph. The train was lined into track 6.

Figure 2. Diagram of tracks at Atlantic Terminal. (Brook 2 is to the right of Brook 1 and is not shown in the figure.)
