National Transportation Safety Board

Railroad Accident Brief

Southeastern Pennsylvania Transportation Authority Trolley Collision

January 4, 2017

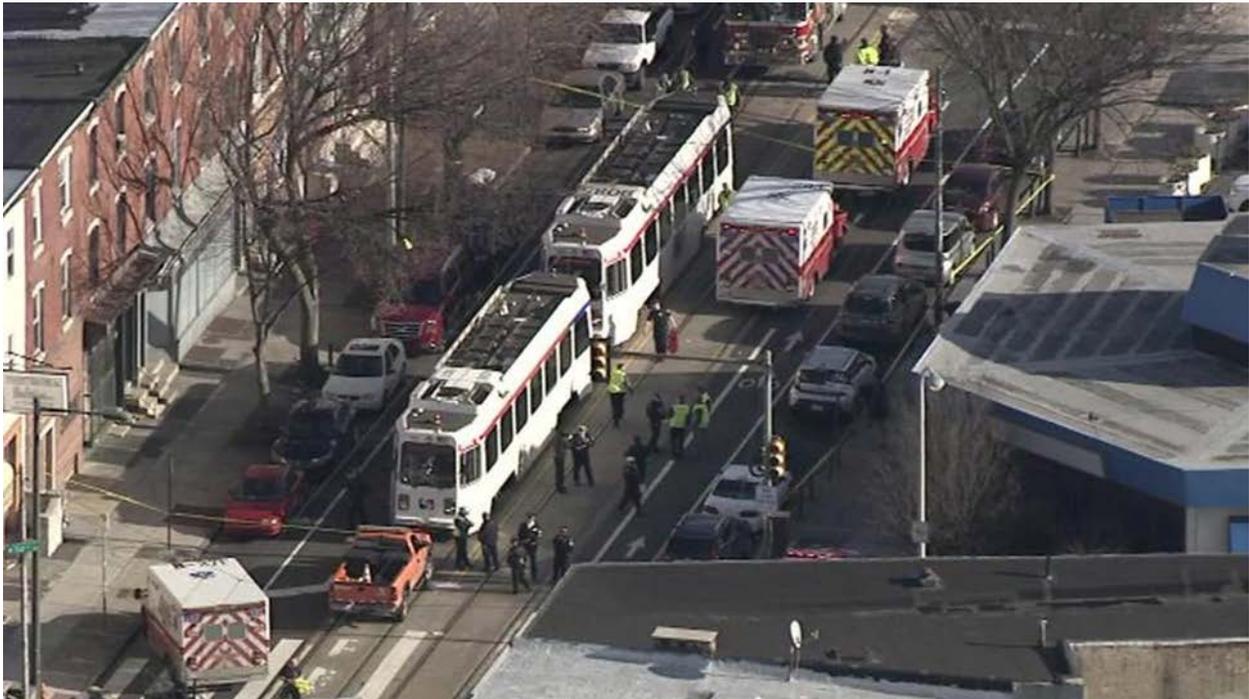
On January 4, 2017, at 12:47 p.m. eastern standard time, Southeastern Pennsylvania Transportation Authority (SEPTA) trolley 9101 (struck trolley), traveling northwest on trolley route 10 with an estimated 47 passengers on board, stopped near the intersection of Lancaster Avenue and 38th Street, in Philadelphia, Pennsylvania, to offload passengers.¹ SEPTA trolley 9085 (striking trolley), with 6 passengers on board, was also traveling northwest on trolley route 10, and struck stopped SEPTA trolley 9101 in the rear at an estimated impact speed of 10 mph. First responders transported 40 passengers and both operators to local hospitals for treatment of minor injuries. The total estimated equipment damage to both trolleys was \$60,000. At the time of the accident, the sky was partly cloudy, visibility was 10 miles, and the temperature was 54°F. Figure 1 shows the accident scene.

Figure 1. Overhead view of the accident scene. (Photo courtesy of WPVI-TV.)

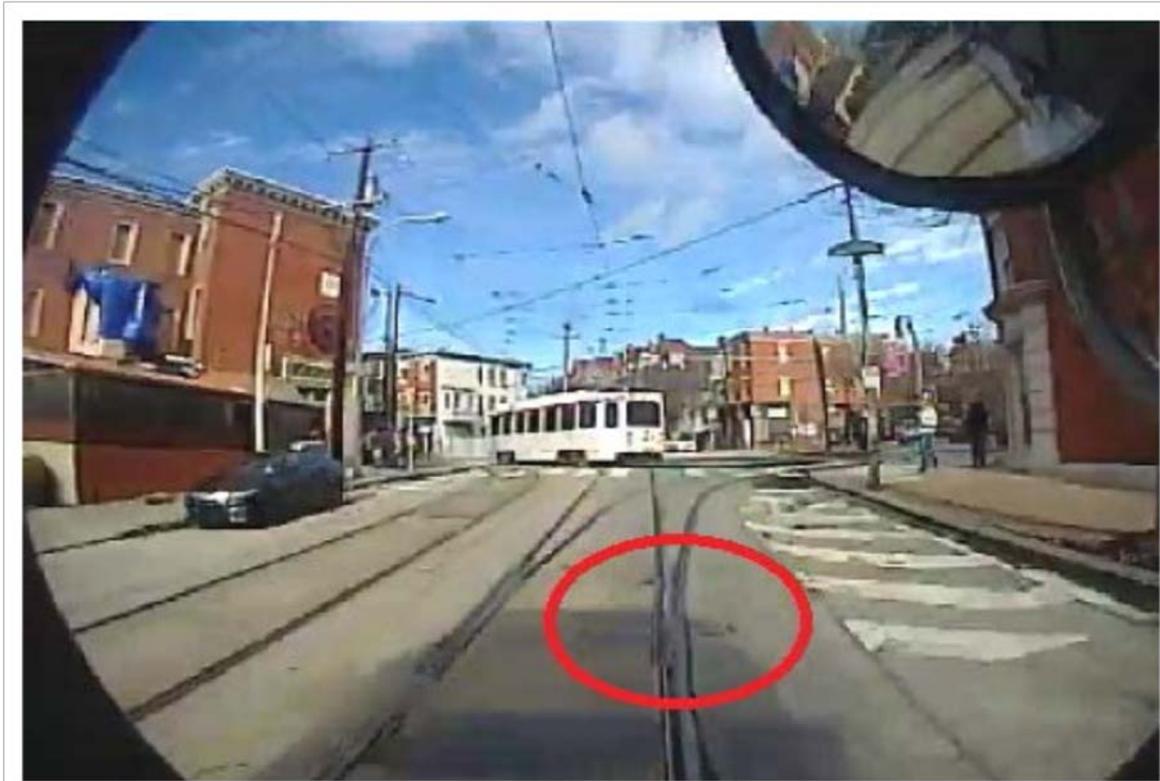
Figure 2. Forward-facing image of the facing point switch at 36th Street and Lancaster Avenue.

SEPTA operating rule RDR-65 requires trolley operators to bring the trolley to a complete stop before traversing a facing point switch to ensure proper switch point alignment. The facing point switch is circled in red in figure 3. According to the video, at 12:45:59 p.m., the striking trolley turned left onto Lancaster Avenue. After rounding the corner onto Lancaster Avenue, trolley 9101 was visible. By 12:46:19 p.m., the alternating, flashing red brake lights, and the steady, red tail lights of the struck trolley are visible in the video. At this time, trolley 9101 was at the intersection of Powelton Avenue and Lancaster Avenue and trolley 9085 was at the intersection of 37th Street and Lancaster Avenue.

- The operator of the striking trolley failed to stop and confirm the correct position of the facing point switch at 36th Street and Lancaster Avenue.
- Inward-facing video of the striking trolley revealed that about 1 minute prior to the accident, the operator of the striking trolley was propping his head up with his hands while stopped at the Powelton Avenue traffic light. When the light turned green, he moved the trolley forward, but continued to rest his head on his hands. The operator of the striking trolley remained in this position until a few seconds before the collision with trolley 9101, at which point he sat up with his back fully against his seatback—a movement consistent with a bracing position, looked out the front window, and activated the trolley brake.

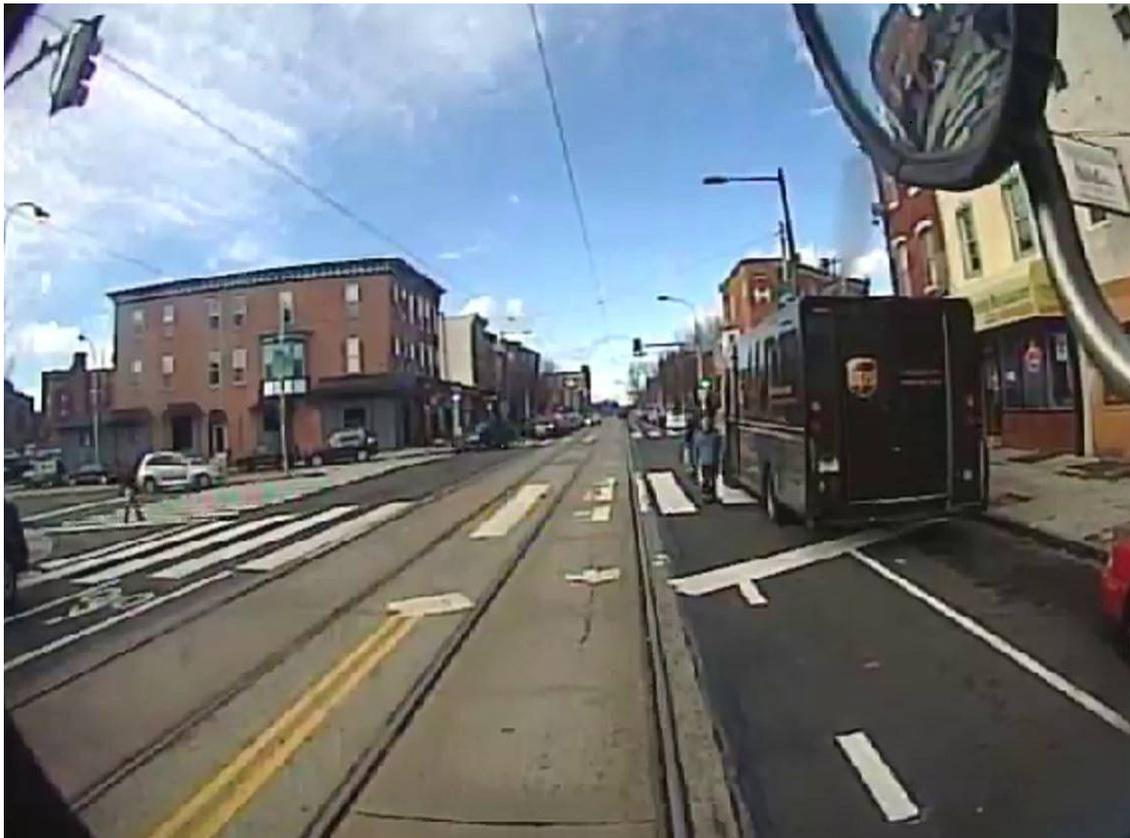
The operator of the striking trolley told NTSB investigators that it was at this point that he began to feel groggy. He said that he blinked his eyes and saw trolley 9101, that was stopped behind a delivery truck, immediately in front of him. Although he slammed on his foot brake, trolley 9085 struck the rear of trolley 9101 at a speed of 10 mph. (See figure 3.)

Figure 3. The view from the struck trolley's forward-facing camera, 2 seconds before impact.
