# National Transportation Safety Board

## Railroad Accident Brief

### CSX Transportation Employee Fatalities at Ivy City Washington, DC

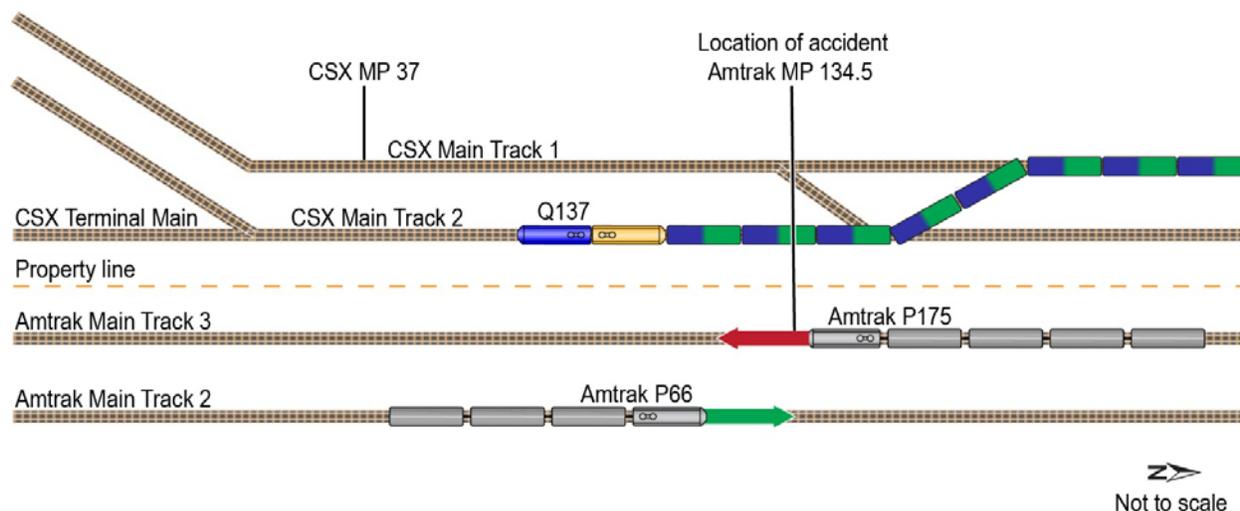
Figure 2. Diagram of accident site.

As shown in figure 2, Amtrak main track 3 was nearest the CSX main track 2. Southbound Amtrak train P175, on Amtrak main track 3, was traveling in the same direction as the CSX freight train Q137 on CSX main track 2. The outside track, furthest from the CSX train, was Amtrak main track 2, where Amtrak train P66 was traveling north at the time the employees were struck.
