National Transportation Safety Board

Railroad Accident Brief

BNSF Railway Head-On Collision

June 28, 2016

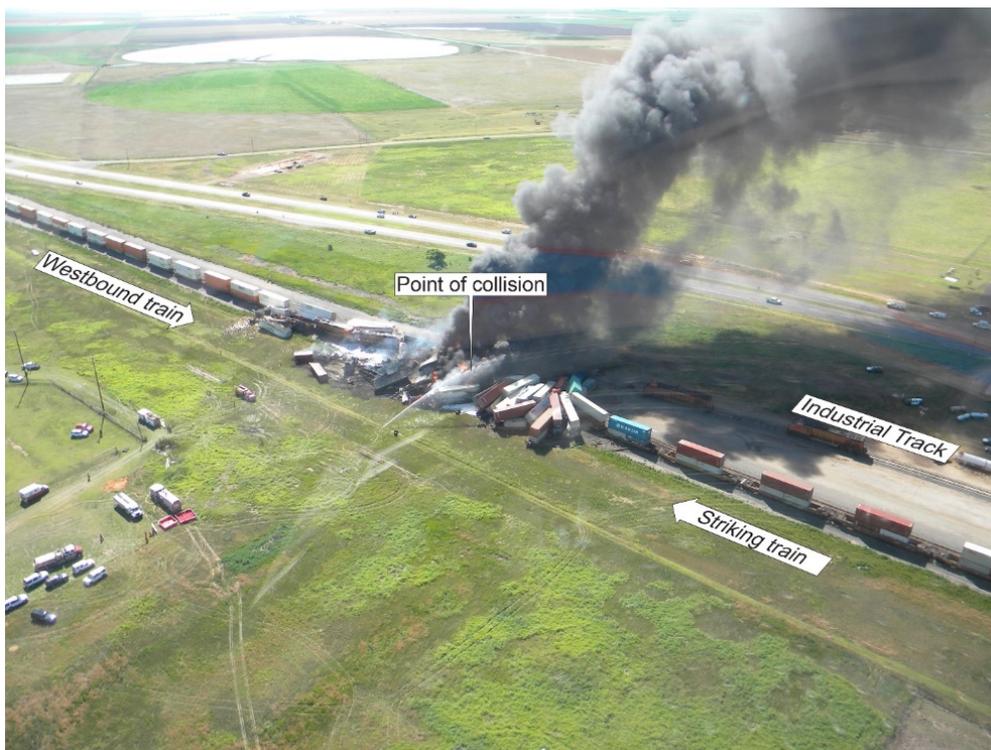
On June 28, 2016, at 8:21 a.m. central daylight time, eastbound BNSF Railway (BNSF) train S LACLPC1-26K (striking train) collided with BNSF train Q CHISBD6 27L (westbound train) at milepost (MP) 525.4 on the BNSF Panhandle Subdivision near Panhandle, Texas.¹ The collision occurred about 0.5 mile east of the east switch of the Panhandle siding. A significant fire resulted from the collision. The locomotive engineer and conductor on the striking train and the conductor on the westbound train died in the accident. The three head-end locomotives and 10 intermodal cars of the striking train derailed. All five head-end locomotives and three intermodal cars of the westbound train derailed. (See figure 1.)

Figure 1. Accident scene. Photo courtesy of BNSF.

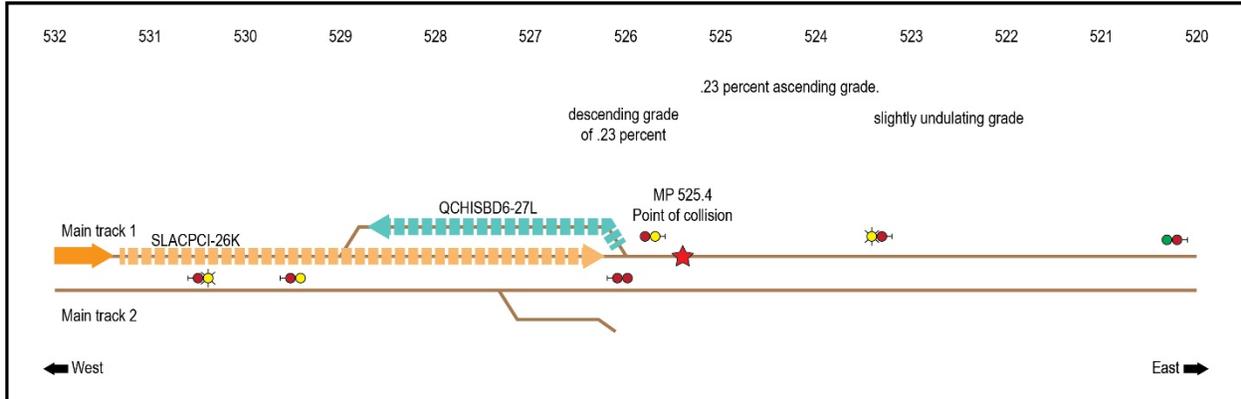
priority train (Z-SBDWSB-626), eastward on main track 2 around the striking train. Figure 2 illustrates the planned routing of the striking train and the westbound train at the Panhandle siding.

Figure 2. Train dispatcher-planned routing for striking train S-LACLPC1-26K and westbound Q-CHISBD6-27L.
