# National Transportation Safety Board

## Railroad Accident Brief

Dallas, Garland & Northeastern Railroad Employee Fatality

August 13, 2018

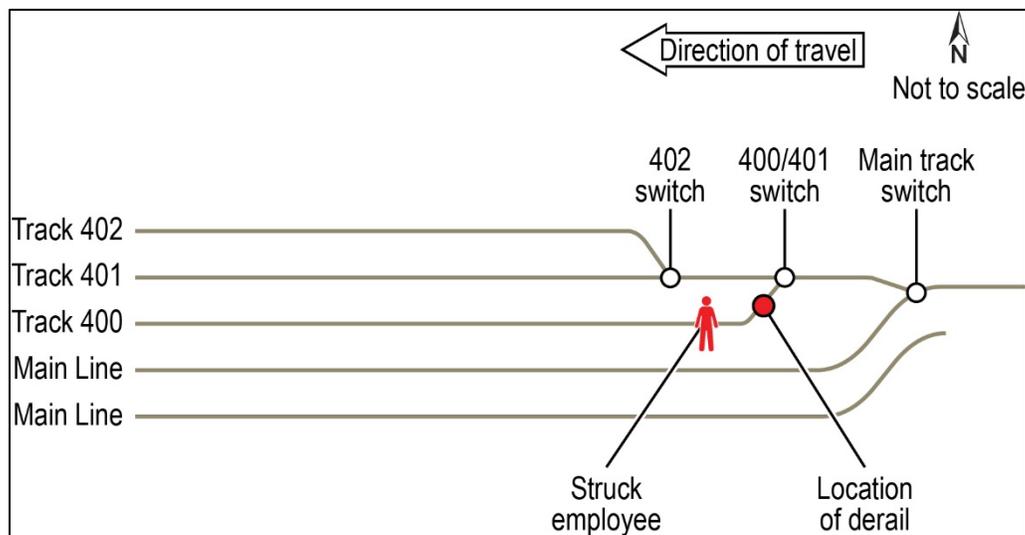
After a job briefing, the trainmaster transported the crew to Cadiz Yard. Cadiz Yard runs east to west and includes DGNO tracks 400 through 402; the tracks are adjacent to the UP double main tracks. (See figure 1.)

Figure 1. Cadiz Yard with main line and DGNO tracks.

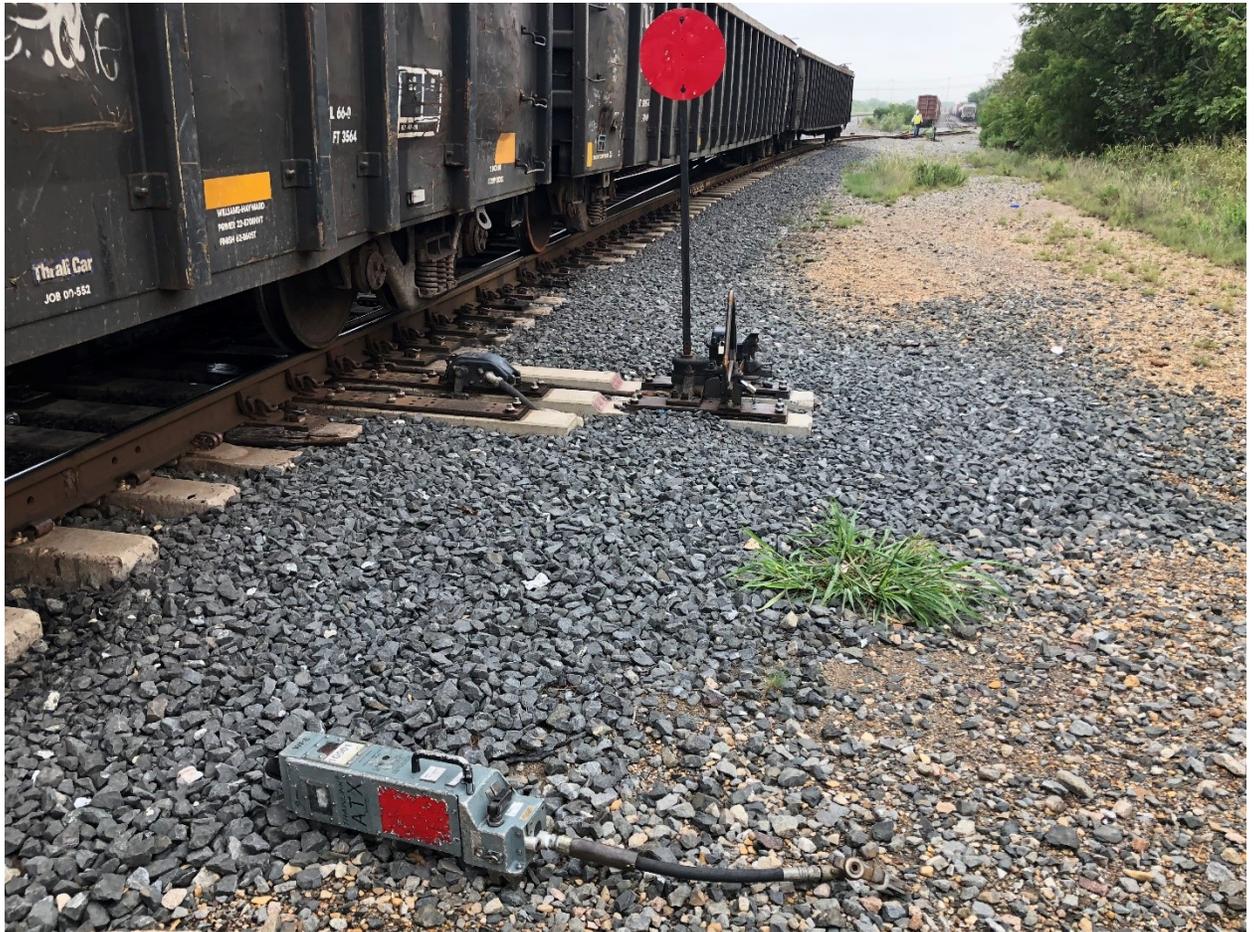
**Figure 2.** The accident train at the misaligned switch.

When the crew arrived at Cadiz Yard, the intended route to be taken was already lined for track 401. Because the switch was found lined for track 400, it is likely that the conductor inadvertently lined the switch to track 400, where the conductor was standing. The conductor likely proceeded to track 400 to operate the derail, believing that the track would be routed to track 401. He was likely directing his attention to the derail, rather than protecting the shoving movement, when he was struck.

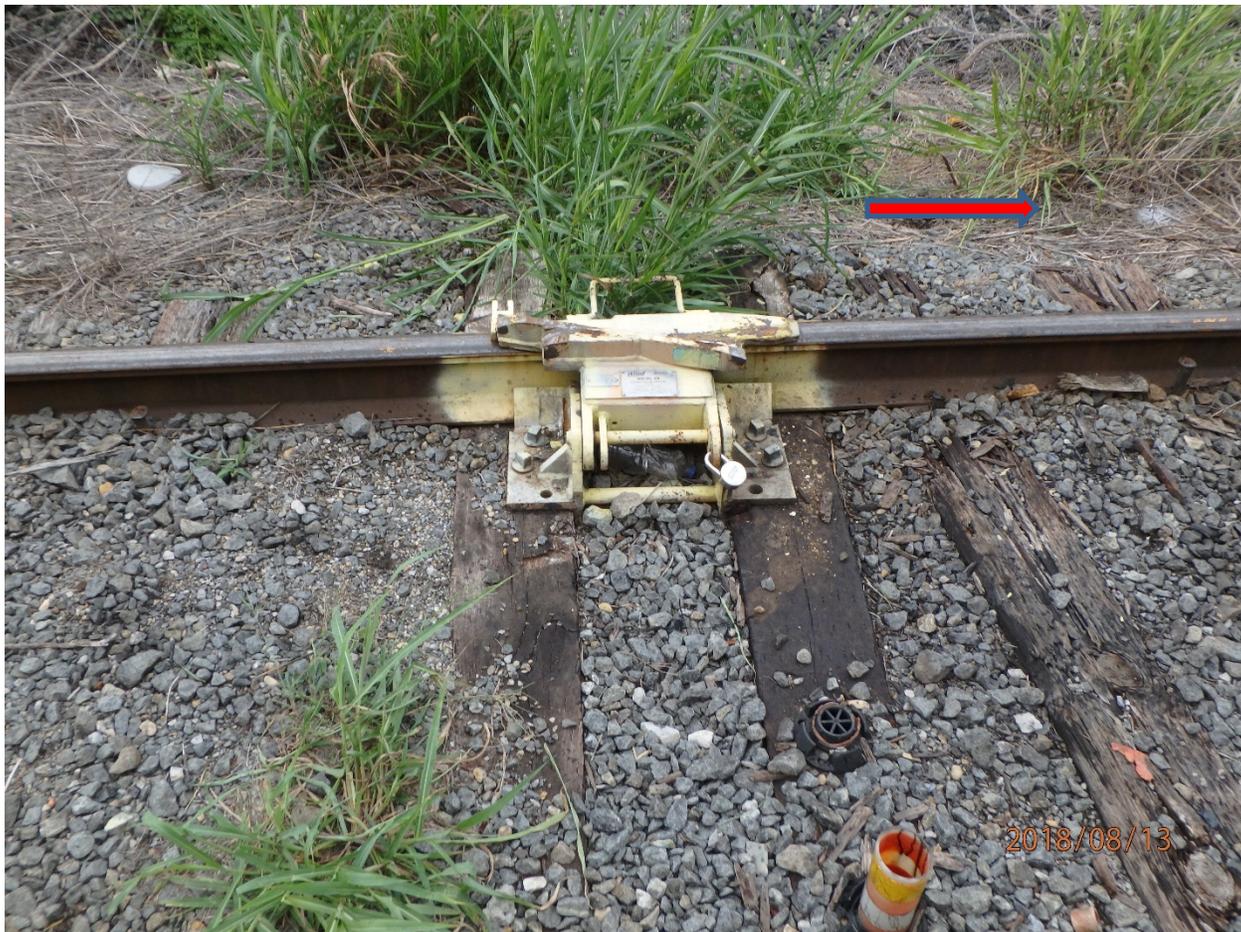
The DGNO general manager was dispatched to the accident site and found the conductor's switch keys and cap near the derail on track 400. (See figure 3.) The DGNO general manager found that the derail on track 400 was still lined and locked for the derailing position.

**Figure 3.** Photo of derail on track 400 and location of conductor's switch keys.

The National Transportation Safety Board determines that the probable cause of this accident was the conductor improperly lining a switch for movement onto a track that he was occupying. Contributing to the accident was the conductor's inattention to the train's movement.

G&W initiated a campaign across all owned or leased railroads titled "Moving Equipment Can Kill." The campaign emphasizes the importance of situational awareness and rule compliance when crossing tracks and moving between equipment.
