National Transportation Safety Board
Railroad Accident Brief
CSX Transportation Freight Train Derailment and
Bridge Collapse
Alexandria, Virginia
May 19, 2018

CSX Transportation Train Derailment and Partial Bridge Collapse

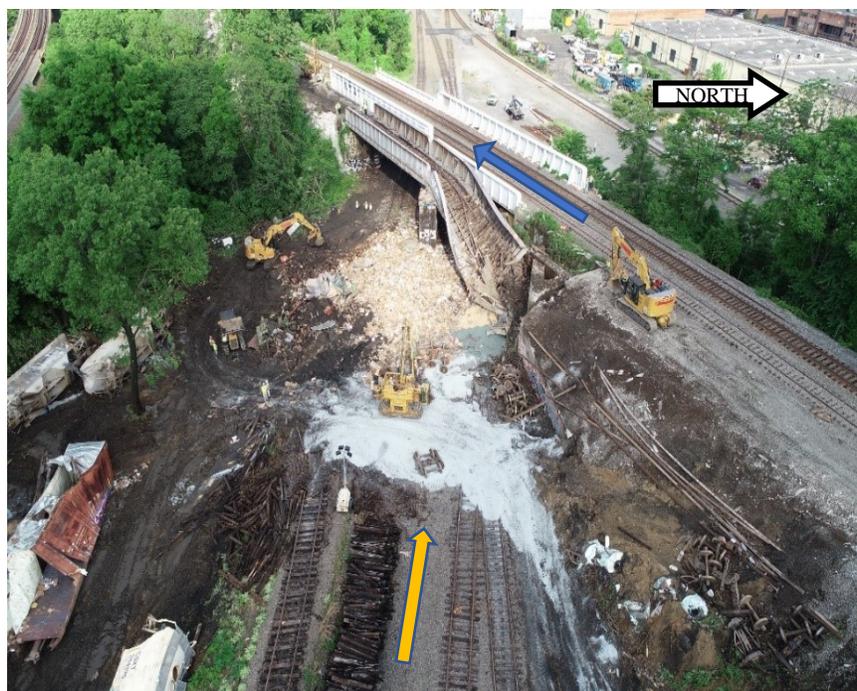
On May 19, 2018, at 7:02 a.m. local time, southbound CSX Transportation (CSX) freight train X41518 derailed near milepost (MP) 102.9 as it approached a bridge overpass in Alexandria, Virginia.¹ The train had been traveling on main track one of the RF&P subdivision.² As a result of the derailment, the CSX bridge supporting main track one was extensively damaged and collapsed at the approaching abutment wall. The bridge structure and 8 of the 31 derailed railcars fell upon the tracks below, owned by Norfolk Southern Railways (NS). (See figure 1.) The CSX bridge for main tracks two and three was not involved and remained in service throughout the investigation.³

Figure 1. The damaged bridge. The blue arrow indicates the direction of travel on the CSX track and the yellow arrow indicates the NS tracks.

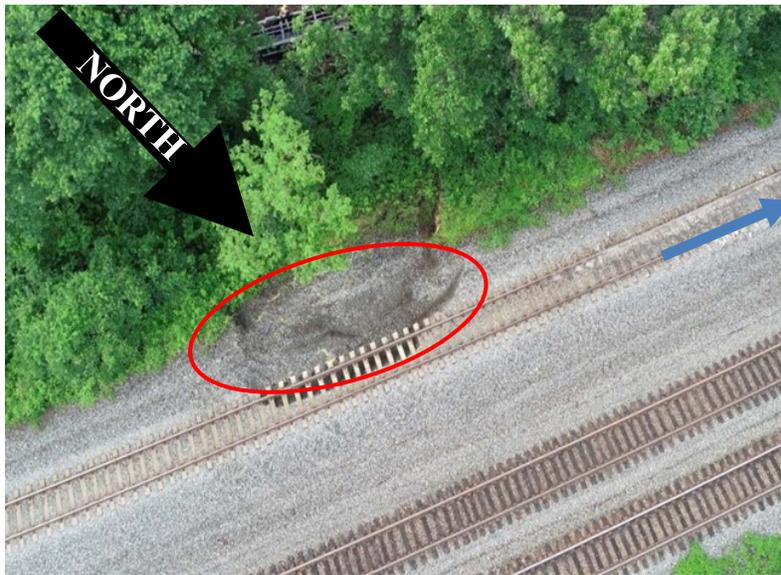
The investigation revealed an area in a curve at MP 102.9 where the subgrade fill subsided from the track structure on main track one, about 500 feet before the bridge spanning the NS tracks.⁶ Upon their arrival on scene, CSX personnel discovered that the subgrade fill and track ballast had subsided for about 26 feet in length, and at a depth of about 18 inches below the top surface of the cross-ties. Figure 2 shows the POD, circled in red, and the subgrade fill failure. Main track one is at the top, main track two is in the middle, and main track three is at the bottom of the figure.

Figure 2. The POD location and the subgrade fill failure indicated with the red circle. The blue arrow indicates the direction of train travel.

- The subgrade fill in the failure area was composed of relatively weak and wet soil.
- There was a concentration of water in a ballast pocket which saturated the slope in the failure area.

These findings were consistent with the on-scene observations of NTSB investigators. The weak and saturated soil, combined with the heavy rains that impacted the area, caused the subgrade fill to subside in the area of the POD.

The National Transportation Safety Board determines that the probable cause of the CSX Transportation train derailment and subsequent bridge collapse on May 19, 2018, was a subgrade fill failure of the track structure that displaced a large area of ballast under the low rail of the track near milepost CFP 102.9, resulting in a cross-level deviation of the track significant enough to allow a wheel climb derailment.

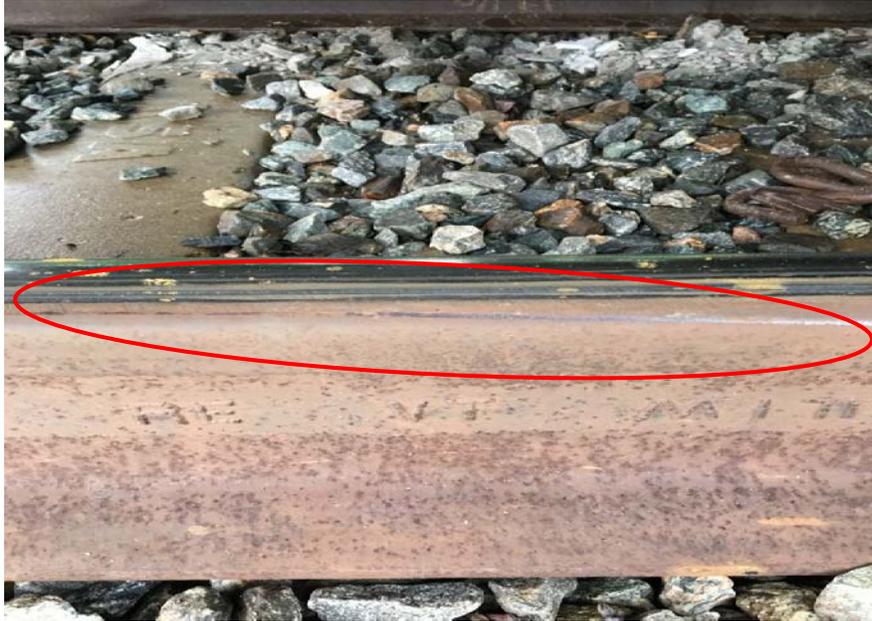
NTSB investigators identified a flange mark, consistent with a departure from the normal wheel rail interface, traversing the top of the high rail at MP CFP 102.9. At this location there was an irregular cross-level deviation between the high and low rail due to subgrade fill failure.⁷ (See figure 3.) The resulting cross-level deviation was enough to allow a wheel climb derailment.

Figure 3. High rail with the flange mark circled in red.
