National Transportation Safety Board

Railroad Accident Brief

Union Pacific Railroad Derailment and Employee Fatality

Arlington, Texas

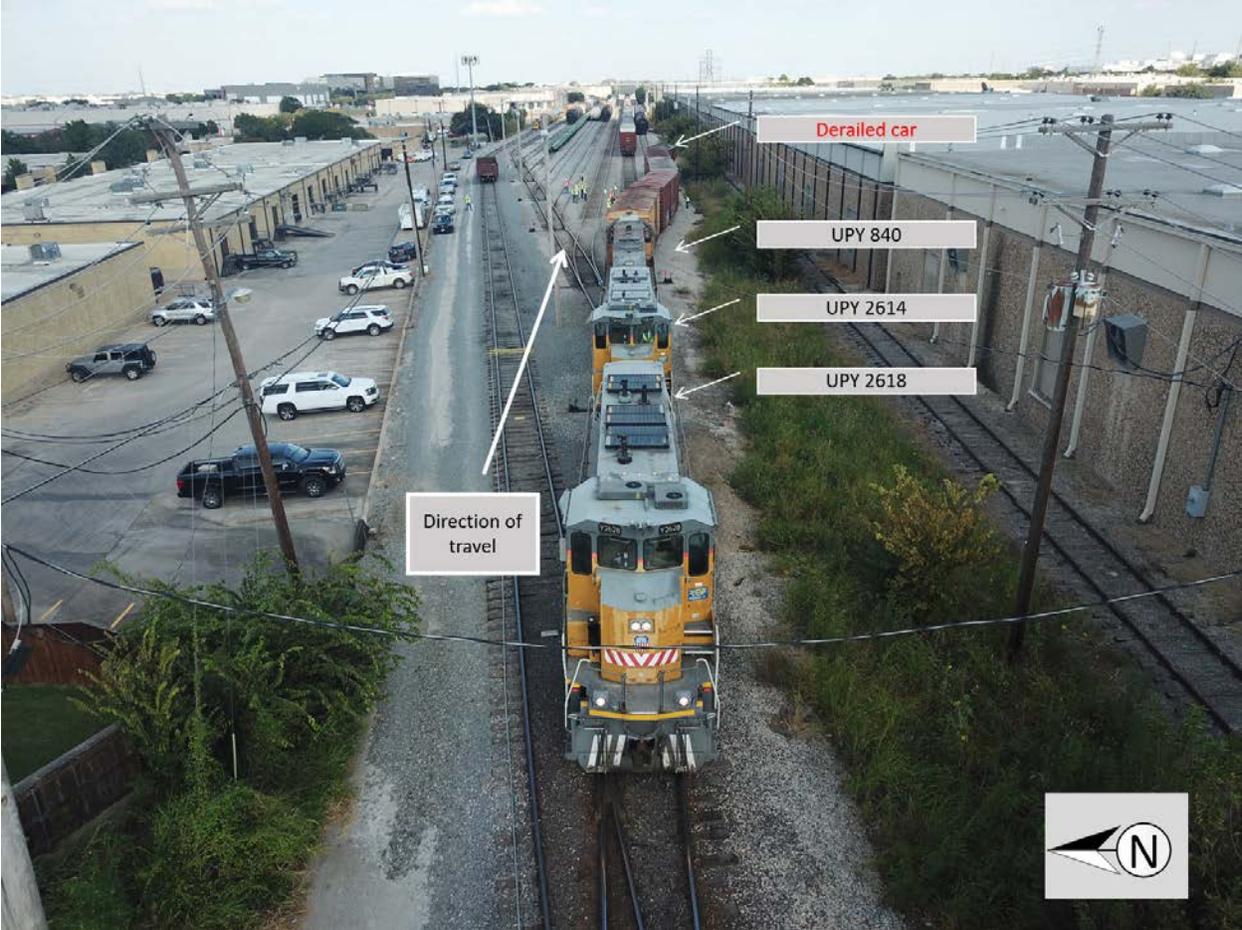
On September 22, 2017, about 11:06 a.m., local time, Union Pacific Railroad (UP) train Y-GW51R-22 derailed during a coupling operation in the UP Great Southwestern (GSW) Yard in Arlington, Texas. (See figure 1.)¹ At the time, a helper controlled the train remotely from the rear car.² A foreman was positioned on the lead locomotive of the train and maintained radio communication with the helper. As the train traveled in reverse through a switch at a speed of 8 mph to couple with eight cars on track 001, the train's emergency brakes activated, and a "man down broadcast message" went out over the railroad radio.³ The foreman attempted to radio the helper. After receiving no response, he went to the rear of the train and saw that a car had derailed and that the helper was between the third and fourth cars of the train. (See figure 2.) The foreman said he made an emergency call on the radio requesting help and for someone to call 911. The helper died from injuries sustained during the accident.⁴

Figure 1. Derailed train.

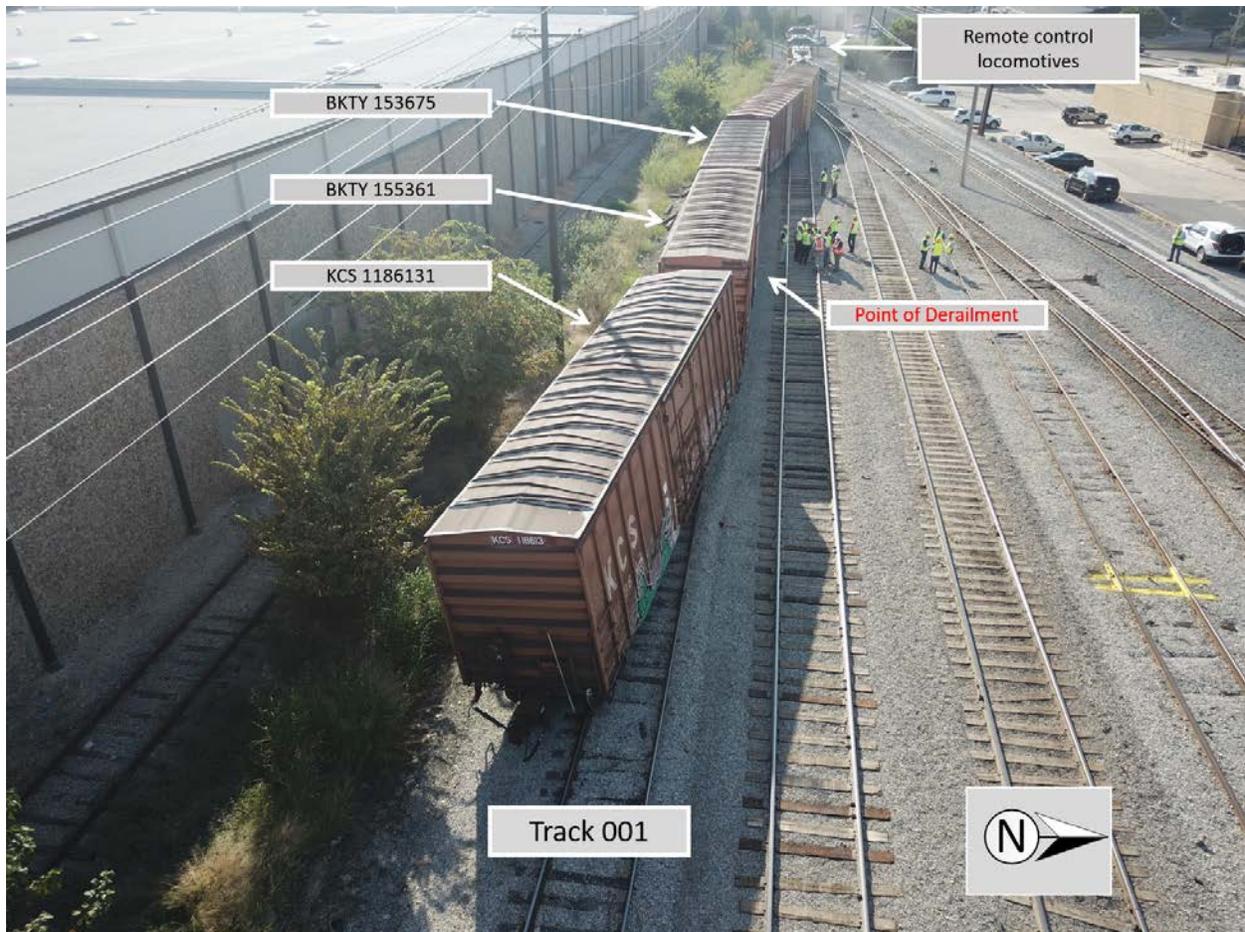
Figure 2. Derailed train cars.

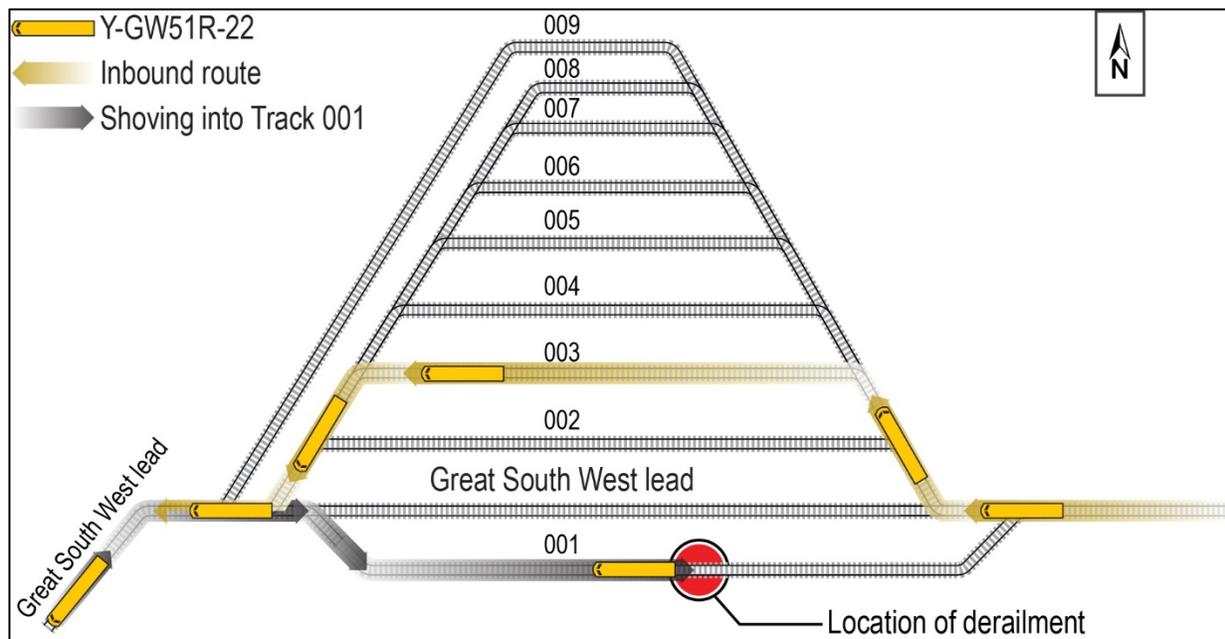
The foreman told investigators that upon completion of the transfer air brake test at packaging, they returned westward to the GSW Yard and that he was controlling the train. He said that as they approached the yard, he told the helper they would run through track 003 and then move to track 001, where an earlier train had left some outbound cars. (See figure 3.) He said that they went through track 003 and stopped at the yellow clearance mark on the track. The helper walked to the switch, lined the switch, and signaled for the foreman to come ahead. The foreman operated the train westward around a slight curve, where the helper stopped him once clear of the 1 switch. At this time, the foreman transferred control of the train back to the helper.

Figure 3. Train Y-GW51R-22 movements.

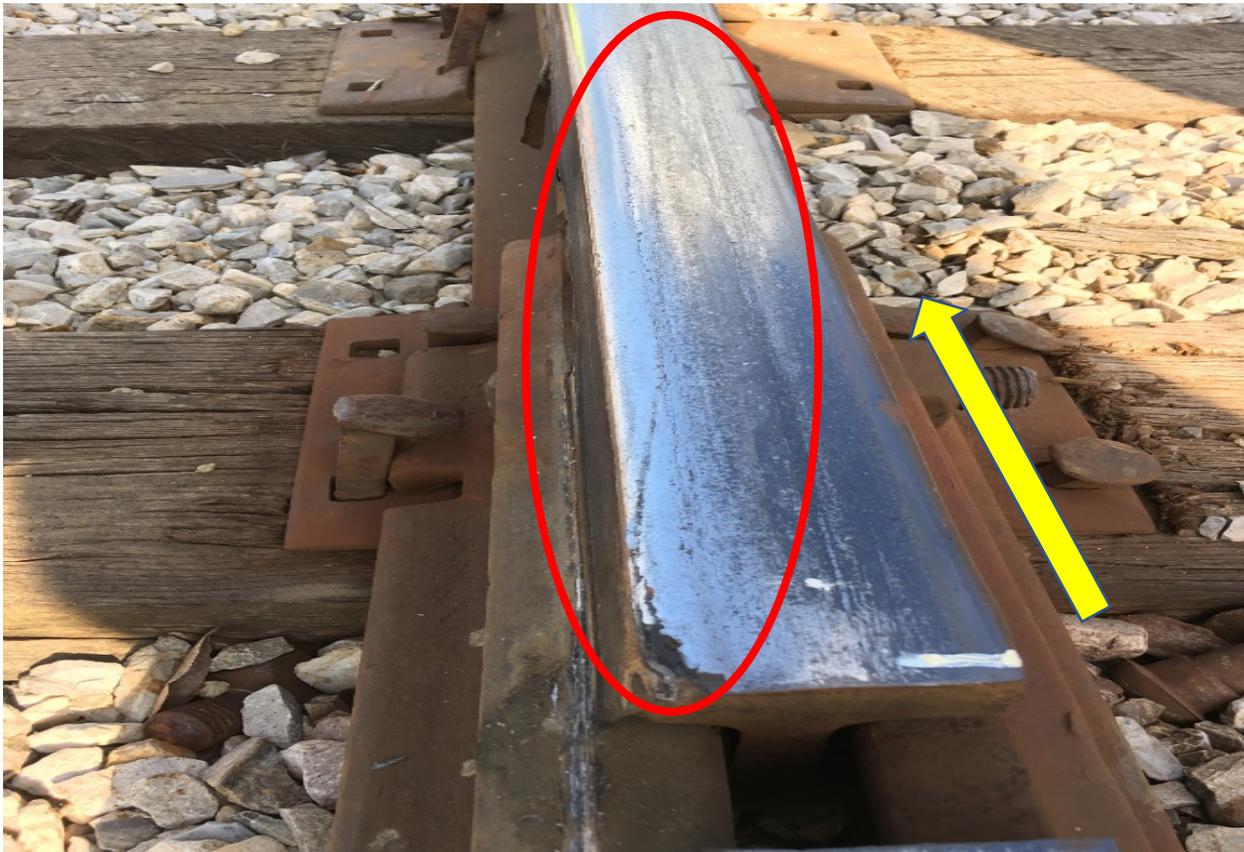
Investigators determined that the point of derailment (POD) occurred at a suspended and bolted rail joint located on the south rail, about 60 feet east of the switch leading into track 001.¹⁶ Figure 4 shows the south rail gage face corner indicating wheel climb at the rail joint. The red circle encloses the derailing wheel flange witness mark beginning at the gage corner and going diagonally across the top of the rail head. The yellow arrow shows direction of travel.

Investigators observed a witness mark at the south rail gage face corner that was created by the flange of the train wheel.¹⁷ The wheel flange witness mark traversed from the gage corner of the receiving rail face and continued to travel up and over to the tread portion of the running rail head, where it extended and angled eastward for about 24 inches toward the field side of the running rail. A corresponding wheel departure mark was identified across the top surface of the opposite running rail head (north rail), matching the POD determination. Evidence of displaced and broken ballast was observed on the field side of the south rail, indicating that the train continued east for another 152 feet after departing the rail at the POD.

Figure 4. South rail gage face corner indicating wheel climb at rail joint.

Track geometry measurements were conducted and recorded by investigators. Measurements taken around the derailment revealed that the train was traversing a straight track as it approached the POD. The track gage measured 57 5/8 inches under load at the POD, in compliance with FRA Excepted Track requirements. Cross-level measurements indicated that the rail joint was 1 5/8 inches lower than the south rail at the POD.¹⁸

Investigators observed that the rail joint at the POD was extremely loose, allowing static gage and tread rail head mismatch of 1/8 inch. They also observed that the four-hole rail joint was assembled with only three joint bar bolts, indicating that one of the rail ends only had one joint bar bolt at the time of the derailment. Investigators observed a broken joint bar bolt laying in the gage area of the POD. Investigators used a portable track loading fixture (PTLF) at the rail joint to determine an underload measurement at the rail gage and rail tread.¹⁹ They applied 4,000 psi at the rail joint and recorded a loaded measurement at 3/8 inch at both the gage and running surface portions of the rail as part of an examination of the rail, which includes loading the rail to look for changes in measurements taken when it was not loaded.

Because of the excepted track designation, conditions were present at the POD that otherwise would not be permitted if the track was designated as Class 1 or higher. The conditions included a loose and improperly fastened rail joint and rail surface mismatch.

The NTSB determines that the probable cause of the switching employee fatality was a single car derailment caused by a loose, improperly fastened rail joint, which allowed the car's wheel to climb the mismatched rail. Contributing to the accident was the designation of the

Track 001 in the UP GSW Yard was taken out of service the day of the accident and remains out of service. Work has been completed to repair and upgrade the track (and other yard tracks) to include the installation of new switch ties and appropriate surfacing with new ballast. UP intends to install new rail to eliminate the rail joints in the curved portion of the track.
