**National Transportation Safety Board**  
**Railroad Accident Brief**  
**Port Authority Transit Corporation Employee Fatality**  
**Lindenwold, New Jersey**  
**July 26, 2020**

## Lindenwold Employee Fatality

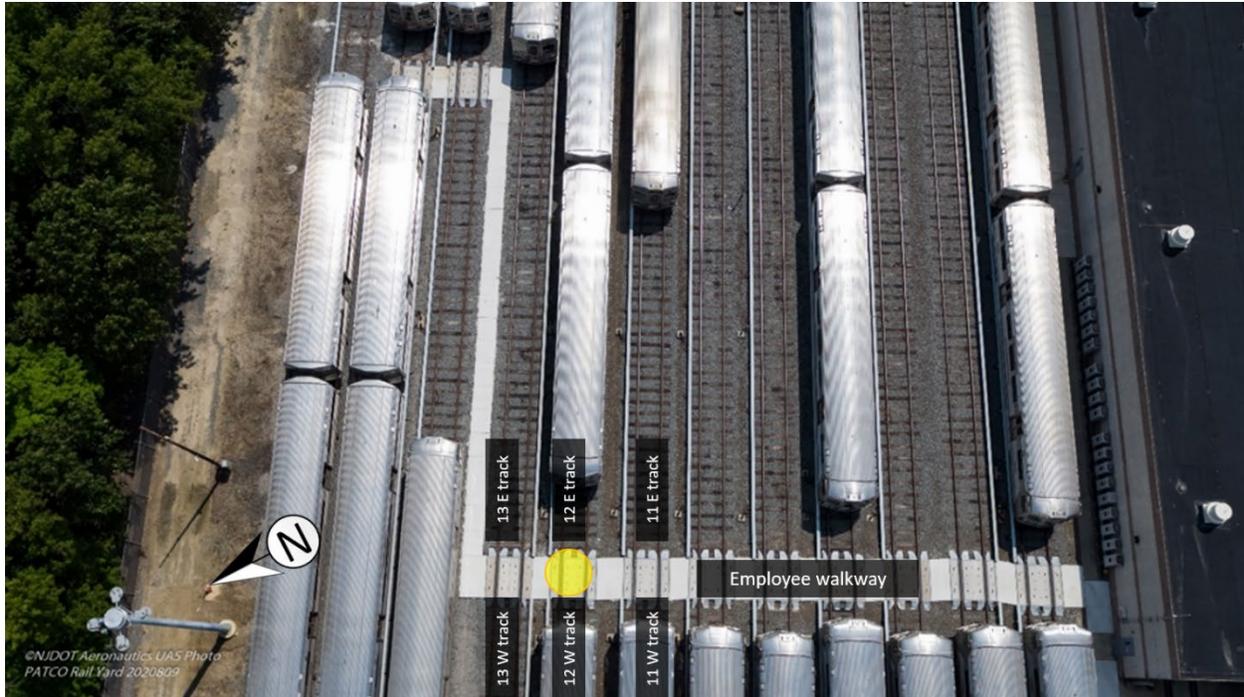
**Figure 1.** Aerial photograph of employee walkway. (Photo courtesy of New Jersey Department of Transportation.)

Note: This photograph, taken August 9, 2020, shows an aerial image after the accident of the employee walkway that was blocked by stored railcars on the night of the accident. A yellow circle indicates the location of the blocked walkway on track 12. Tracks are numbered in decreasing order from north to south, and tracks 12 east and 12 west can be seen on either side of the blocked walkway.

According to the DRPAD investigation report, the maintenance employee arrived at the Lindenwold facility for the start of his shift at 7:47 p.m. He was then seen on video leaving the maintenance building and entering the yard at 8:24 p.m., likely walking to his work assignment on track 15. He was not seen again on video. A second train consisting of six passenger railcars was stored on track 12 west and blocking a designated employee walkway.

At the time of the accident, PATCO did not have a rule or requirement that employees use dedicated walkways and pathways within the Lindenwold facility. As a result of this accident, PATCO management changed its safety rules to include designating walkways as the only permissible route for employees to use in the yard, prohibiting the blocking of designated walkways by stored equipment, and requiring train operators to come to a full stop and activate the horn at all designated walkways. PATCO also established storage limits on specific yard tracks to create greater spacing between stored sets of railcars. Further, PATCO management emphasized the use of reflective apparel in its internal safety rule compliance program and conducted a rule review with employees, emphasizing the use of required personal protective equipment, including safety vests, in yards.

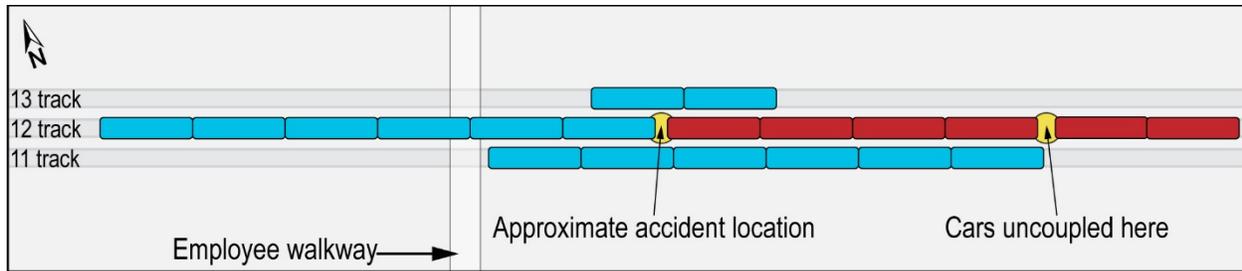
Interviews and a review by PATCO officials of on-train maintenance data indicate that the operator of the striking train first tried to uncouple two railcars from the six-railcar consist on track 12 east at 8:37 p.m. This first attempt was unsuccessful, and there was no movement of the train consist recorded. At 8:43 p.m., the train operator moved to the 4th railcar in the consist, car 1077, and performed a second successful uncoupling maneuver separating two passenger railcars from the six-railcar consist. This movement occurred for 1.4 seconds, and train speed was recorded at 1 mph. PATCO officials also indicated that the train operator activated the train horn prior to performing the uncoupling move as required by operating rules.<sup>4</sup> According to PATCO officials, the passenger railcar coupler is mechanically designed to push away from the adjacent railcar during an uncoupling move. At the time of the accident PATCO did not have a rule in place establishing minimum distances between stored railcars. The deceased maintenance employee was pinned between the railcars during the uncoupling maneuver and was found by another maintenance employee at about 9:03 p.m. two car lengths away from the employee walkway and between the four remaining railcars on track 12 east and a train stored on track 12 west. (See Figure 2.) The two separated railcars were moved by the train operator to another location in the yard.

**Figure 2.** Approximate accident location.

Note: Graphic of trains stored in Lindenwold Yard at the time of the accident. The location of the accident is indicated by an arrow. The employee walkway is located approximately 2 car lengths from the incident location.

The NTSB determines that the probable cause of the accident was the maintenance employee walking in an area not designated for foot traffic between two railcars with insufficient clearance and being struck during an uncoupling maneuver. Contributing to the accident was the Port Authority Transit Corporation's storage of railcars on the designated employee walkway and not requiring employees to use these walkways in the yard.
