# National Transportation Safety Board

## Railroad Accident Brief

### Union Pacific Railroad Employee Fatality

April 23, 2020

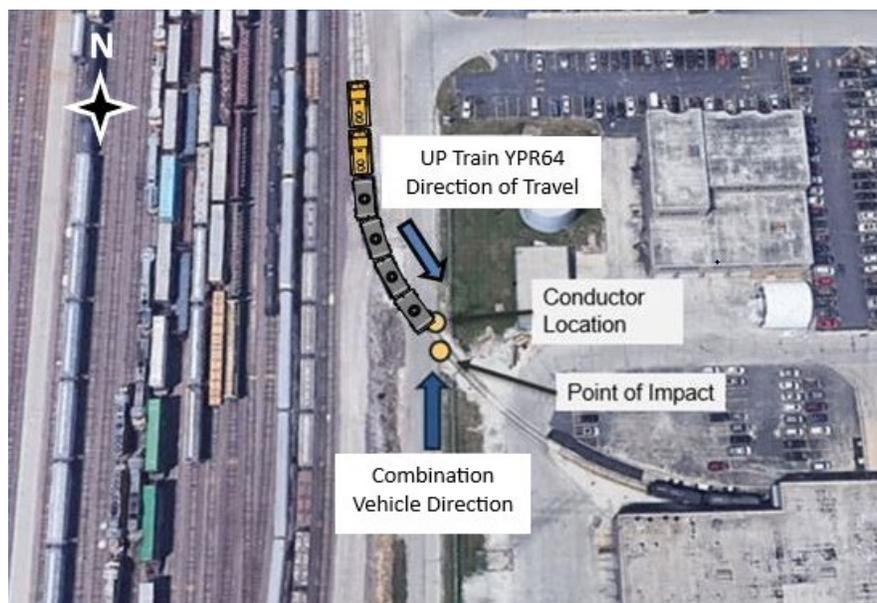
On April 23, 2020, at 10:02 a.m. local time, Union Pacific Railroad (UP) train YPR6423, consisting of two locomotives and four rail cars, collided with a truck tractor in combination with a semi-trailer (combination vehicle) as the train entered a public highway-rail grade crossing outside of the Proviso Yard in Northlake, Illinois. The train was traveling at a speed of 10 mph while shoving rail cars into an industry track.<sup>1</sup> The remote-control locomotive (RCL) operator was controlling the movement of the train from the end rail car and died as a result of the collision as the train entered the grade crossing at Railroad Avenue. (See figure 1.)<sup>2</sup>

**Figure 1.** Aerial view with illustration of the accident scene.

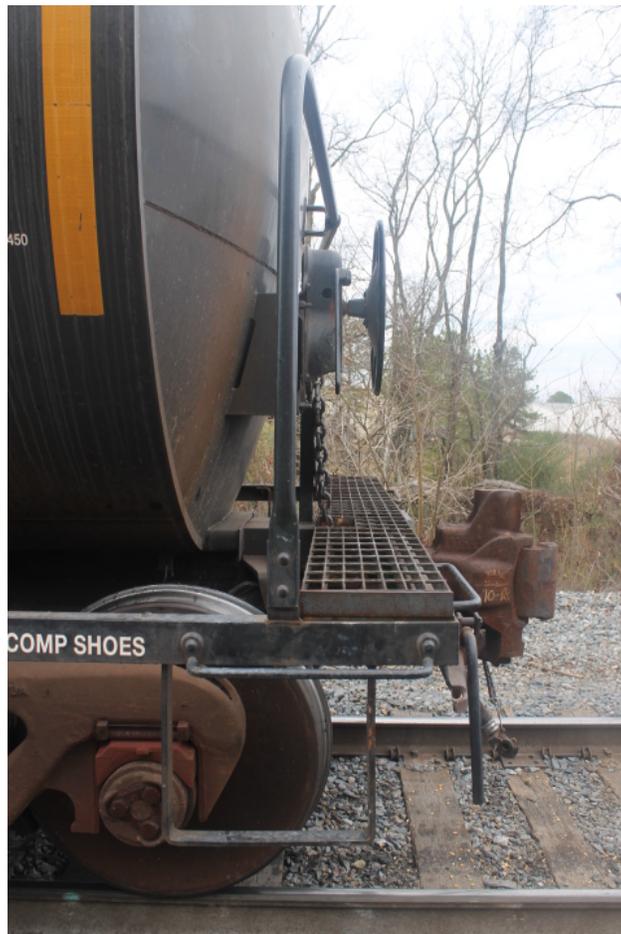
The yard crew was assigned to deliver the train to the customer, The American Bottling Company.<sup>4</sup> The train's configuration required the crew to make a shoving movement into track 719. When the yard crew started the shoving movement, the switchman sat in the cab of the controlling locomotive, the trainee sat in the second locomotive, and the RCL operator operated the train from the rear tank car. The RCL operator rode on the north end of the tank car as the train moved toward the public highway-rail grade crossing into track 719. (See figure 2.)

**Figure 2.** Photo of end platform on an exemplar tank car that the RCL operator was riding. (Source: FRA)

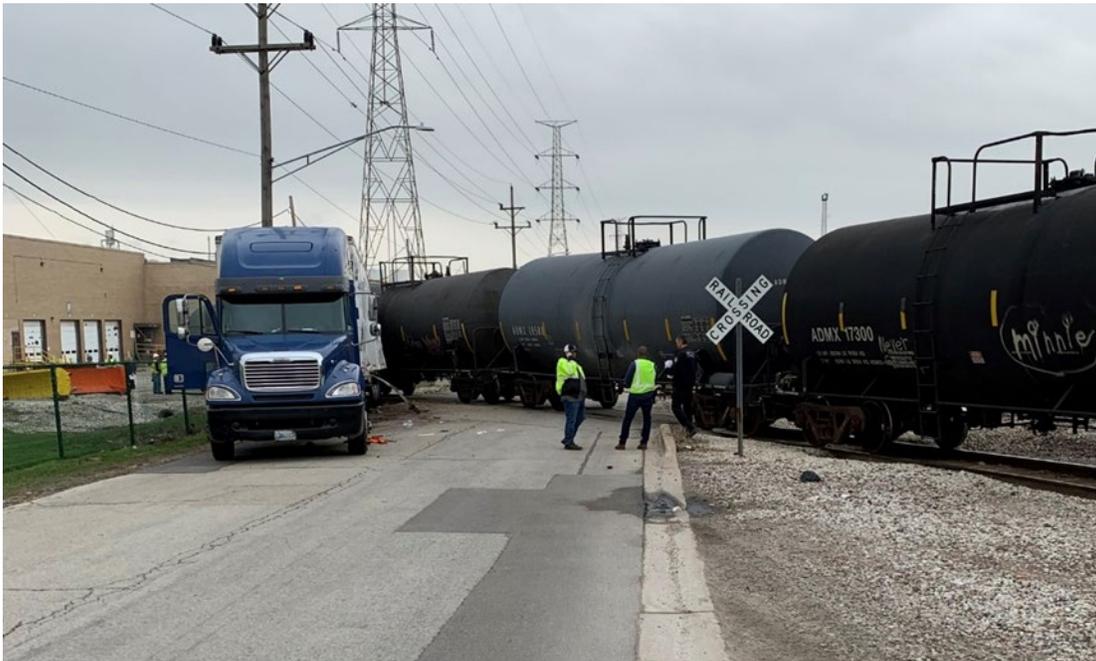
The switchman in the cab of the locomotive told investigators that shortly after hearing the train horn, he noticed the combination vehicle traveling northbound on Railroad Avenue. NTSB investigators reviewed a recording from a video surveillance camera that monitors the rail yard. The video camera footage shows that the train (traveling an estimated speed of 10 mph) and combination vehicle (traveling at an estimated speed of 25 mph) entered the public highway-rail grade crossing at approximately the same time. (See figure 3.)

**Figure 3.** Final resting position of combination vehicle and the train. (Source: UP)

The National Transportation Safety Board determines that the probable cause of this accident was Union Pacific Railroad's allowance of train movement through a grade crossing without first stopping the train to provide warning. Also contributing to the accident was the combination vehicle driver's failure to yield to the train as he approached the public highway-rail grade crossing.

As a result of the accident, UP distributed an Incident Alert systemwide to all employees and briefed employees in the Chicago area. The incident alert included rules to review including shoving movements, providing warning over road crossings, job briefings, and riding equipment. Additionally, UP made modifications to the public highway-rail grade crossing on April 23, 2020. Specifically, an additional crossbuck and an emergency notification sign was installed. The Illinois Department of Transportation updated pavement markings to include railroad crossing symbols and stop lines and installed a yield sign at the crossing.<sup>9</sup>
