Railroad Accident Brief: RAB-21/06

Southeastern Pennsylvania Transportation Authority Roadway Worker Fatality

Philadelphia, PA
July 8, 2019

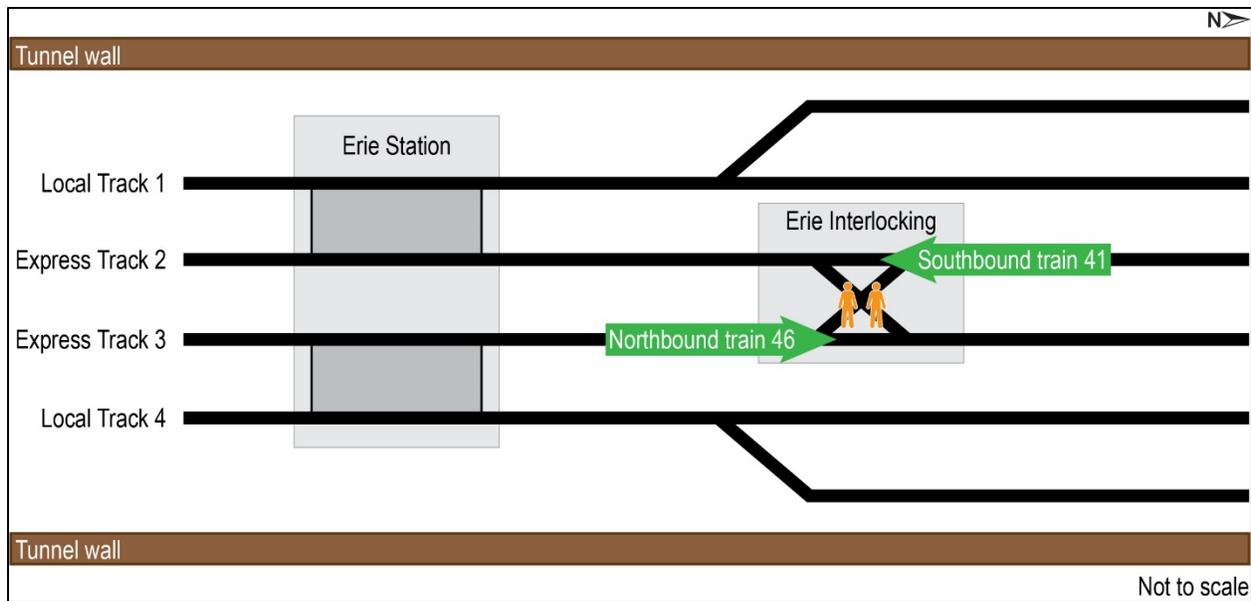
On Monday, July 8, 2019, about 5:21 p.m. local time, northbound Southeastern Pennsylvania Transit Authority (SEPTA) train 46, struck two SEPTA roadway workers on express track 3 (track 3) on SEPTA's Broad Street Subway Line in Philadelphia, Pennsylvania.¹ One worker was killed, and the other was transported to a local hospital with non-life-threatening injuries. Prior to the accident, a southbound SEPTA train (train 41) was operating on express track 2 (track 2) just north of SEPTA's Erie interlocking and passed the workers. Simultaneously, northbound train 46 struck the roadway workers as it departed the Erie Station on track 3. (See figure.)

Figure. Diagram of accident location on Broad Street Subway Line.

Note: This diagram shows tracks 1, 2, 3, and 4 running through the Erie Station to the south. Train 41 is headed south through the Erie interlocking on track 2, and train 46 is headed north through the Erie interlocking on track 3. The accident site and the two roadway workers who were hit are shown in the Erie interlocking between tracks 2 and 3.

The accident occurred within the Erie interlocking.² Forward-facing image recordings from train 46 show that when it was stopped at the passenger platform on track 3 at the Erie Station, the track worker that would be fatally injured was about 300 feet away walking toward it waving a flashlight attempting to convey a “stop signal” to the operator.³ The track worker is then seen walking away, with his back to train 46. A review of in-cab image recordings from train 46 show that, at the time the track worker attempted to signal train 46 to stop, the train’s operator had his head outside of the operator’s cab window and was not looking in the direction of the track worker. The operator was looking toward the rear of train 46 as customers loaded and off-loaded the train. The in-cab image recording also shows that the operator of train 46 did not acknowledge or confirm the stop signal from the track worker. Forward-facing image recordings show train 46 departed the station and moved north on track 3 in the direction of the Erie interlocking toward the two roadway workers.

As train 46 entered the Erie interlocking, forward-facing image recordings show both roadway workers standing side-by-side in the middle of the interlocking, between the tracks, as the last cars of southbound train 41 move past them moments before being struck. The operator of train 46 told National Transportation Safety Board (NTSB) investigators that it was dark, and he saw bright headlights from the southbound train.

Forward-facing image recordings show that about the time train 46 neared the interlocking, headlights from the approaching southbound train 41 on track 2 resulted in a bright light that likely blurred and diminished the operator's view of the workers. As the operator of train 46 proceeded, he told investigators he saw the reflection of two safety vests between tracks 2 and 3 and immediately heard a loud noise on the left side of his train (train operators are on the right side of the controlling cab). The operator then immediately applied the train's emergency brakes. Shortly after, the operator of train 46 heard a mayday call over the radio.⁴ He further said that the mayday call came from one of the roadway workers.

Use of Train Approach Warning - Immediately following the accident, SEPTA had stand-down meetings with its track department staff. SEPTA has resumed track inspection work but prohibits using TAW to perform any minor repairs to track components by track inspectors. Once a track worker identifies the need for a repair, the track will be taken out of service or speed restriction issued if conditions warrant until the repairs can be made. The repairs will be scheduled when train service has stopped, or a work zone or out-of-service track and associated protection can be established.

Prohibiting Fouling Work During Peak Service Hours - In September 2019, SEPTA's assistant general manager for operations and engineering maintenance and construction issued a notice to employees prohibiting nonemergency work from being

Additional Manpower/Advance Mobile Watchperson - In July 2019, SEPTA started to assign qualified watchpersons to station platforms preceding the track inspection crews. In this role, the watchperson communicates with train operators to warn them of the track workers and warns track workers via radio communication of approaching trains. SEPTA will monitor the effectiveness of this practice and adjust as needed to further enhance the protection. SEPTA hired additional full-time positions to support this role.

Updated Hot Spot List - A "Hot Spot" list is a reference manual provided to all track workers that designates certain track segments where a greater level of on-track protection is required due to limited line of sight, difficult or nonexistent egress, loud noise, and close clearances. Since the accident, SEPTA has updated its Hot Spot list to include interlockings and provided the list to the training department to include as a reference in their track safety classes.
