Railroad Accident Brief: RAB-21/08

Southeastern Pennsylvania Transportation Authority Light Rail Vehicle Collision

Upper Darby, PA
August 22, 2017

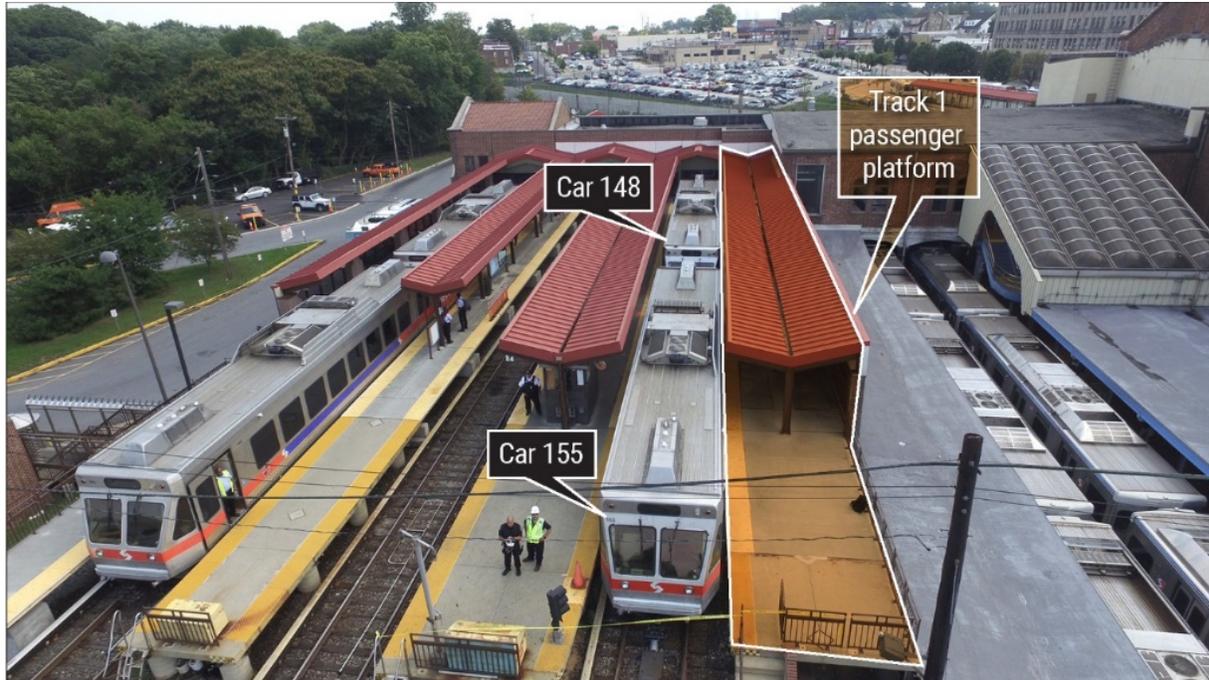
Figure 1. Aerial view of accident location looking southeast on the morning after the collision. (Source: SEPTA)

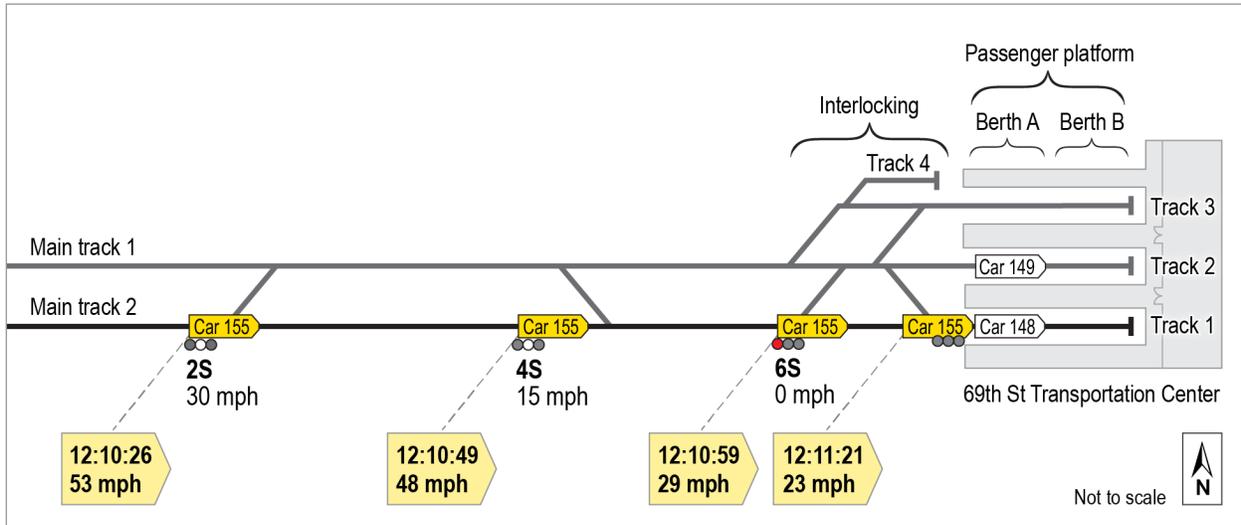
At 12:10:26 a.m., after departing Township Line Road station, car 155 reached signal 2S, the first of three wayside signals, along the approach into the 69th Street station. (See figure 2.) Car 155 passed signal 2S traveling at 53 mph even though the onboard cab signal indicated a maximum allowable speed of 30 mph.² The operator

At 12:10:49 a.m., car 155 passed signal 4S at 48 mph while the onboard cab signal indicated a maximum allowable speed of 15 mph. At 12:10:59 a.m., car 155 passed signal 6S at 29 mph as the onboard cab signal indicated a maximum allowable speed of 0 mph. At 12:11:21 a.m., traveling at 23 mph, car 155 struck the rear of car 148 on station track 1.

Figure 2. Diagram of car 155’s approach to the 69th Street Transportation Center.

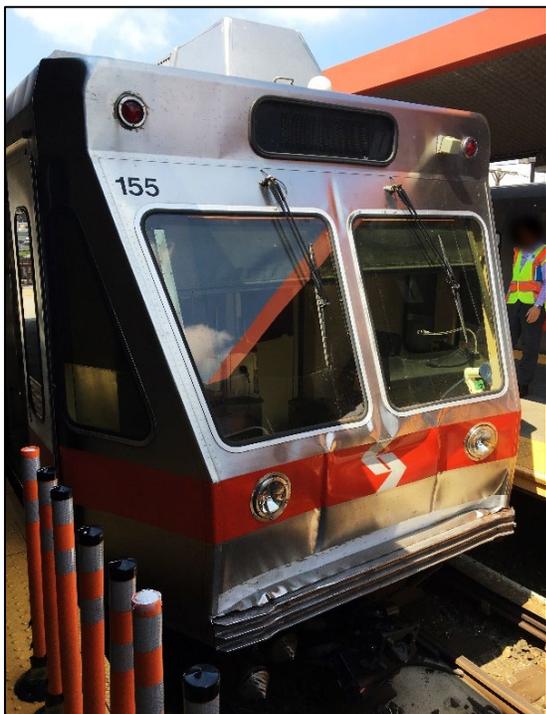
Figure 3. Postaccident collision damage to car 155.

Car 155 sustained exterior damage on the striking end of the coupler and front bulkhead panel and adjacent sidewall structure.⁴ (See figure 3.) On car 148's exterior, the struck end coupler, front bulkhead, and adjacent sidewall structure were damaged. The collision damage on both cars did not extend into the interior occupant space; only localized minor frame buckling was found. In addition, minor floor panel buckling, a broken door panel window, wall and ceiling panel cracks, dislodged seat cushions, and a misaligned door panel were noted on each car.
