RAILROAD ACCIDENT REPORT

COLLISION OF AMTRAK TRAIN 304-26
WITH A HIGHWAY VEHICLE AT A
HIGHWAY-RAIL GRADE CROSSING
MCLEAN, ILLINOIS
SEPTEMBER 26, 1999

**NTSB/RAR-01/03
PB2001-916303
Notation 7385
Adopted September 18, 2001**

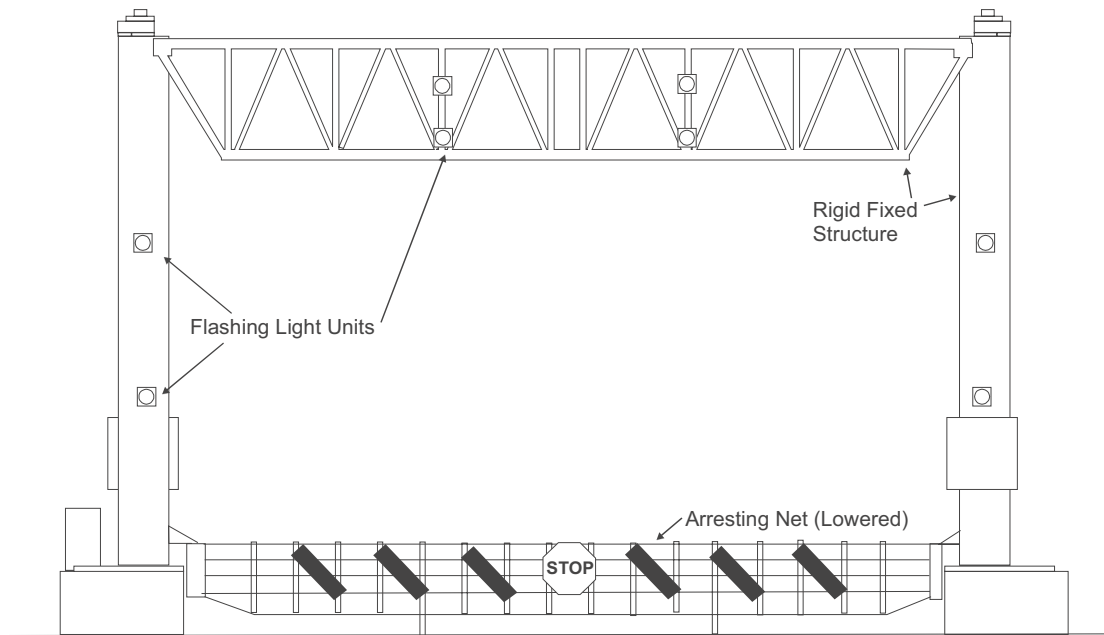
The vehicle arresting barrier system at the U.S. Route 136 highway-rail grade crossing in McLean was installed on October 30, 1998, and put in service on March 16, 1999. The vehicle arresting barrier system comprises two barriers, one located on either side of the crossing on U.S. Route 136. Each barrier has a net assembly consisting of five horizontal wire cables suspended above the roadway between two towers that are connected by a fixed horizontal rigid truss, also located above the roadway. The towers and connecting truss are equipped with eight 8-inch-diameter red flashing light units for east or westbound traffic on U.S. Route 136. When the vehicle arresting barrier is deployed, the flashing light units are activated and the net assembly is lowered to a position across all lanes of U.S. Route 136. (See figure 4.)

Figure 4. Diagram of vehicle arresting barrier with net lowered and deployed.

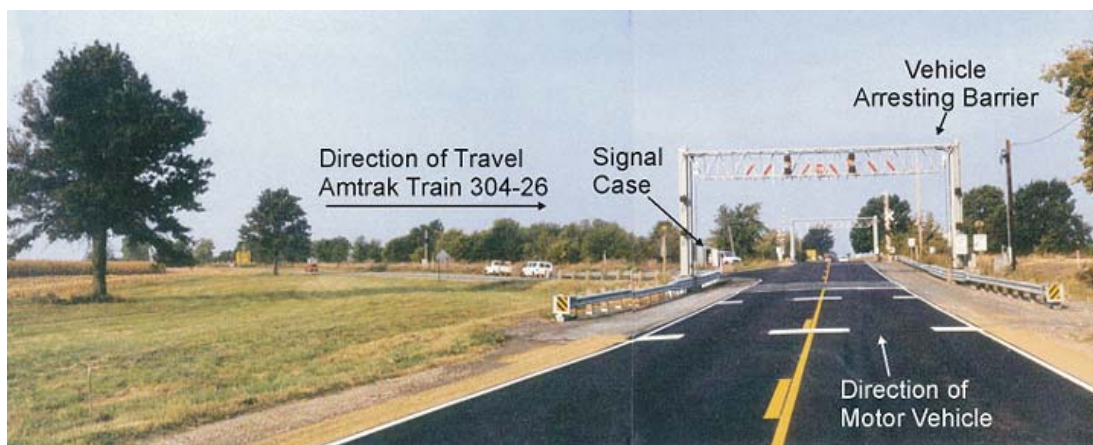
According to the American Association of State Highway and Transportation Officials, for a vehicle approaching a crossing, the driver must be able to see a train far enough along the tracks to have time to react to its presence and stop the highway vehicle before the crossing. The quadrant sight distance or “sight triangle” is formed by the distance along the roadway, the distance along the railroad tracks, and the distance along an imaginary line from the train to the highway vehicle. At the U.S. Route 136 crossing, the signal case and a small clump of low vegetation near the track were within the sight triangle. (See figure 5.)

Figure 5. View down tracks from accident vehicle's direction of travel.

Although the sight distance between the crossing and the train was clear enough that the approaching train could have been seen by the vehicle occupants, they apparently did not notice it before they proceeded across the tracks. The Safety Board concludes that because neither the crossing warning system nor the vehicle arresting barrier devices gave any indication of the approach of Amtrak train 304-26, the vehicle driver was not provided these active visual cues that it was unsafe to continue across the railroad tracks.
