**Derailment of CN Freight Train U70691-18 With Subsequent  
Hazardous Materials Release and Fire  
Cherry Valley, Illinois  
June 19, 2009**

**NTSB/RAR-12/01  
PB2012-916301**

# Railroad Accident Report

**Abstract:** About 8:36 p.m., central daylight time, on Friday, June 19, 2009, eastbound Canadian National Railway Company freight train U70691-18, traveling at 36 mph, derailed at a highway/rail grade crossing in Cherry Valley, Illinois. The train consisted of 2 locomotives and 114 cars, 19 of which derailed. All of the derailed cars were tank cars carrying denatured fuel ethanol, a flammable liquid. Thirteen of the derailed tank cars were breached or lost product and caught fire. At the time of the derailment, several motor vehicles were stopped on either side of the grade crossing waiting for the train to pass. As a result of the fire that erupted after the derailment, a passenger in one of the stopped cars was fatally injured, two passengers in the same car received serious injuries, and five occupants of other cars waiting at the highway/rail crossing were injured. Two responding firefighters also sustained minor injuries. The release of ethanol and the resulting fire prom

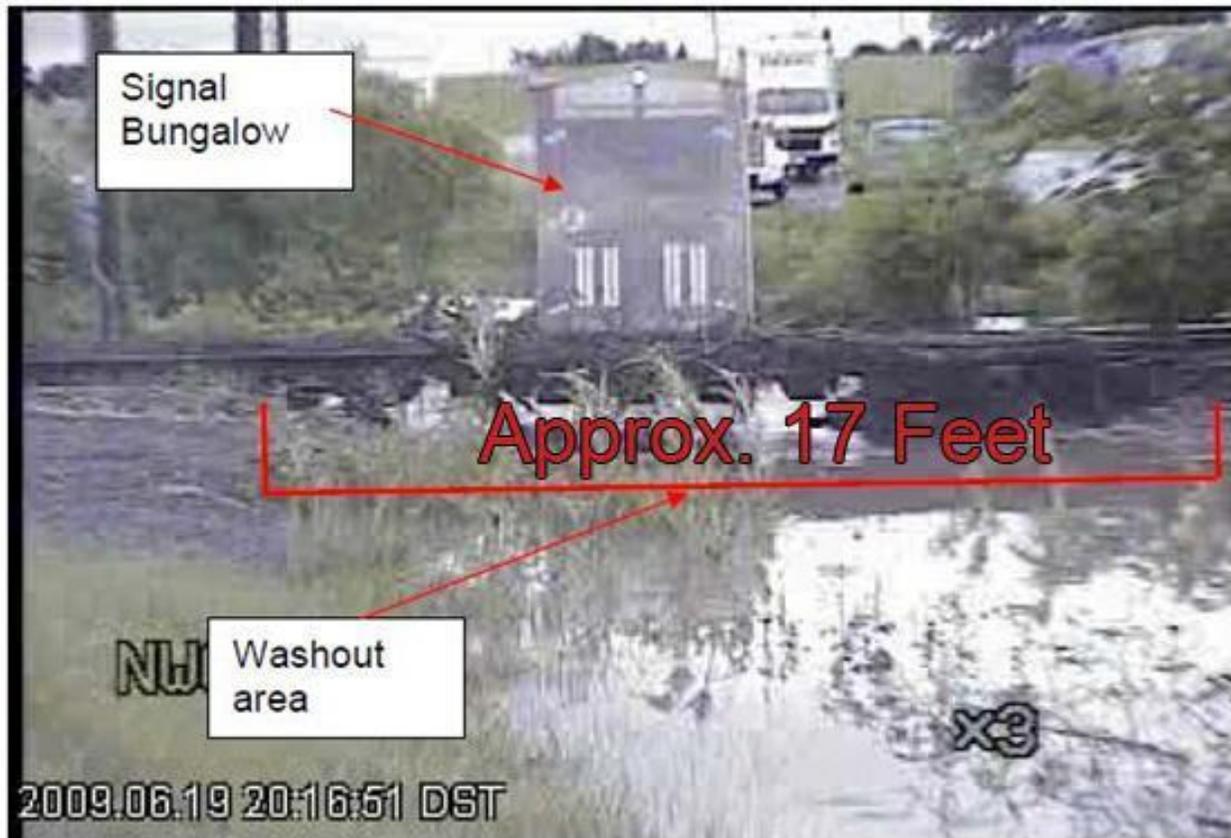
17 feet long along the west side of Mulford Road where water was rushing under the track. (See figure 2.)

**Figure 2.** A still image produced from deputy sheriff's dashboard video recorder looking from a point on west berm of Mulford Road facing south.

The water flow had washed the ballast section out from under the track beginning at a point about 4 feet from the west edge of Mulford Road. The track structure was hanging, with no support under the crossties and rail. The video showed about 10 crossties spiked to the rails that were suspended about 1 foot above the flowing water. Weeds and other debris visible against the north side of the rail and ties indicated that the water level had originally been even higher.

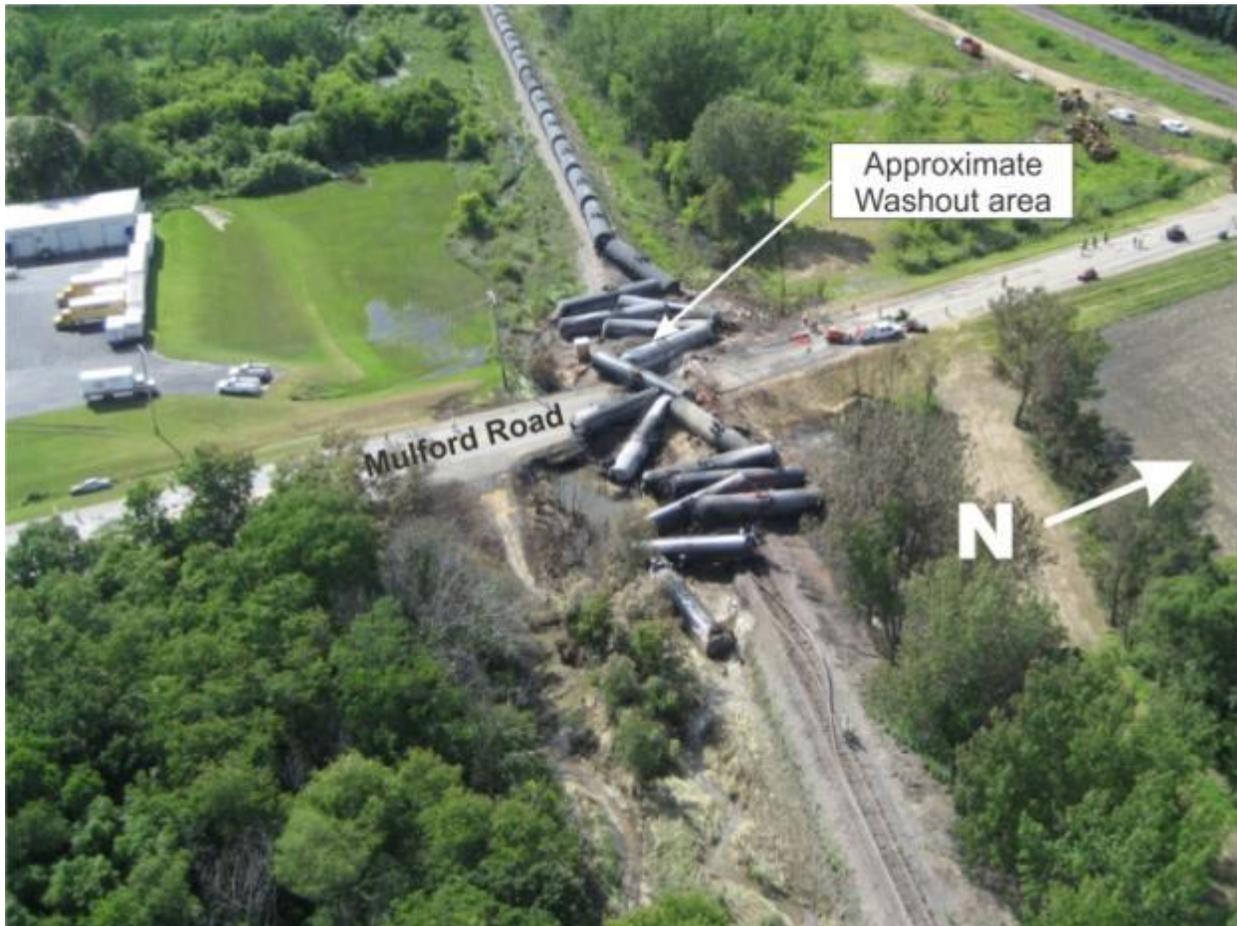
**Figure 3.** Aerial view, looking northwest, of derailed tank cars after locomotives and first 58 cars have been pulled away from wreckage.

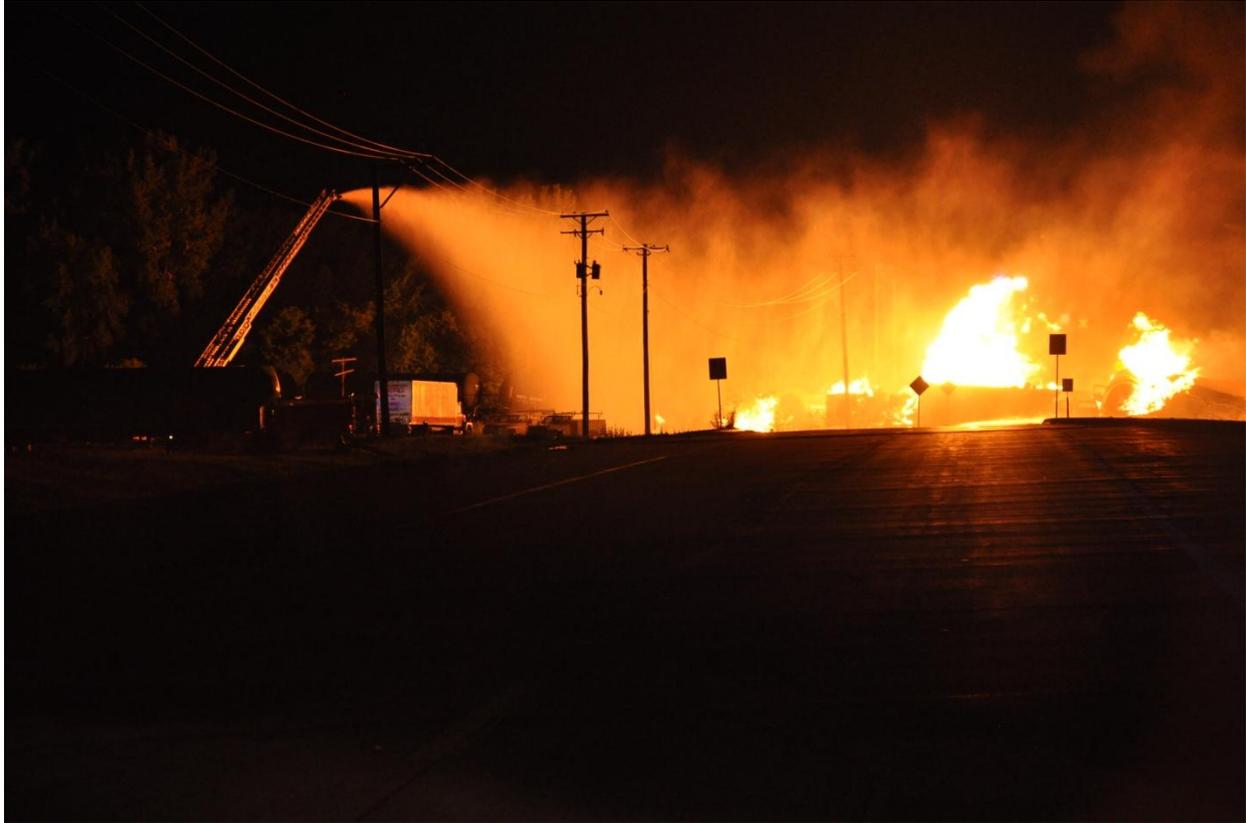
By this time, the flames extended several hundred feet into the air. (See figure 4.) It was not known if the pressure relief valves on the derailed and overturned tank cars were either damaged or inoperable. It was not known if any pressure tank cars<sup>16</sup> were involved in the wreckage pileup. At that point, responders did not know the contents of the burning cars because the placards indicating contents were not readily visible. They also did not know if any locomotives or train crew might be involved.

**Figure 4.** Looking north along Mulford Road toward burning tank cars at crossing.

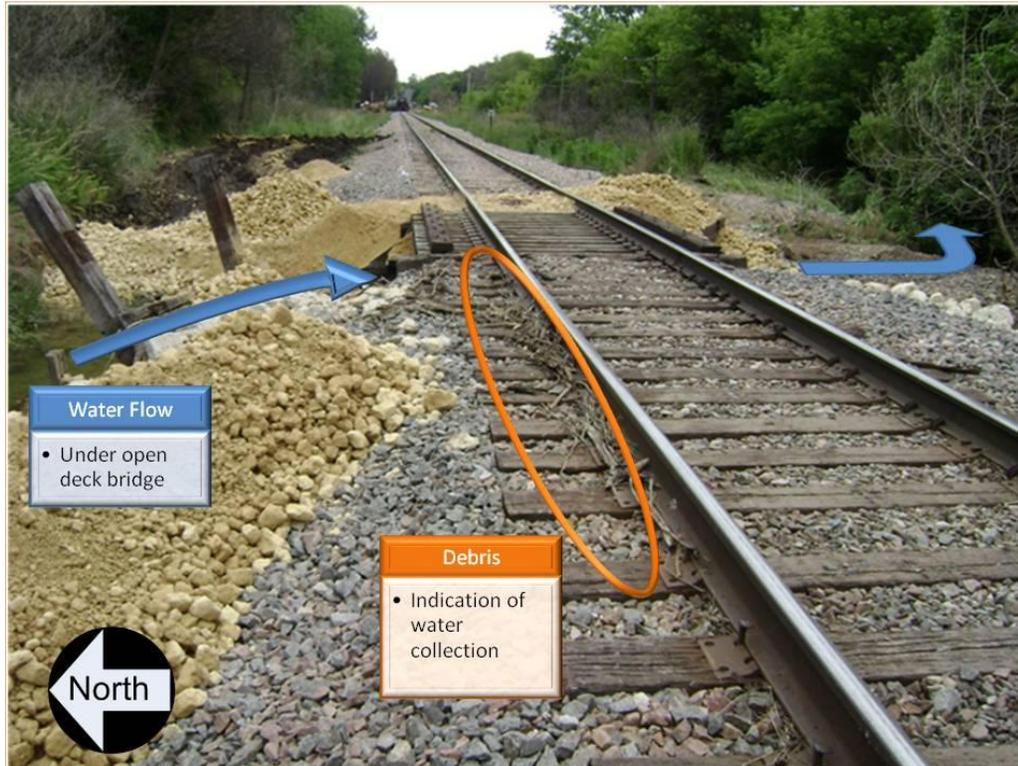
**Figure 5.** Photo shows storm water debris on the track, near the open deck bridge (0.1 mile west of the accident site). Water flow under open deck bridge is also indicated as flowing in southeast direction.

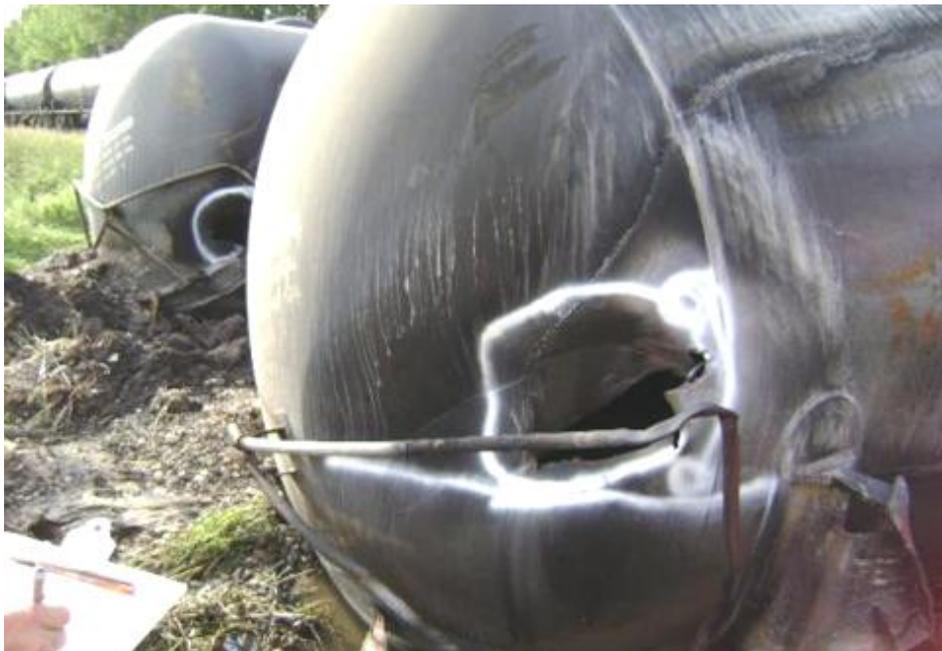
All 15 tank cars in the pileup were damaged as a result of the derailment and subsequent fire, with only 2 of the cars (the first two cars in the pileup) retaining their entire lading. Of the 13 cars that released all or part of their contents, 11 were breached. Most of the cars sustained varying degrees of dents, deformations, and breaches. The derailed tank cars sustained a total of 15 head punctures or tears (figure 9), and 4 tank shell punctures or tears (figure 10). Head failures in seven of the cars were caused by coupler or draft sill strikes. Two of the tank heads were breached by other striking objects or tank car structures. Additionally, side shells of three of the tank cars were breached as a result of car-to-car impacts. Eleven of the tank cars involved in the derailment were fire-damaged as evidenced by scorched or burned-away paint.

**Figure 9.** Tank head punctures in two derailed tank cars (outlined with white paint). (Federal Railroad Administration photo)

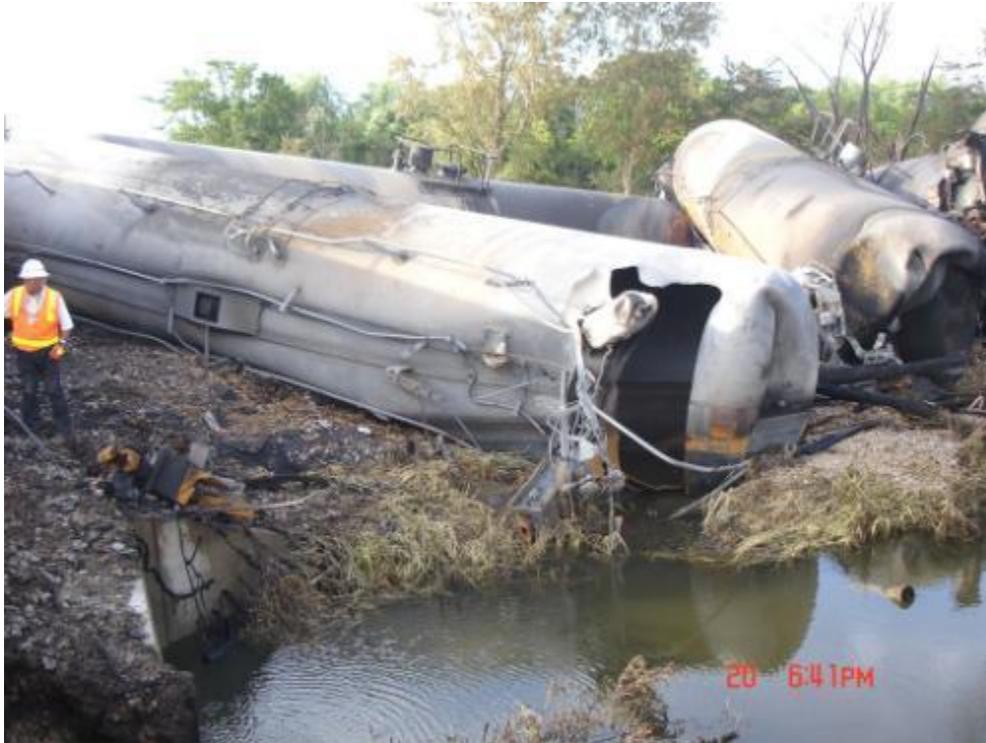
**Figure 10.** Breach in tank car NATX 303504. (Federal Railroad Administration photo)

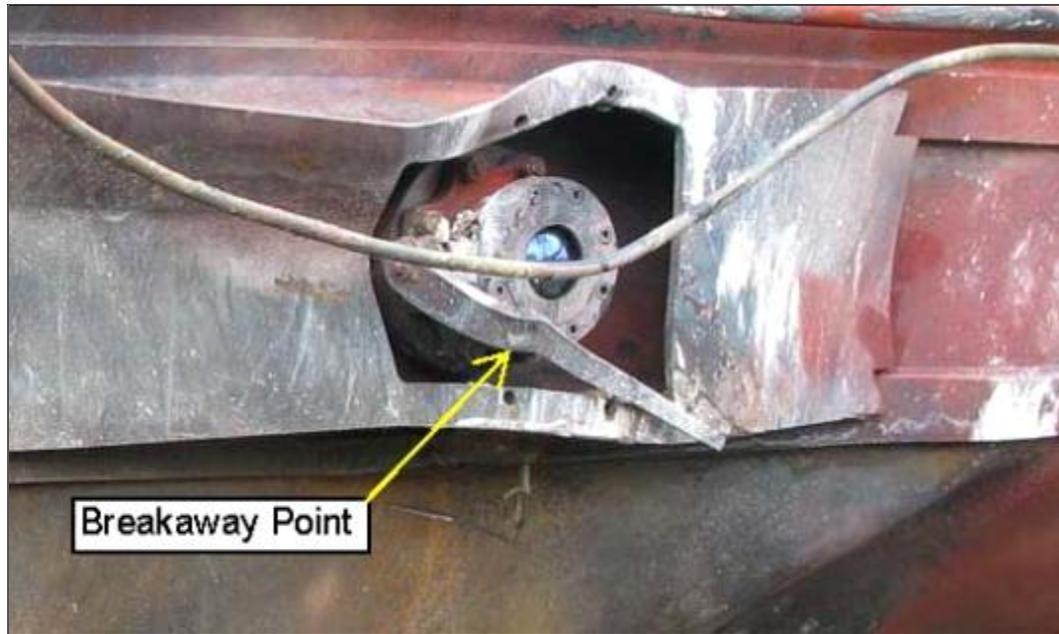
Many of the cars had valve and fitting damage ranging from sheared nozzles to broken valve handles. The postaccident inspection found six cars in which the bottom outlet valve nozzle sheared from the ball valve flange, as designed. Of these six cars, three of the ball valves had opened, contributing to the release of product from their respective cars. The ball valves had opened on three of these six cars, contributing to the release of product from those cars. The postaccident inspection revealed that the valves had opened when the valve levers were bent or pulled away from their retaining brackets during the derailment. Valve and valve configurations of both types (modified CIT and NATX/TILX) were involved in the product release. (See figures 11 and 12.) As evidenced by the burn patterns on the tank shells around the center sides of the three tank cars, the release of product through the bottom outlet valves contributed to the postaccident fire.

**Figure 11.** Bottom outlet valve of car CTCX 731599 showing exposed valve and bent but intact valve operating handle. Handle retaining bracket is missing. (Valve was opened during derailment but was closed by emergency responders.)

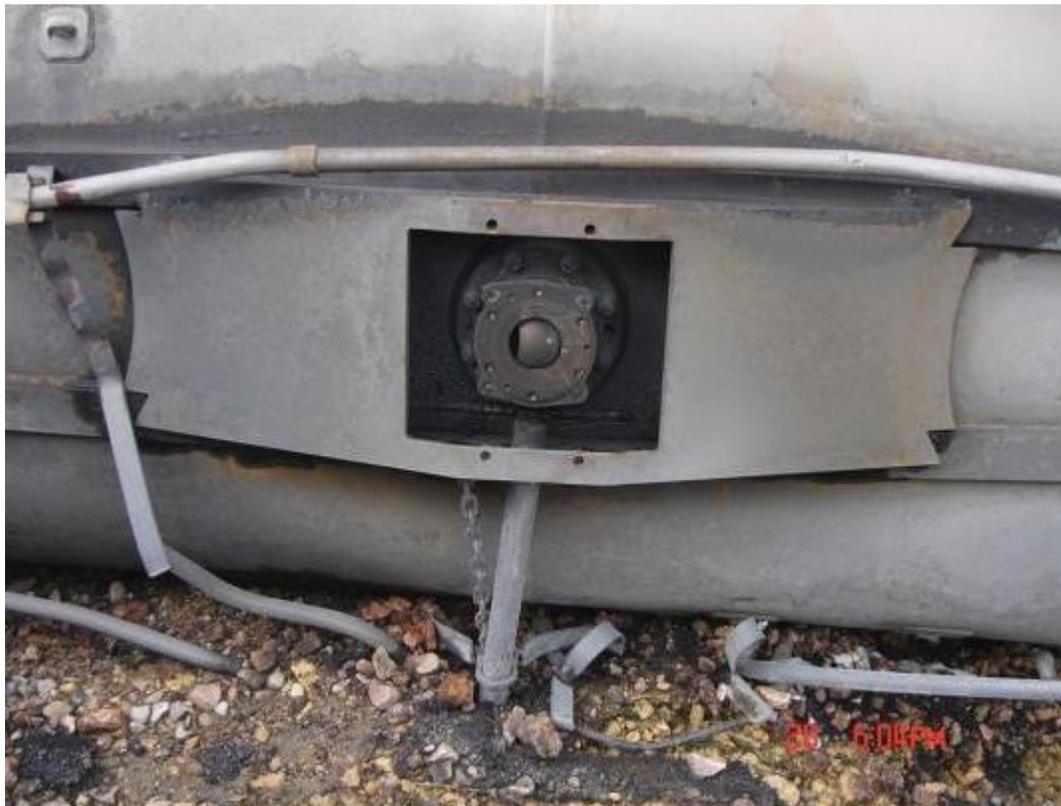
**Figure 12.** Bent valve handle and exposed and partially open bottom outlet valve on car NATX 303504. (Federal Railroad Administration photo)

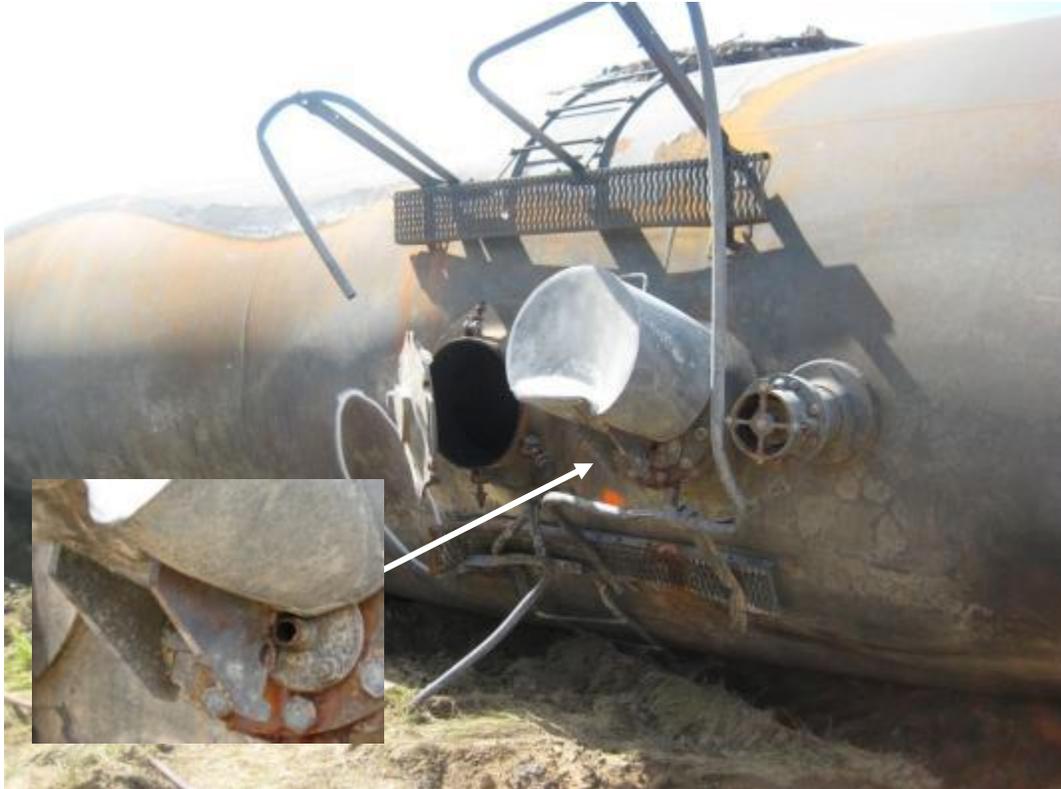
Three top valves were also found to be damaged and either partially or fully open. In the case of one car, CTCX 224236, the protective housing separated from the car, and both the liquid and the vapor valves were sheared from their threaded pipes, causing the car to lose about 26,357 gallons of product. The protective housing cover of car TILX 193772 (figure 13) was knocked askew in the derailment, breaking the vapor valve from its fitting and contributing to the release of product from that car. While the protective housing did prevent damage to fittings in the case of one car (CTCX 731600), which came to rest lying upside down in a muddy stream channel, the top fittings were damaged in other instances where the protective housings contacted harder objects.

**Figure 13.** Top fitting damage, car TILX 193772. (Overall photo by Trinity Tank Car. Inset photo by the CN.)

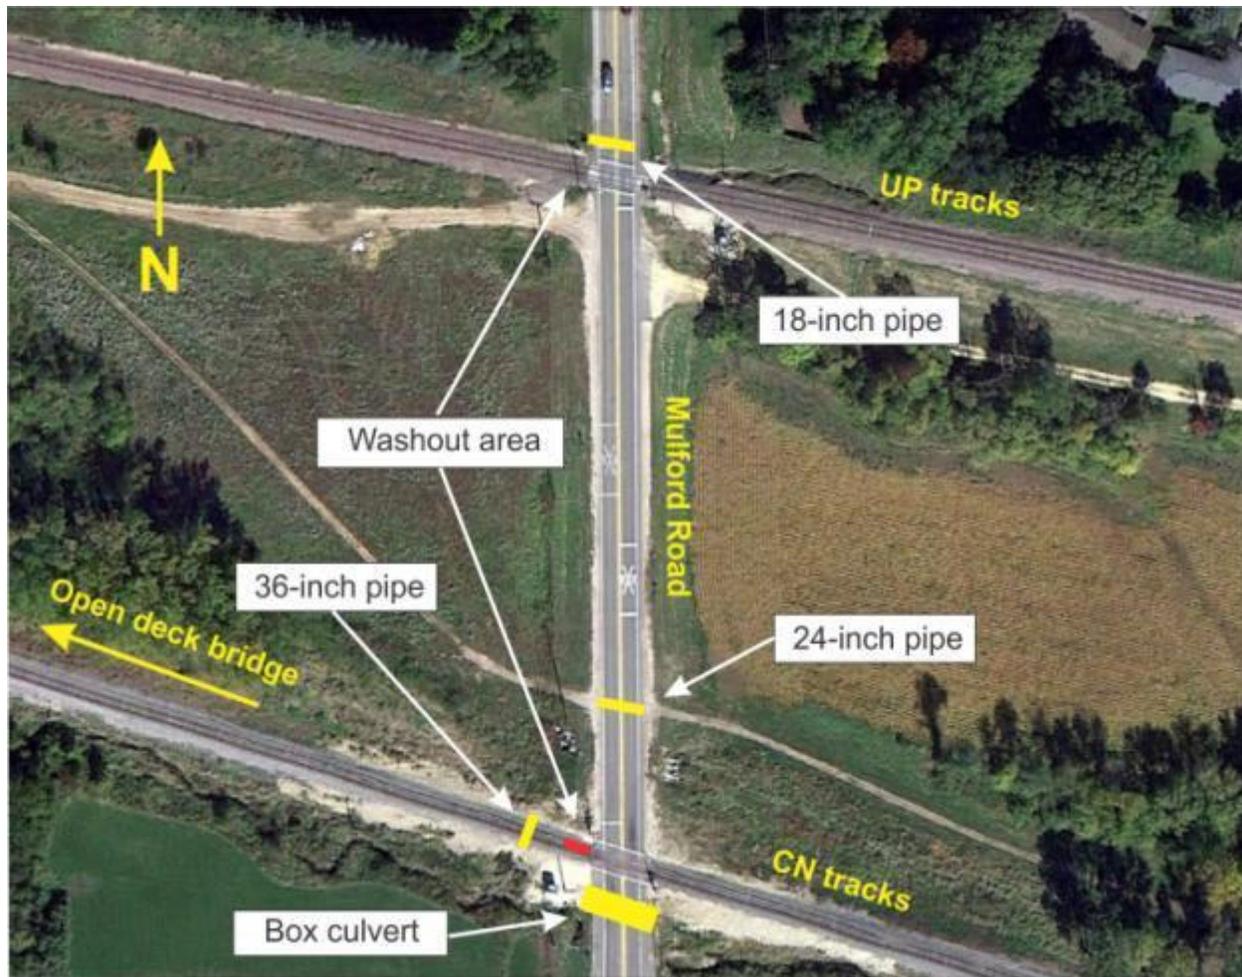
The Mulford Road grade crossing and the area to its north and east had a number of hydrologic features designed to manage and direct the flow of storm water. These included, in addition to the 36-inch pipe the CN had installed under its tracks in 2007, an 18-inch-diameter corrugated metal pipe culvert under Mulford Road just north of the UP Mulford Road crossing, a 24-inch-diameter corrugated metal pipe culvert under Mulford Road north of the CN crossing, and a 5- by 10-foot reinforced concrete box culvert under Mulford Road just south of the CN crossing. The pipes and culvert were installed by the Winnebago County Highway Department in 1970 as part of the reconstruction of Mulford Road. (See figure 14.)

**Figure 14.** Aerial view illustrating CN and UP grade crossings and location of culverts and washouts on day of accident.

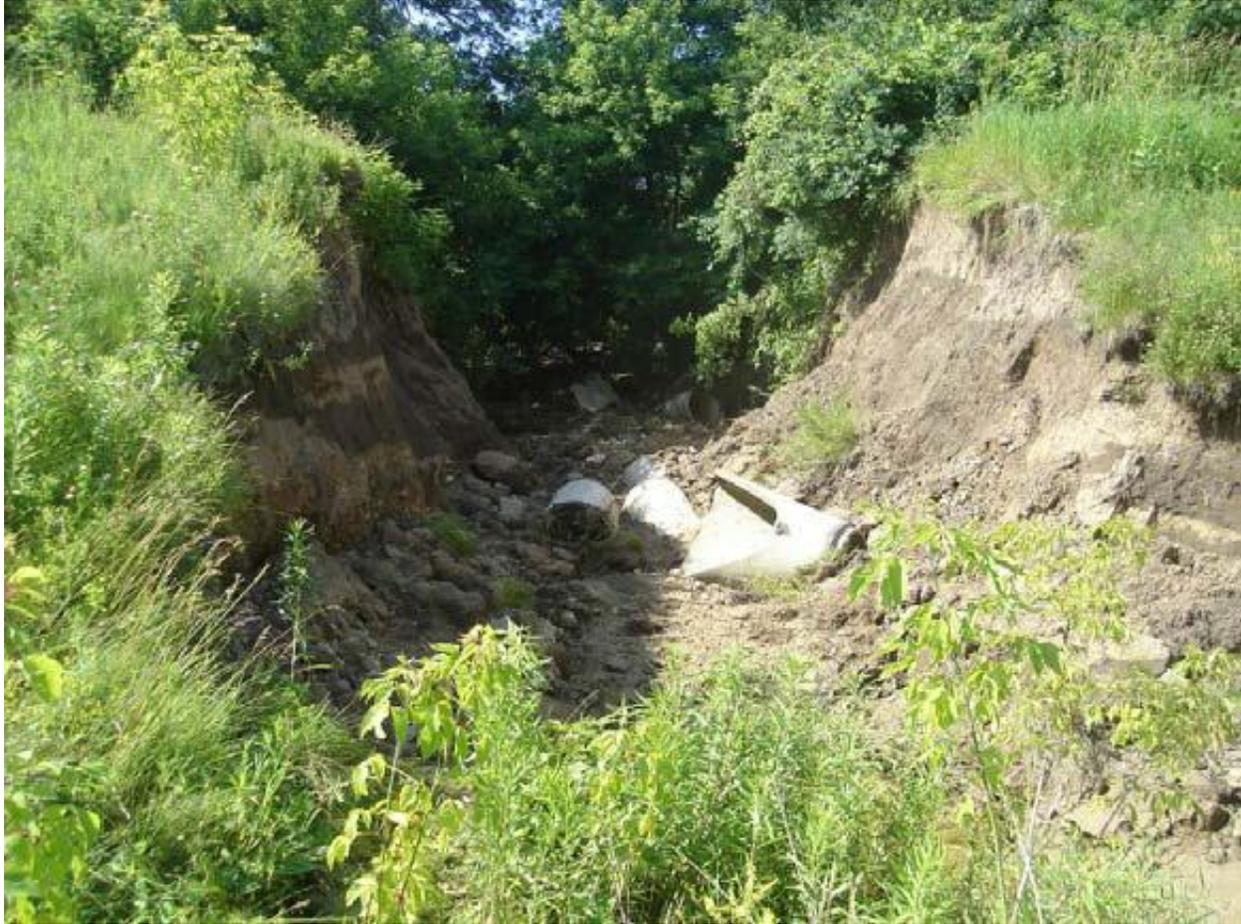
During the postaccident investigation, SWM pond 1 was found to have a breach in its southeast corner at the site of the pond outlet. The breach measured 12 feet high by 18 feet wide with water continuing to flow out from north to south. Inside the pond, investigators found a small stream leading to the breach. The stream was 4 to 6 inches deep and 2 to 3 feet wide. The remains of several pieces of 27-inch-diameter reinforced concrete pipe were found scattered at the bottom of the breach opening. (See figure 16.)

Further investigation of the breach revealed a plume of material (sand, clay, dirt, small rock) as well as flowing water (2 to 4 inches deep) extending southeast out of the retention pond and toward the UP track. Investigators followed traces of water flow that led to the UP track and discovered washout damage (about 15 to 20 different locations from below the outlet going east to Mulford Road that varied in length and depth below the bottom of the ties and outside of the end of the cross-ties). From the UP washout, the water appeared to flow in a southeast direction.

**Figure 16.** Postaccident photograph showing breach in SWM pond 1 as viewed from inside pond looking south.

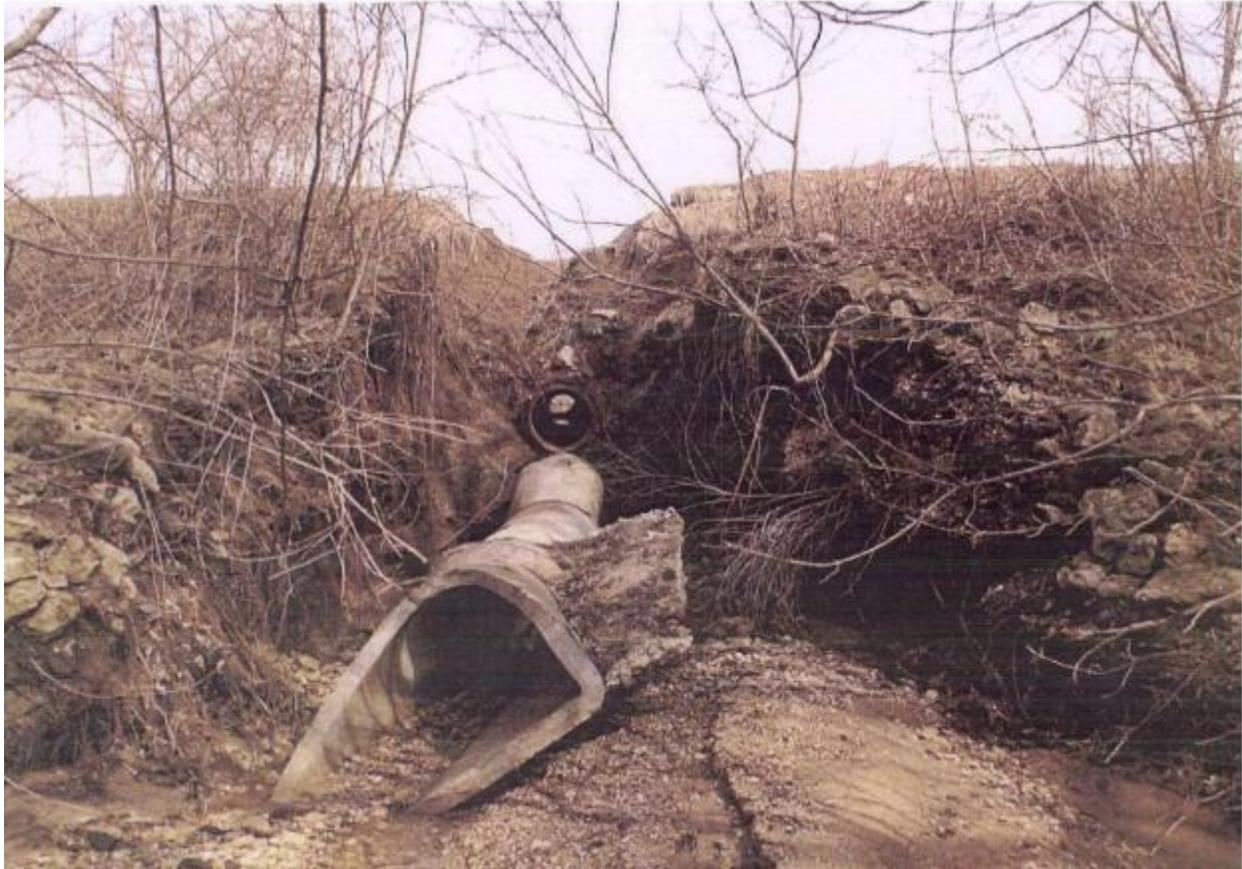
Investigators interviewed several residents who lived adjacent to SWM pond 1. The residents told investigators that the berm directly over the outlet of the pond had been deteriorating for the past several years. The managing agent (a local realty firm) for the Harrison Park Landowners Association<sup>43</sup> provided investigators with an April 2008 photograph (figure 17) showing a view looking north from the downstream end of the outlet area of the detention pond.

**Figure 17.** View looking north from downstream end of outlet area of SWM detention pond 1 showing erosion over top of outlet culvert and erosion below outlet. (Photo taken in April 2008.)

The recorded plat of the Harrison Park subdivision notes that “the maintenance of the drainage and storm water detention easement shall be the sole responsibility of the individual property owner.” According to the records of the Harrison Park Landowners Association, after the deterioration at the outlet of SWM pond 1 had been noted in April 2008, a local construction company submitted a bid to repair the damage for \$23,436. In 2009, the association agent began assessing Harrison Park landowners to pay for the repairs. At the time of the accident, the balance in the fund to repair the damage was \$23,288.11. The breach was repaired on September 3, 2009, at a cost of \$23,500.

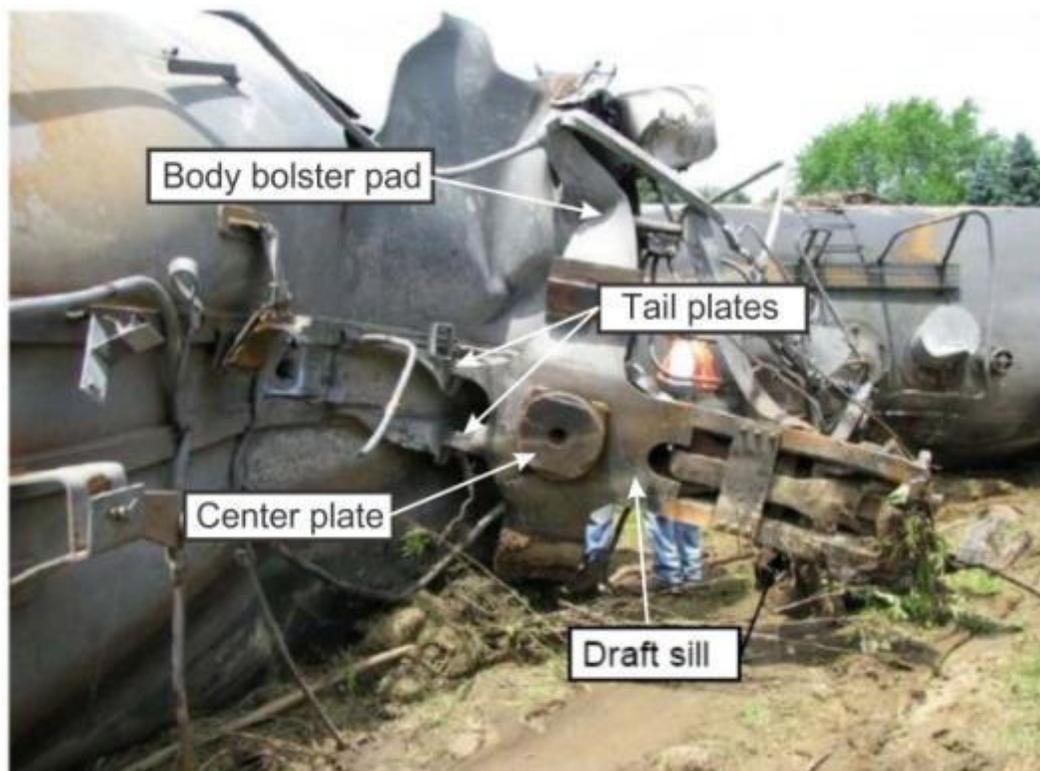
Figure 21. Underside of B end of tank car NATX 303504 as viewed from A end.

Examination of the lower side of the tank at the front sill pad attachment area showed that the fillet weld attaching the sill pad to the tank shell had fractured through weld metal. The weld fractures occurred in various planes from parallel to the tank outer surface to almost perpendicular to the tank surface. The fracture features had a matte gray appearance with a light orange oxide, consistent with ductile overstress fracture with some postfracture oxidation. The fracture features were generally uniform in color and texture, with no evidence within the welds of slag, undercuts, porosity, lack of fusion, or cracks. The portions of the weld metal remaining attached to the tank surface had features that were consistent with fracture propagation from front to rear along the sides of the front sill pad. The weld fractures at the edges of the front sill pad ended at the edge of the body bolster pad, a position also corresponding to the location of the circumferential fracture through the shell. At the lower surface of the tank car, the circumferential shell fracture occurred adjacent to the fillet weld for the body bolster pad and the butt weld attaching the front sill pad to the body bolster pad and bolster pad fillet weld. Investigators did not find evidence of preexisting damage such as fatigue cracking.
