Collision of Port Authority Trans-Hudson Train with
Bumping Post at Hoboken Station
Hoboken, New Jersey
May 8, 2011

Accident Report

NTSB/RAR-12/05
PB2012-916305

Railroad Accident Report

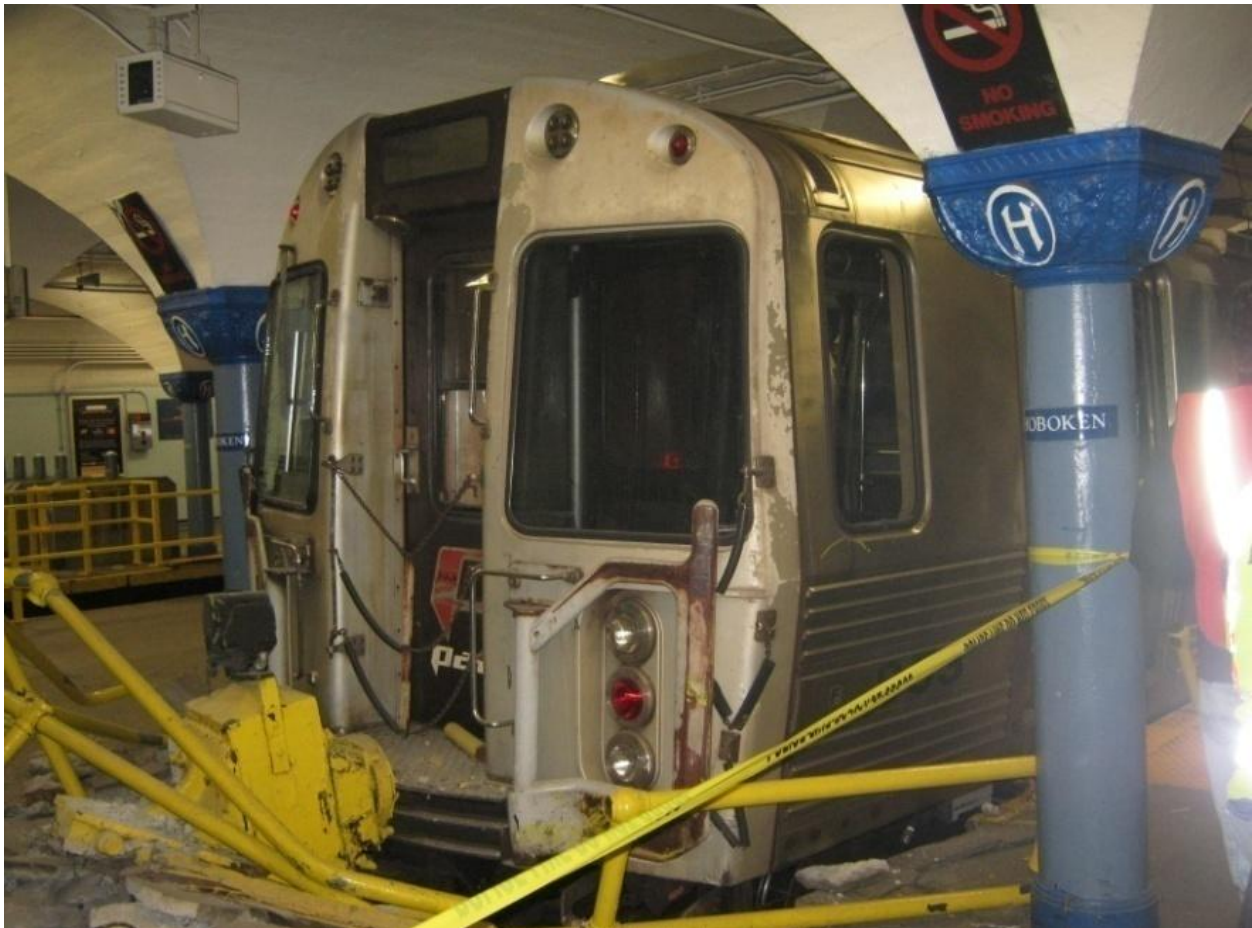
After it struck the bumping post, train 820 came to a stop about 11 feet past the seven-car marker.⁴ (See figure 1.) The front set of wheels derailed on the first car of the train. The lead car's front end and the mechanical coupler sustained minor damage. The other cars in the train had signs of engagement at the anticlimbers.⁵ Additionally, as a result of the impact, the shear bolts⁶ in the couplers in the train broke. The platform bumping post was severely damaged and pushed back 5 feet 2 inches. The concrete station platform also was damaged. PATH estimated total damages to be \$352,617.

Figure 1. Photograph of accident site at Hoboken station.

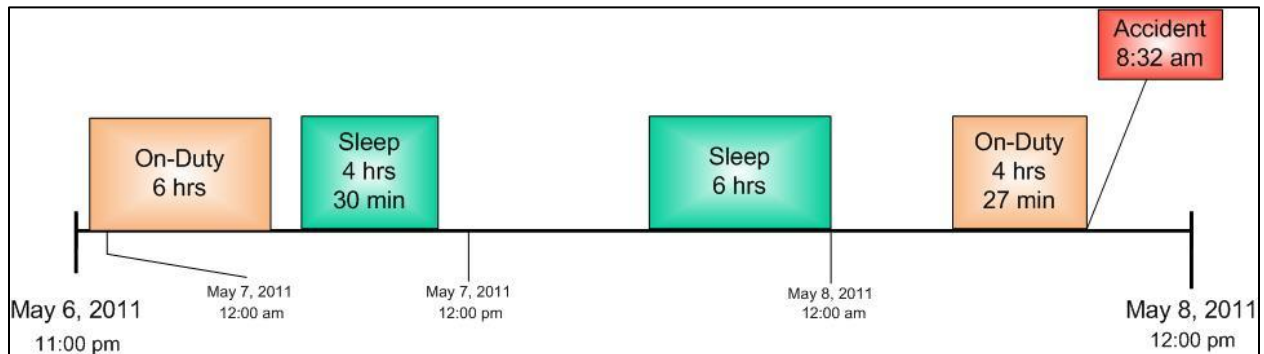
When questioned about sleeping habits, the engineer said she napped twice a day for a period of at least 4 hours. When asked about the day before the accident (May 7), the engineer said she had two naps totaling 10 1/2 hours. (See figure 2.)

Figure 2. Engineer's work/sleep/wake history.

There was insufficient information available to determine whether the engineer was fatigued at the time of the accident.
