Conrail Freight Train Derailment with  
Vinyl Chloride Release  
Paulsboro, New Jersey  
November 30, 2012

NTSB/RAR-14/01  
PB2014-108828

# Railroad Accident Report

**Abstract:** This report discusses the 2012 accident in which a Consolidated Rail Corporation (Conrail) train derailed while traveling over a moveable bridge in Paulsboro, New Jersey. Three tank cars containing vinyl chloride came to rest in Mantua Creek, of which one was breached and released about 20,000 gallons of vinyl chloride. On that day, 28 residents sought medical attention for possible exposure, and the train crew and many emergency responders were also exposed. Damage estimates were \$451,000 for equipment and about \$30 million for emergency response and remediation.

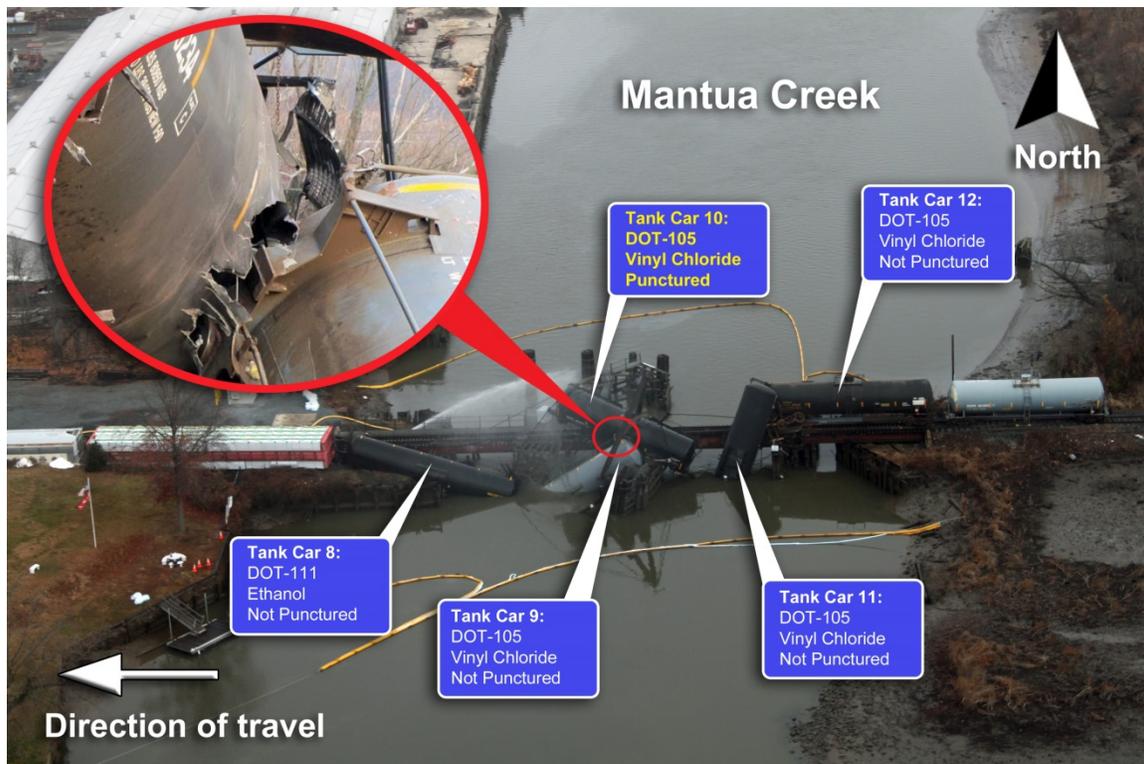
**Figure 2.** Five derailed tank cars, their commodities, and their condition after the derailment. The inset shows the punctured vinyl chloride tank car.

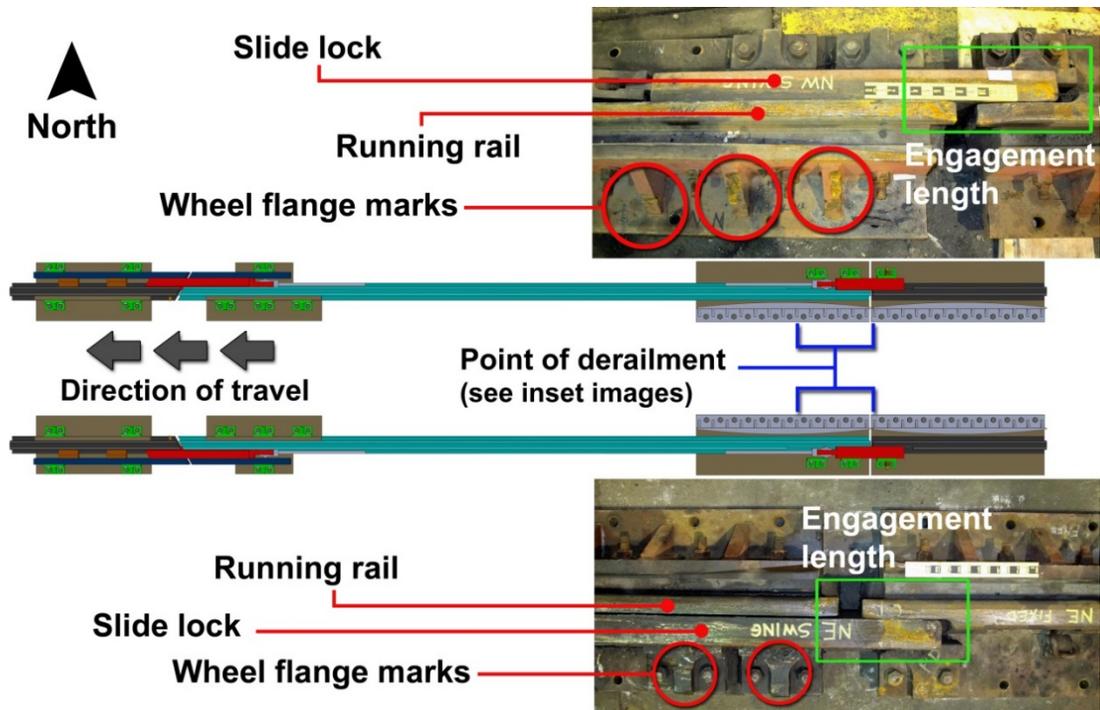
The west slide lock components on both rails were significantly damaged during the derailment. Examination of the west-side fixed rail components indicated that the locks were engaged about 6 inches, even though the slide locks were not detected by the proximity sensors and not indicated as locked on the signal system event report. A portion of the fixed-end south running rail had an overstress fracture through the web and head of the rail. Dents were apparent on the base flange side consistent with wheel impacts after fracturing. Although the BCS data indicated that none of the slide locks had reached the locked state, photographic evidence indicates that the northern slide lock was fully engaged, or nearly so. Evidence of the position of the south slide lock was less clear; however, because both slide locks were mechanically connected to a common drive mechanism, it is likely that both west end slide locks were partially engaged, meaning that the slide lock crossed the 2 and 3/4-inch normal rail gap and would prevent bridge rotation, but not engaged far enough to be detected by the proximity sensors. Based on these observations of the fractured south fixed running rail, the south slide lock was likely partially engaged.

The train crew told NTSB investigators that the conductor visually confirmed that the slide locks were locked before the train moved onto the bridge. However, the postaccident examination determined that the east end slide locks were not engaged, meaning the slide locks did not span the rail gap. The east end slide locks and fixed side-slot components were undamaged and in the open position. Had the east end slide locks been locked, significant deformations and fracturing of the slide lock components would have resulted when the bridge rotated. Although photographs taken after the derailment show the east end slide locks partially extended, the lack of damage to the mating components indicates that they had no engagement with the fixed side. Therefore, the NTSB concludes the recorded data and postaccident physical condition of the slide lock components indicate that the slide locks were not engaged on the east end of the bridge and the slide locks on the west end were only partially engaged as the train crossed the bridge.

Multiple marks and dents at the east end of the moveable span consistent with wheel flange impacts were noted on the wheel flange guard at the north rail and on top of the slide lock guide of the south rail, indicating that the bridge span rotated counterclockwise as the train crossed the bridge. Calculations showed that the east end of the bridge could have moved several inches to the north, even with the west end slide locks fully engaged. The wheel marks indicate that the swing span rotated under the train and displaced the east end of the span 6 to 12 inches to the north before the first derailed wheels struck. The point of derailment at the east end of the bridge swing span is shown in figure 7. Therefore, the NTSB concludes physical evidence shows that the east end of the bridge span rotated north under the moving train, misaligned the running rails, and caused the train to derail.

Figure 7. The point of derailment on the east end of the moveable bridge.

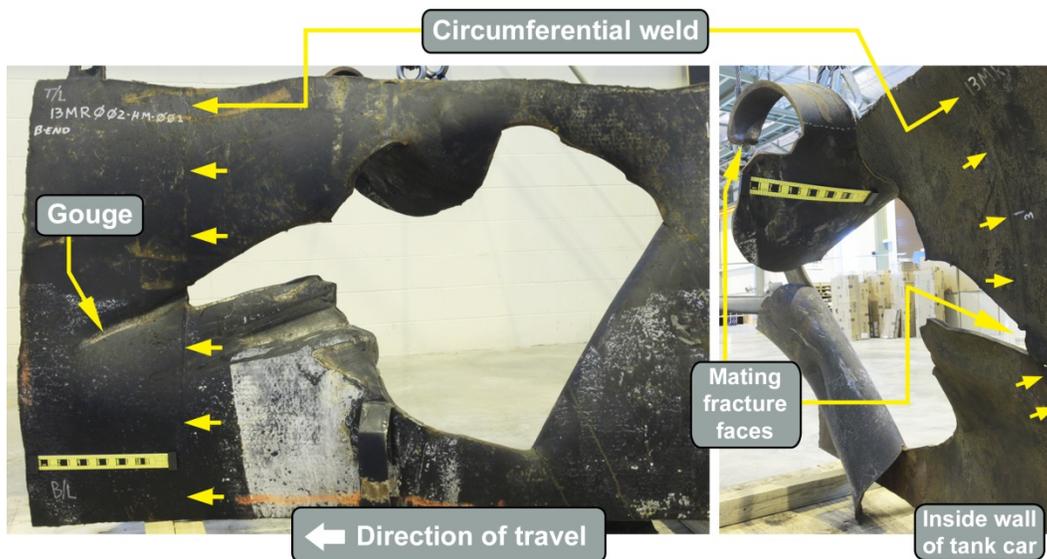
figure 8. The tears opened into an irregularly shaped hole with additional inward deformation that folded sections of the wall inside the shell. The hole measured 37 inches at its widest point.

**Figure 8.** Puncture and tears on the shell of the breached vinyl chloride tank car.

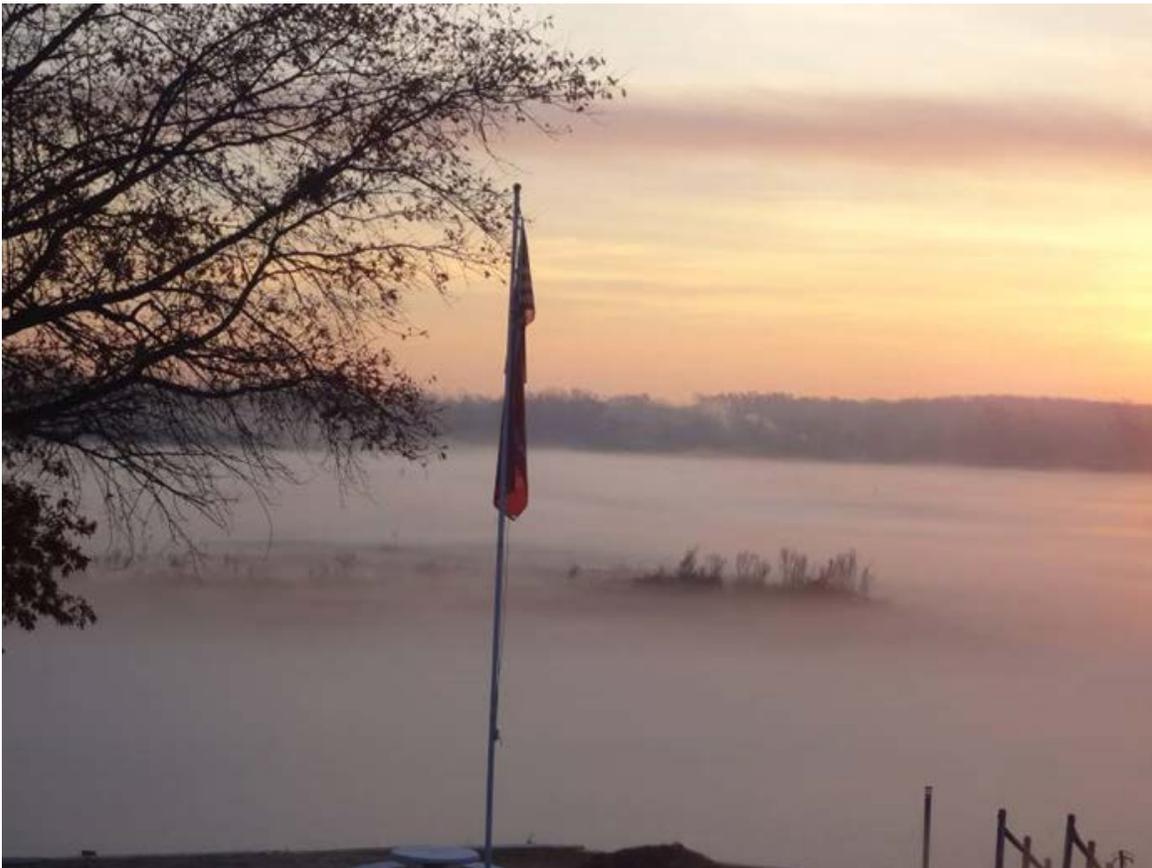
The first police officer arrived about 7:05 a.m., followed shortly thereafter by two other police officers. The officers reported that a "heavy cloud was hovering over Mantua Creek" near the Paulsboro moveable bridge (see figure 9).

**Figure 9.** View of a dense, low lying vapor cloud over Mantua Creek. (Photo provided by a private citizen)

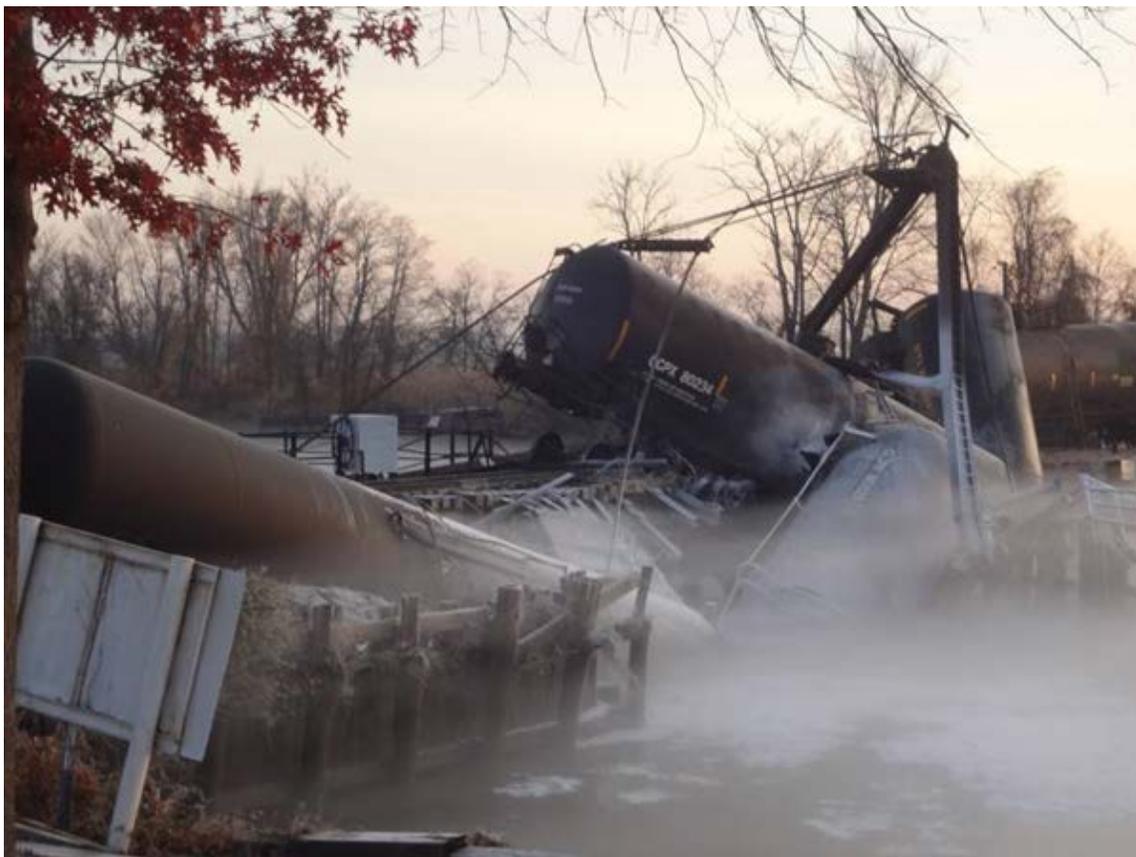
**Figure 10.** The breached tank car leaning off the bridge and the vinyl chloride vapor cloud. (Photograph provided by a private citizen)

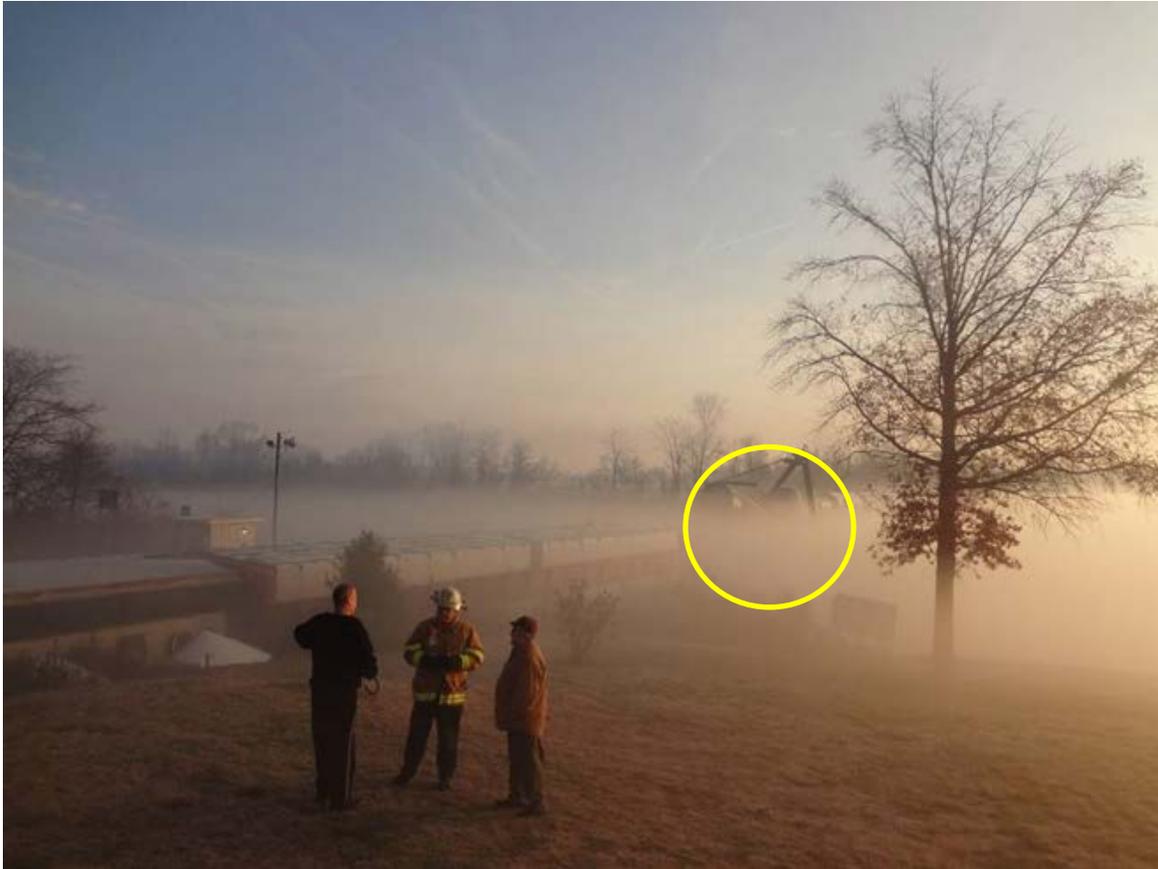
Within minutes of the accident, emergency responders reported a visible vapor cloud indicating that a potentially hazardous chemical release was occurring (see figure 11). Six minutes after the initial report, the Gloucester County Communications Center told the fire chief that “four tank cars [were] in the water leaking.” The deputy fire chief also reported seeing placard number 1086, which corresponds to vinyl chloride. Therefore, the incident commander had compelling information that a vinyl chloride release had occurred and that all personnel should have retreated to a safe location, isolated the area in accordance with the ERG, and should have required the use of appropriate PPE, including respiratory protection.

**Figure 11.** Emergency responders and a resident in the vapor cloud near the breached tank car. The breached tank car is circled. (Photograph provided by a private citizen)

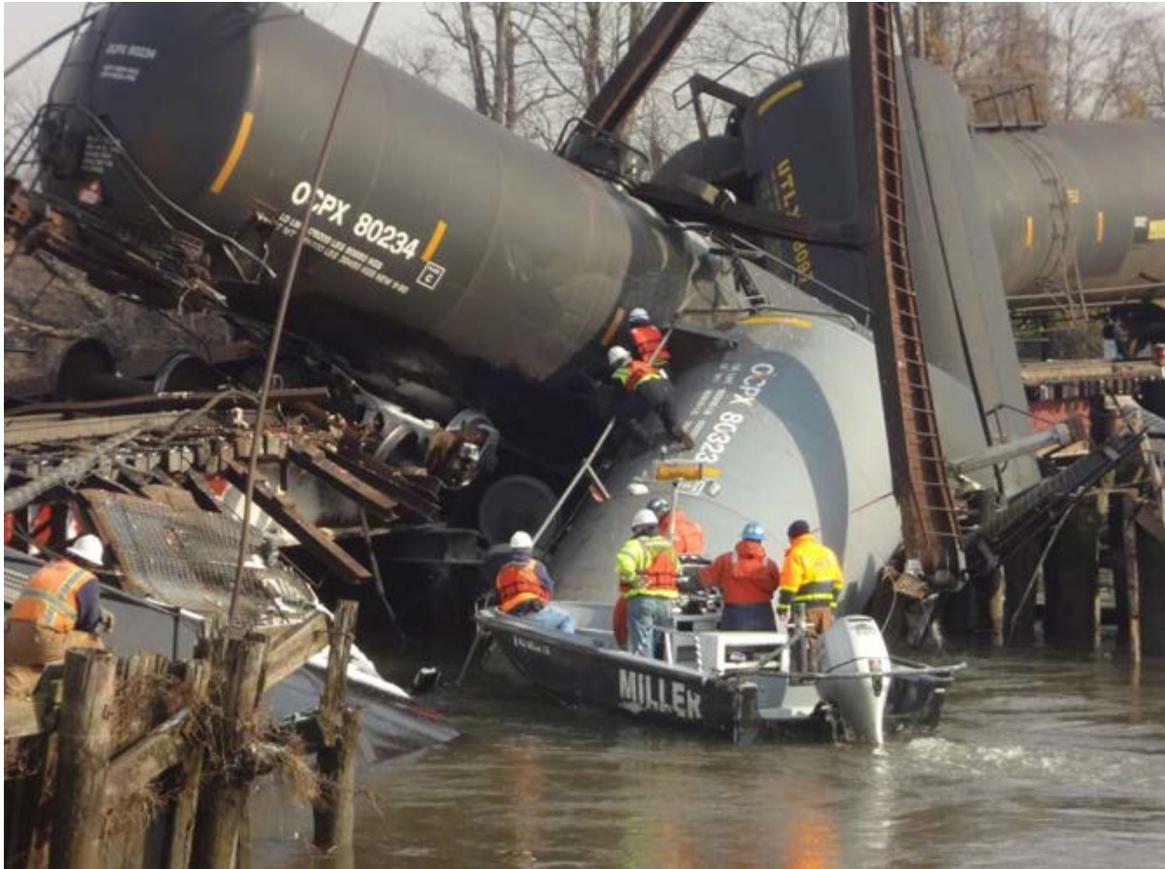
**Figure 12.** Personnel inspecting the breached tank car containing vinyl chloride liquid and vapor.

Although the fire chief testified in the NTSB investigative hearing (NTSB 2013) that he did not ask Conrail employees to examine the wreckage, the HAZWOPER standard found under 29 CFR 1910.120(q)(3) requires the incident commander to delineate and control access to the site.
