Highway-Railroad Grade Crossing Collision
Commerce Street
Valhalla, New York
February 3, 2015

Accident Report

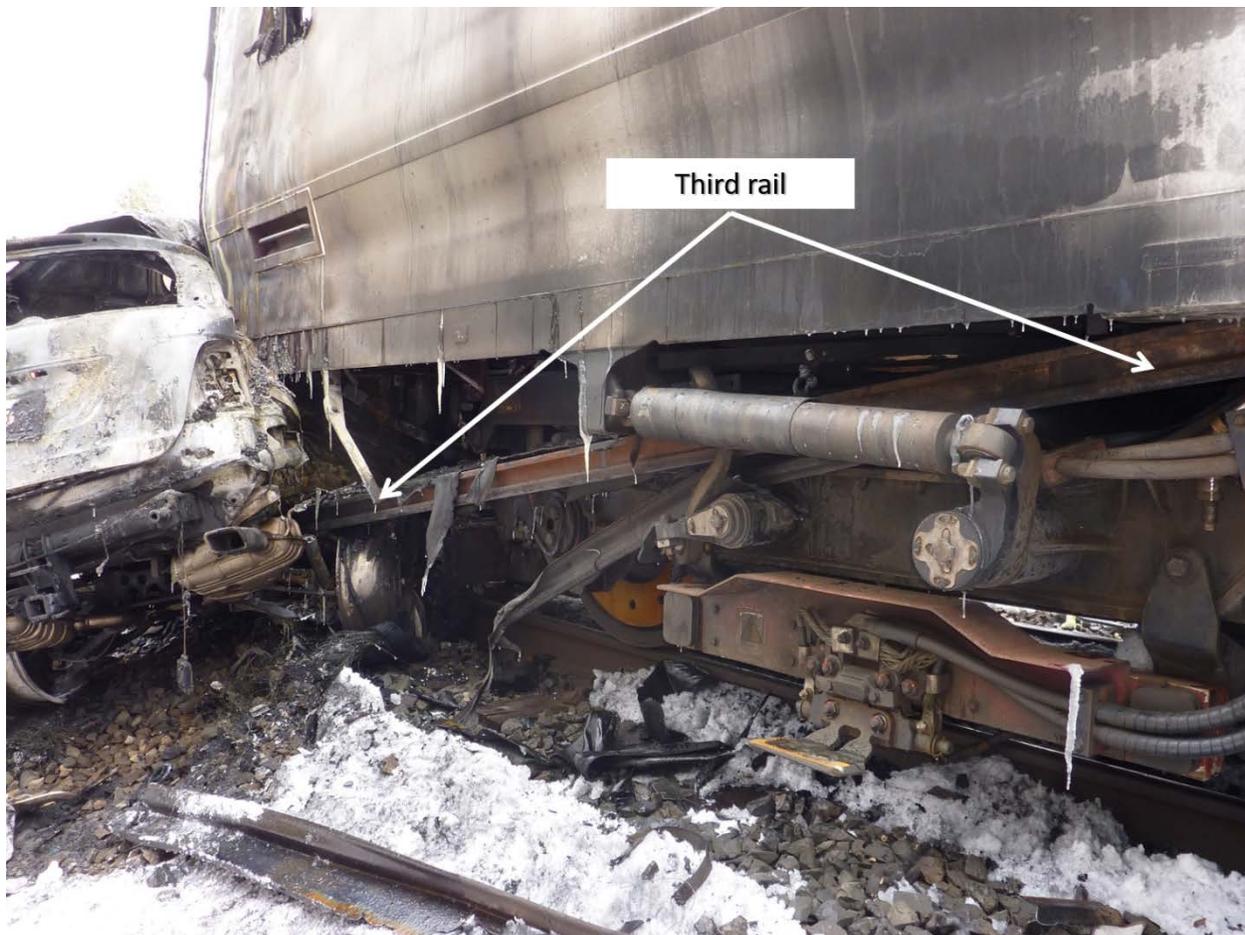
Figure 2. Photograph of the SUV and Metro-North train 659 after the collision.

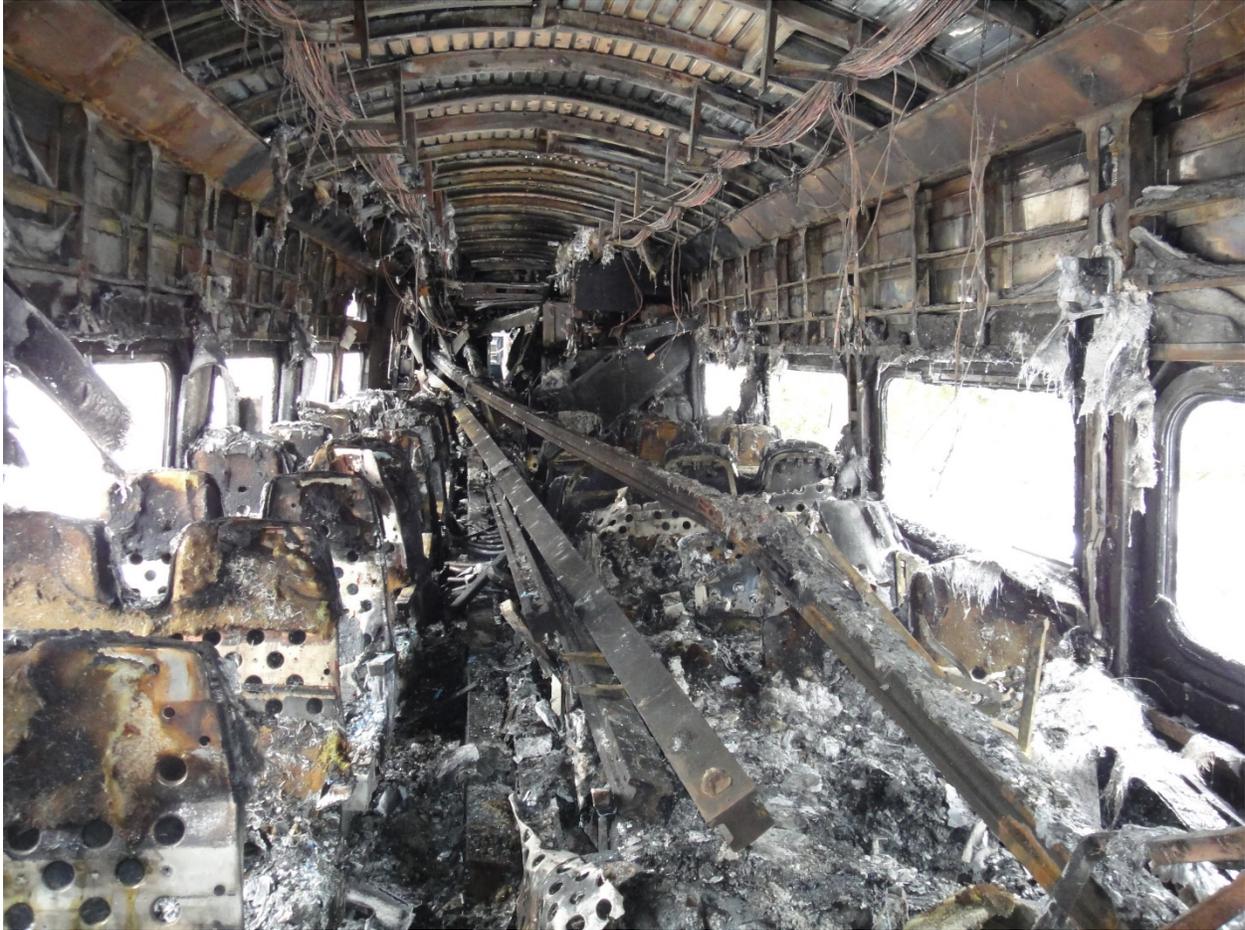
Figure 3. Postaccident photograph of the interior of the lead railcar.

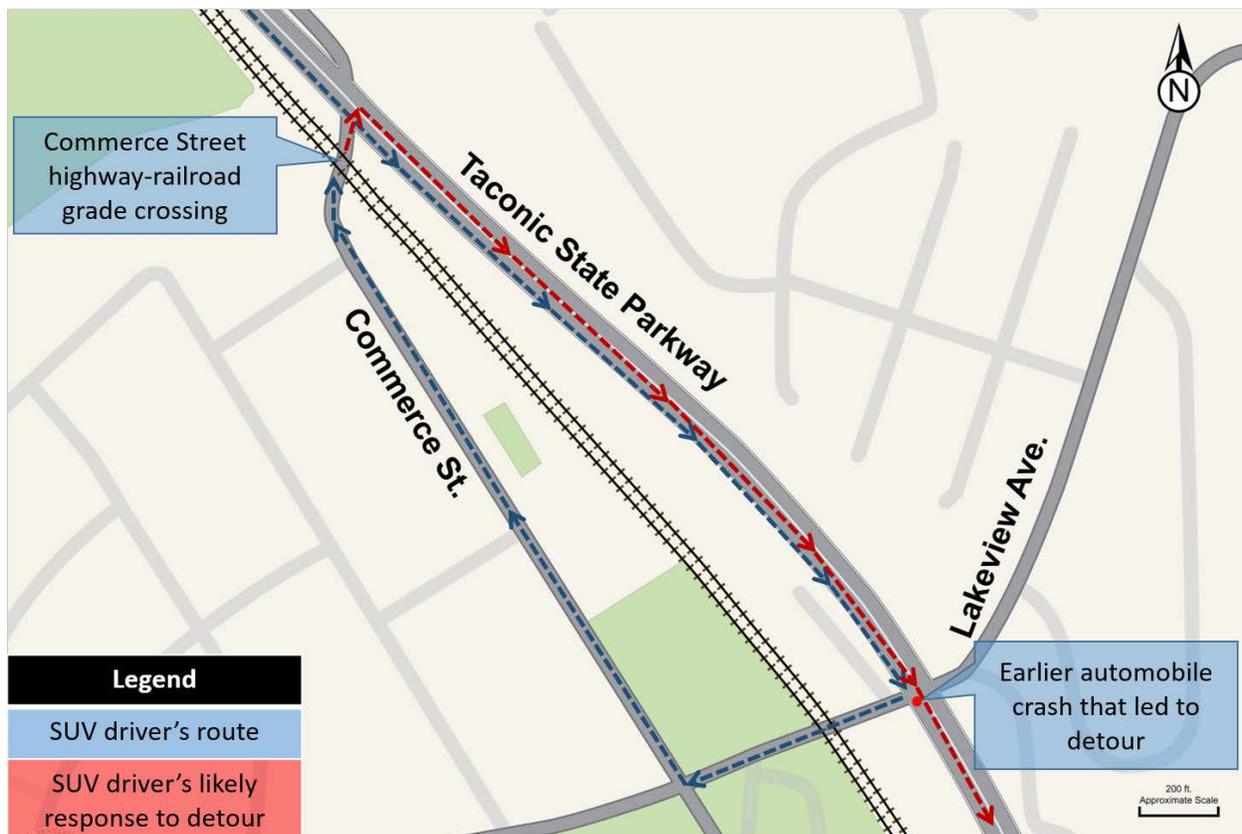
Figure 4. Map of the driver's route. (Source: Google Maps.)

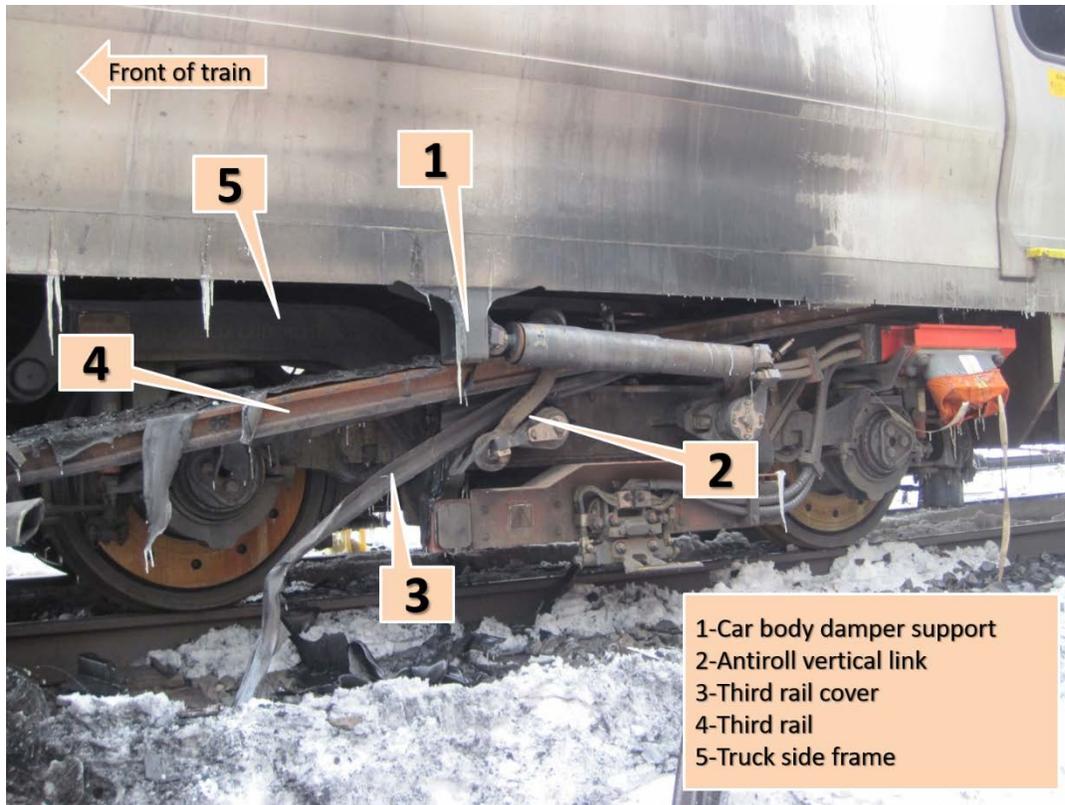
Figure 15. Path of the third rail entry into Metro-North 4333.

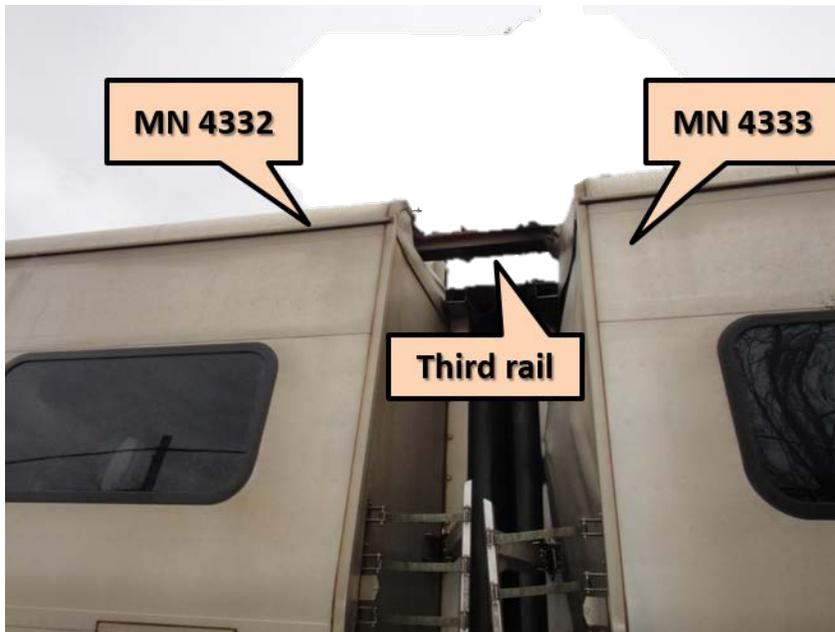
Figure 17. Third rail between railcars Metro-North 4332 and 4333.

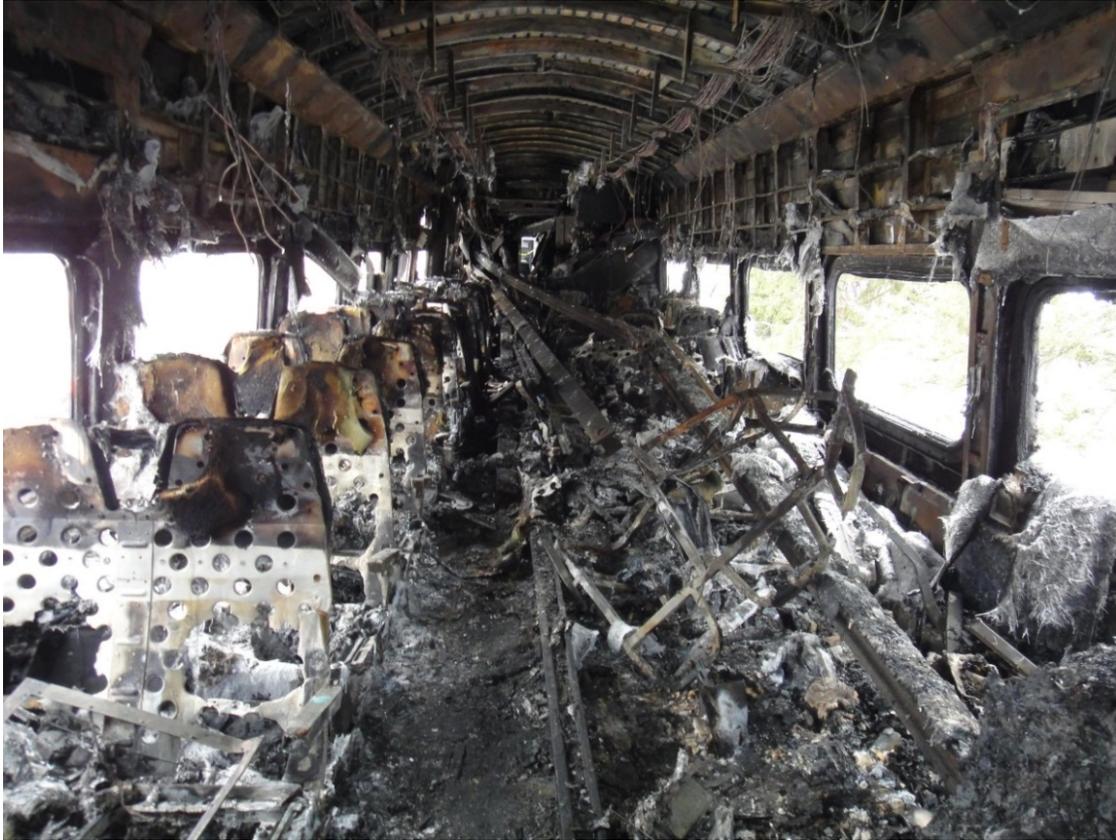
Figure 18. Interior of the lead railcar, front to rear.

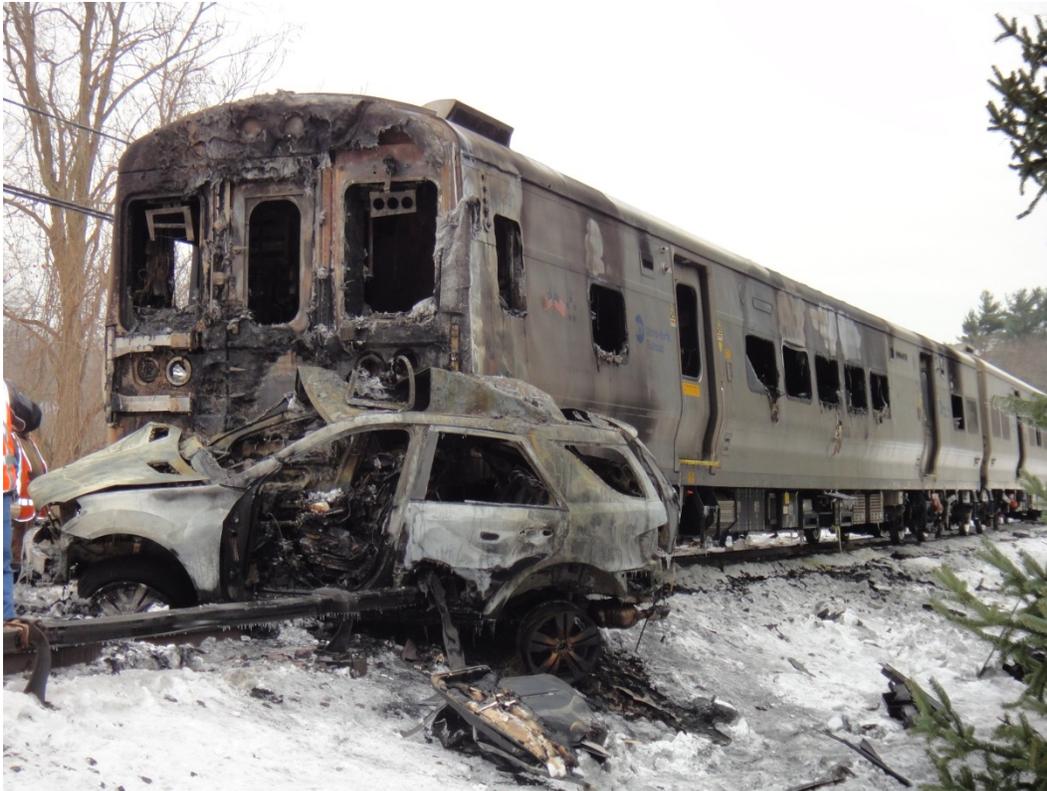
Figure 19. Left side of the lead railcar.

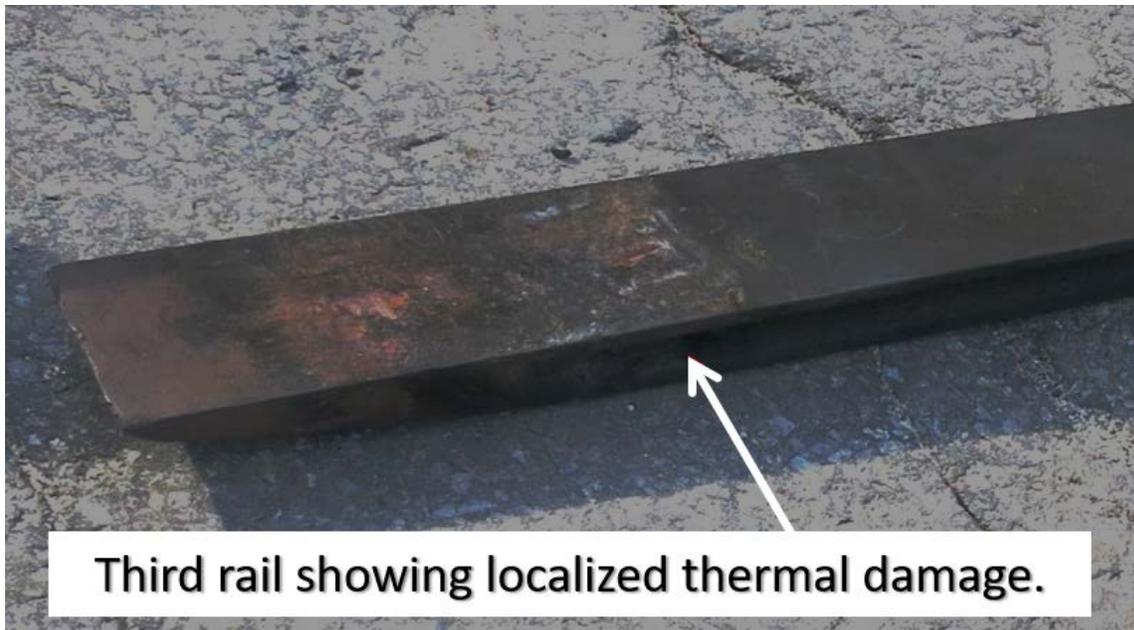
Figure 20. Localized thermal damage to the third rail nose piece surface removed from the lead railcar.

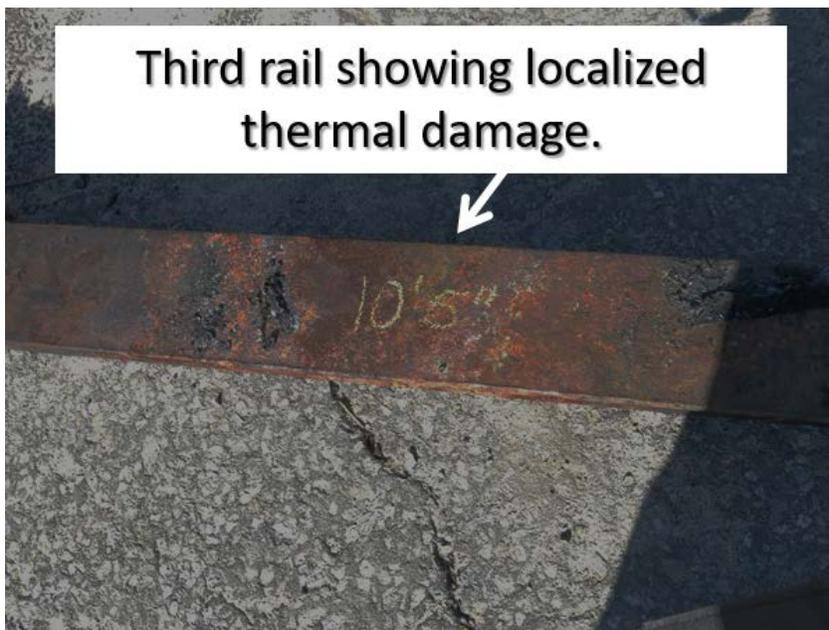
Figure 21. Localized thermal damage to the surface of the third rail removed from the SUV.

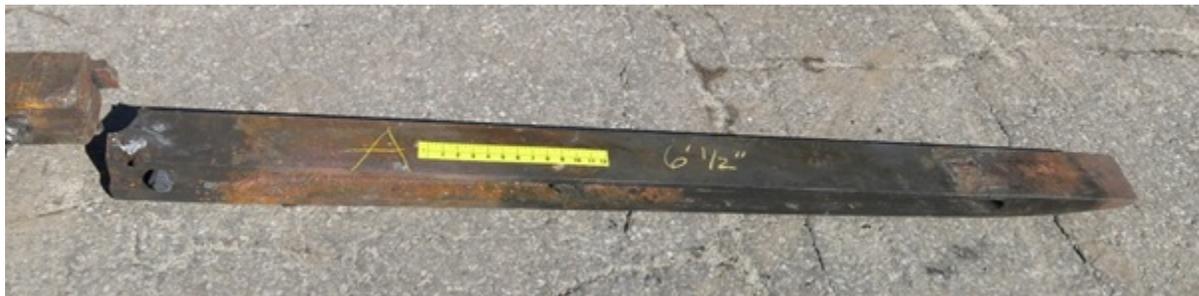
Figure 22. Third rail nose piece involved in this accident.

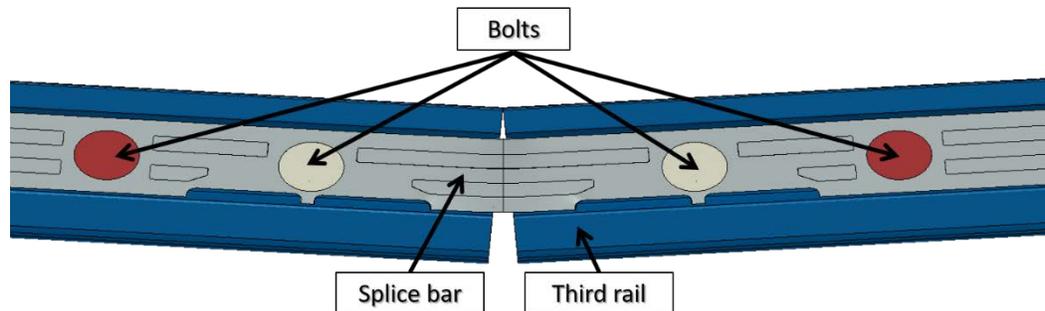
Figure 23. Illustration of third rail and splice bar subjected to in-plane bending.

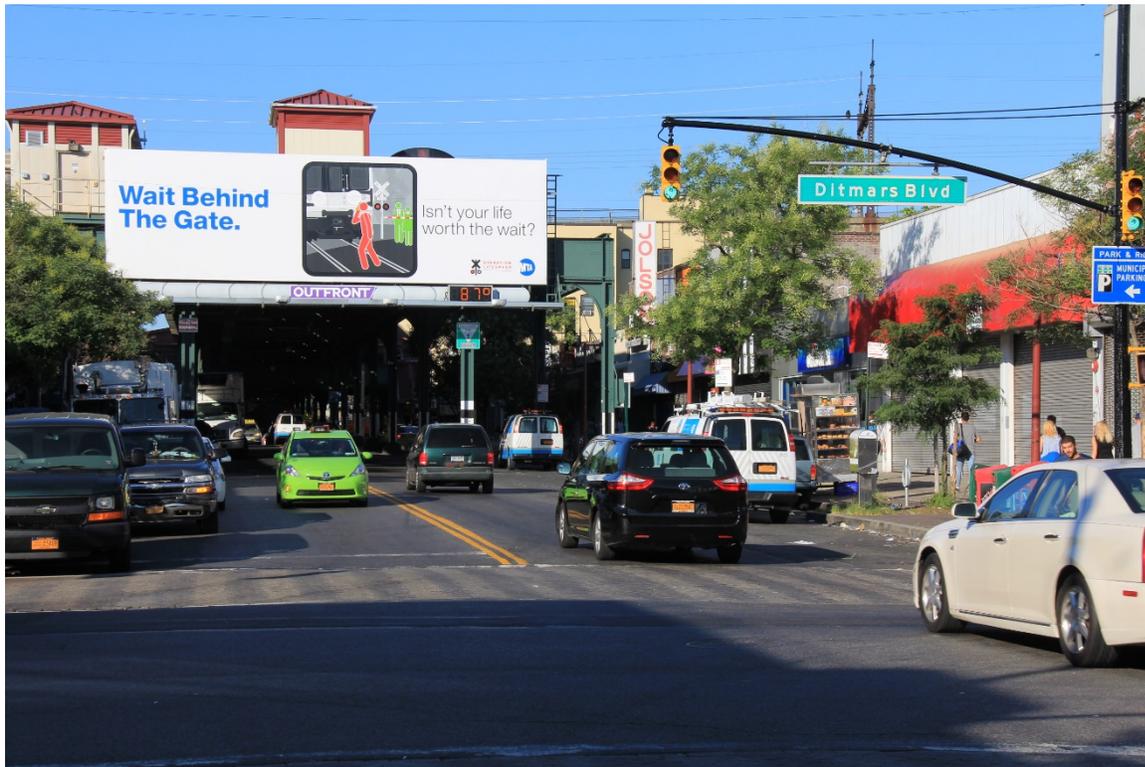
Figure 24. Billboard advertising grade crossing safety in Astoria, New York. (Source: Metro-North.)
