BNSF Railway Roadway Worker Fatalities
Edgemont, South Dakota
January 17, 2017

Accident Report

NTSB/RAR-18/01
PB2018-101430

National
Transportation
Safety Board

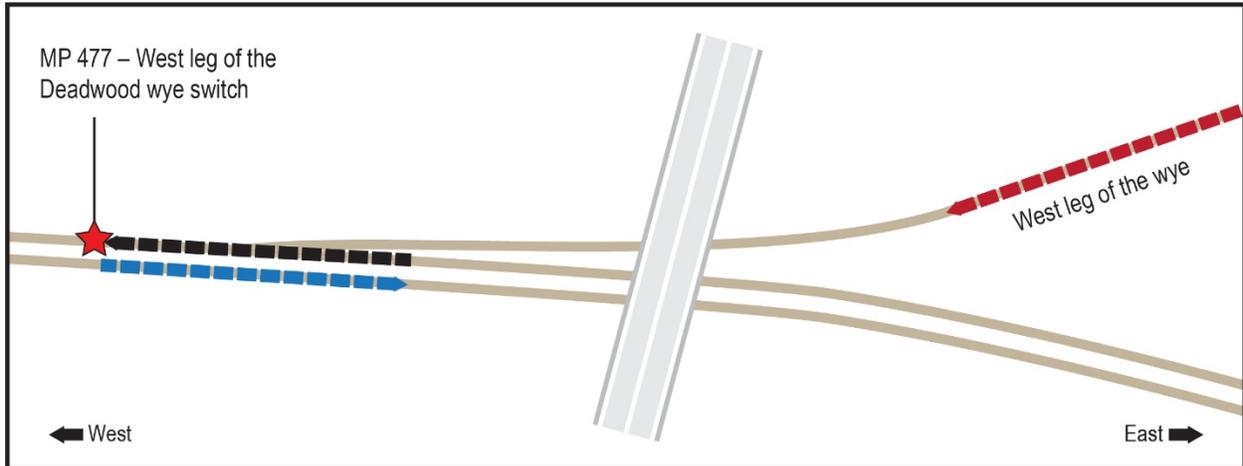
Figure 1. Overview of the accident location.

At the accident location, the Black Hills subdivision consisted of two main tracks. The accident occurred at one of the switches that allowed entry into the Deadwood wye track. Figure 1 shows the accident location (red star) and the three trains discussed in the report: the accident train is shown in black, the train on main track 2 is shown in blue, and the test train is shown in red.

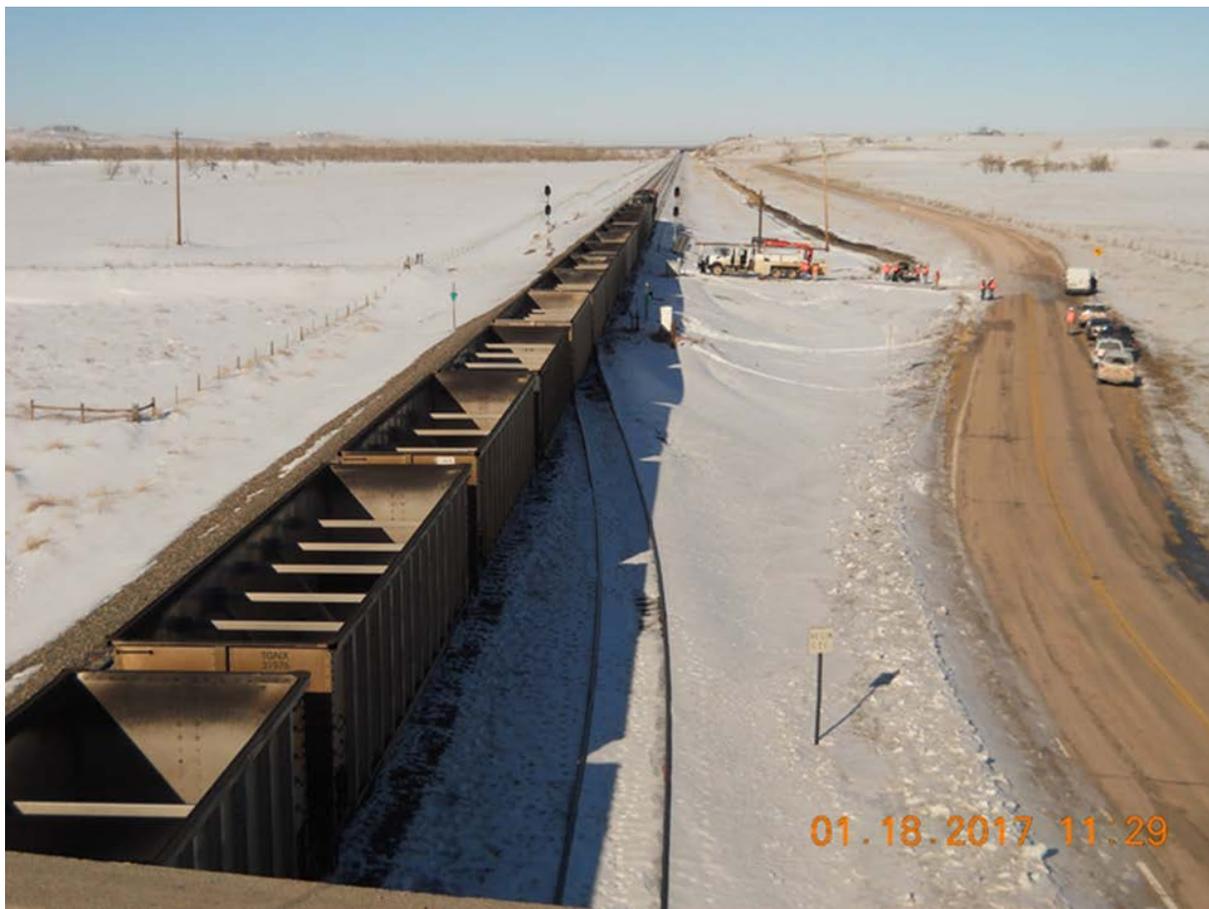
Figure 2. Photograph of the accident site.

The maximum operating speed was 35 mph between MP 476.1 and MP 477.0 on both main tracks. About 20 eastbound and 20 westbound trains per day operated on the main tracks through the accident area, with eastbound trains typically operating on main track 2 and westbound trains operating on main track 1. (See figure 2.)

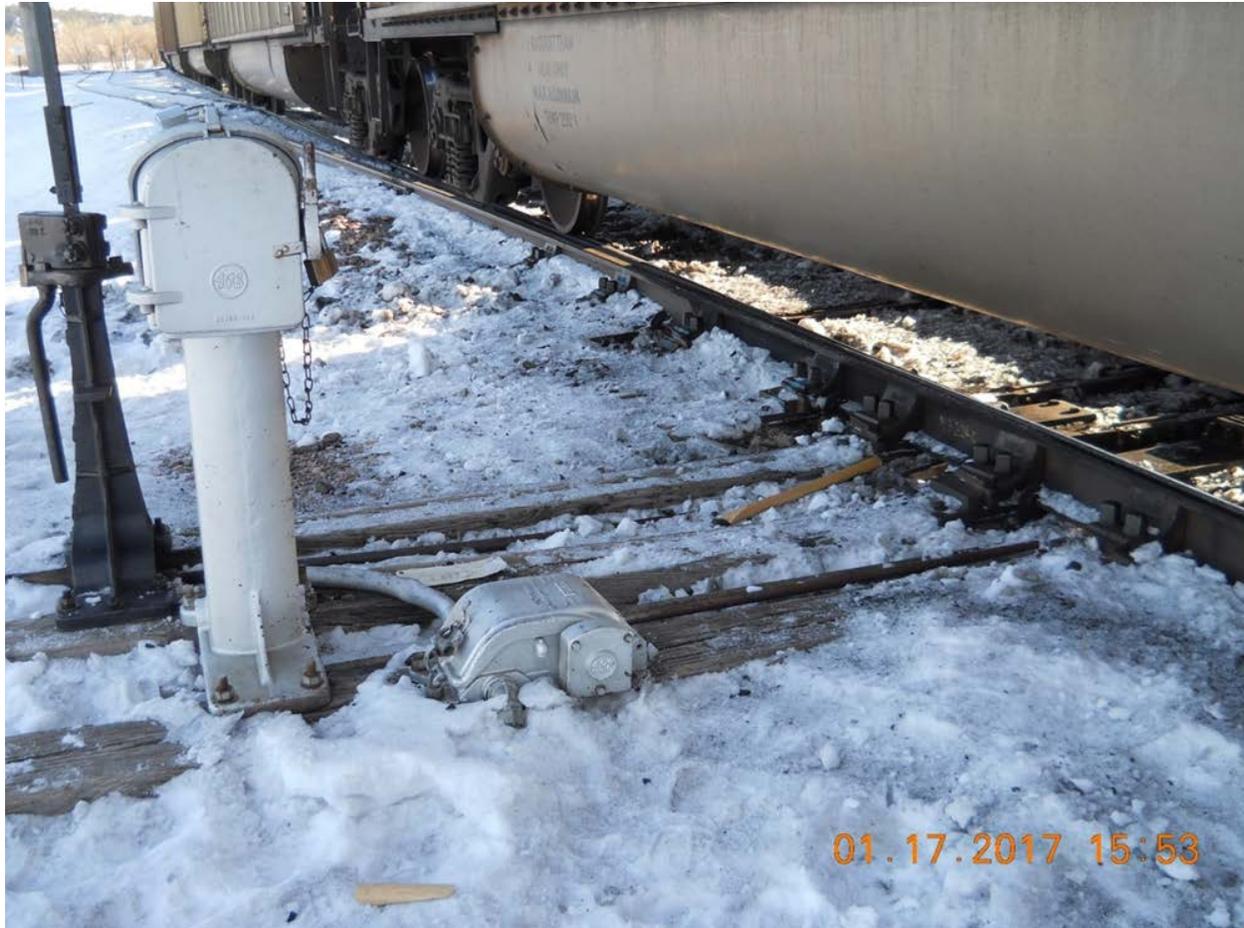
Figure 4. Accident switch and pieces of the long-handled shovel.

⁶ The front-end camera of the lead locomotive of the striking train recorded a long-handled tool in the hands of the watchman/lookout, and a short-handled shovel in the hands of the trackman. The investigation found a broken long-handled shovel on the ground at the accident scene, and a short-handled shovel on the ground near the switch.
