Derailment and Hazardous Materials Release of
Union Pacific Railroad Unit Ethanol Train
Graettinger, Iowa
March 10, 2017

Accident Report

NTSB/RAR-18/02
PB2019-100084

National
Transportation
Safety Board

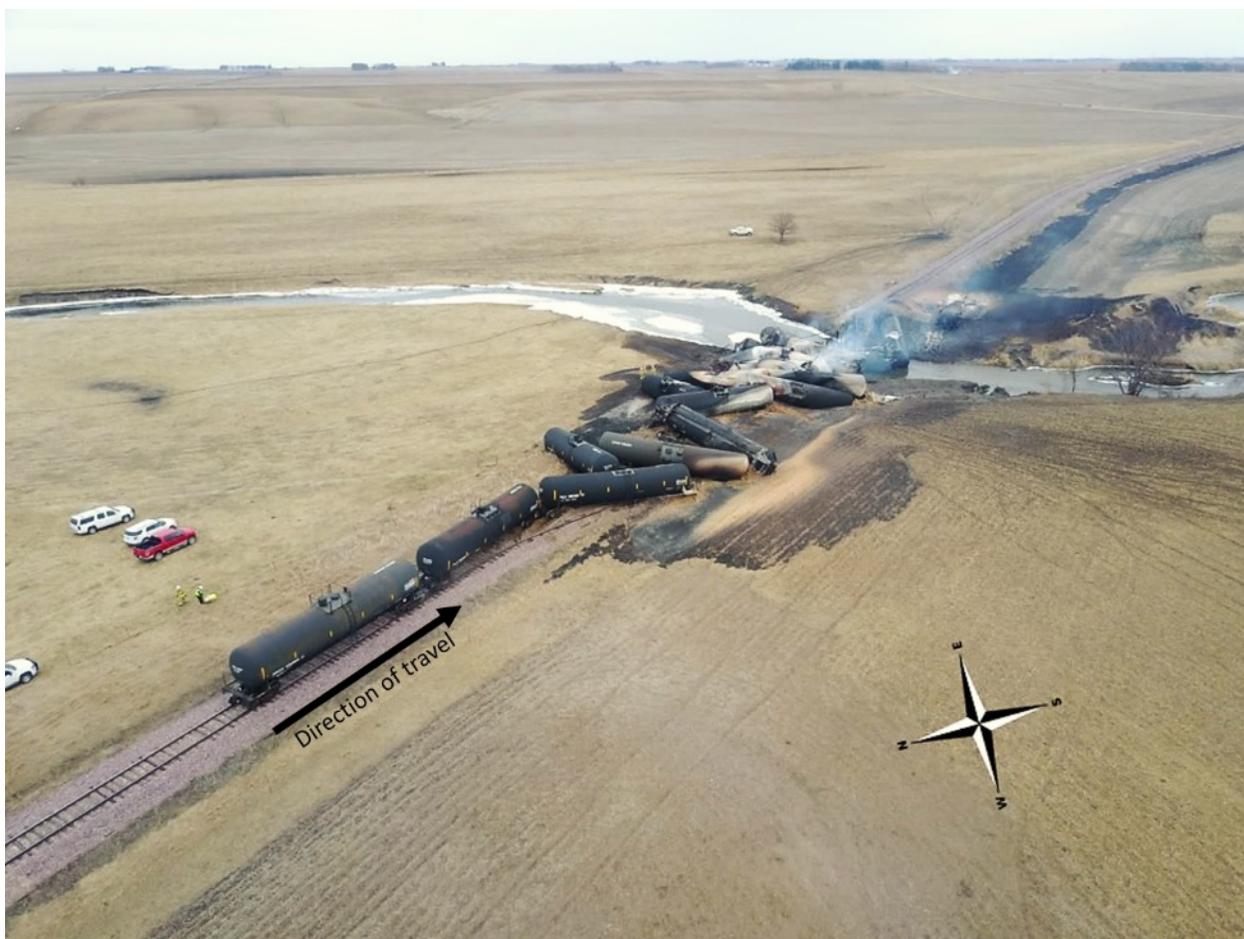
Figure 1. The accident site.

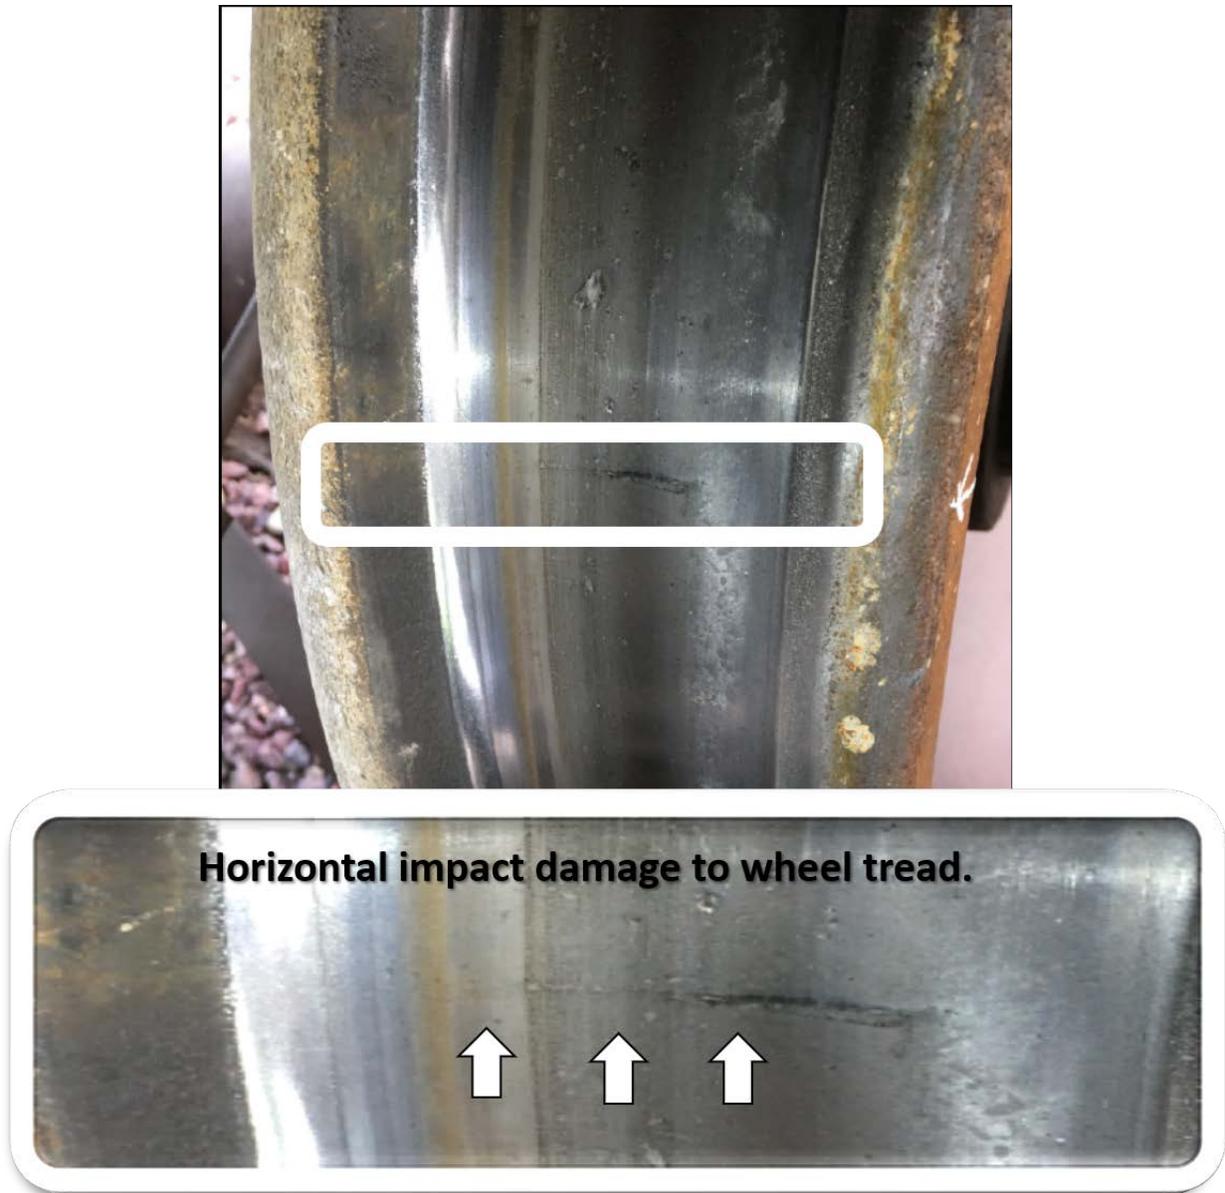
NTSB investigators inspected the nonderailed cars (1st through the 20th) that traveled over the Jack Creek Bridge. NTSB investigators observed that the wheels on the right side of several cars that rolled over the right-side rail (or south rail) exhibited fresh horizontal impact damage (impressions perpendicular to the wheel tread).¹⁰ (See figure 4.) No such damage was observed on the wheels on the left side of the train. (See figure 5.)

Figure 5. Wheel tread impact damage on TCBX 198115.

The damage began to appear on the fourth tank car, but was not present on the fifth or sixth tank cars. On tank cars 10 through 20, the impact damage was observed on every car, becoming more pronounced toward the 20th car, which was a tank car. The 20th car, TCBX 198115, was the last car that traveled through the derailment area without derailing.¹¹

The fresh horizontal impact damage observed on the wheel tread of the 4th through the 20th nonderailed cars that moved over the bridge immediately prior to the derailment was consistent with rolling wheels contacting an exposed leading edge of a broken rail segment. The broken rail segment's leading edge impacted the wheels' treads as they rolled over the damaged area, leaving behind impact damage. NTSB investigators did not observe any horizontal impact damage to the wheel tread on the wheels that traveled over the north rail; however, they documented a total of 14 tank cars and locomotives that had traveled over the south rail which had fresh horizontal wheel damage to the tread. The observed wheel impact damage was more pronounced on the south side wheels of tank cars that were further from the locomotive consist, indicating that the broken rail sections of track became progressively worse until the south rail was no longer able to support the train.

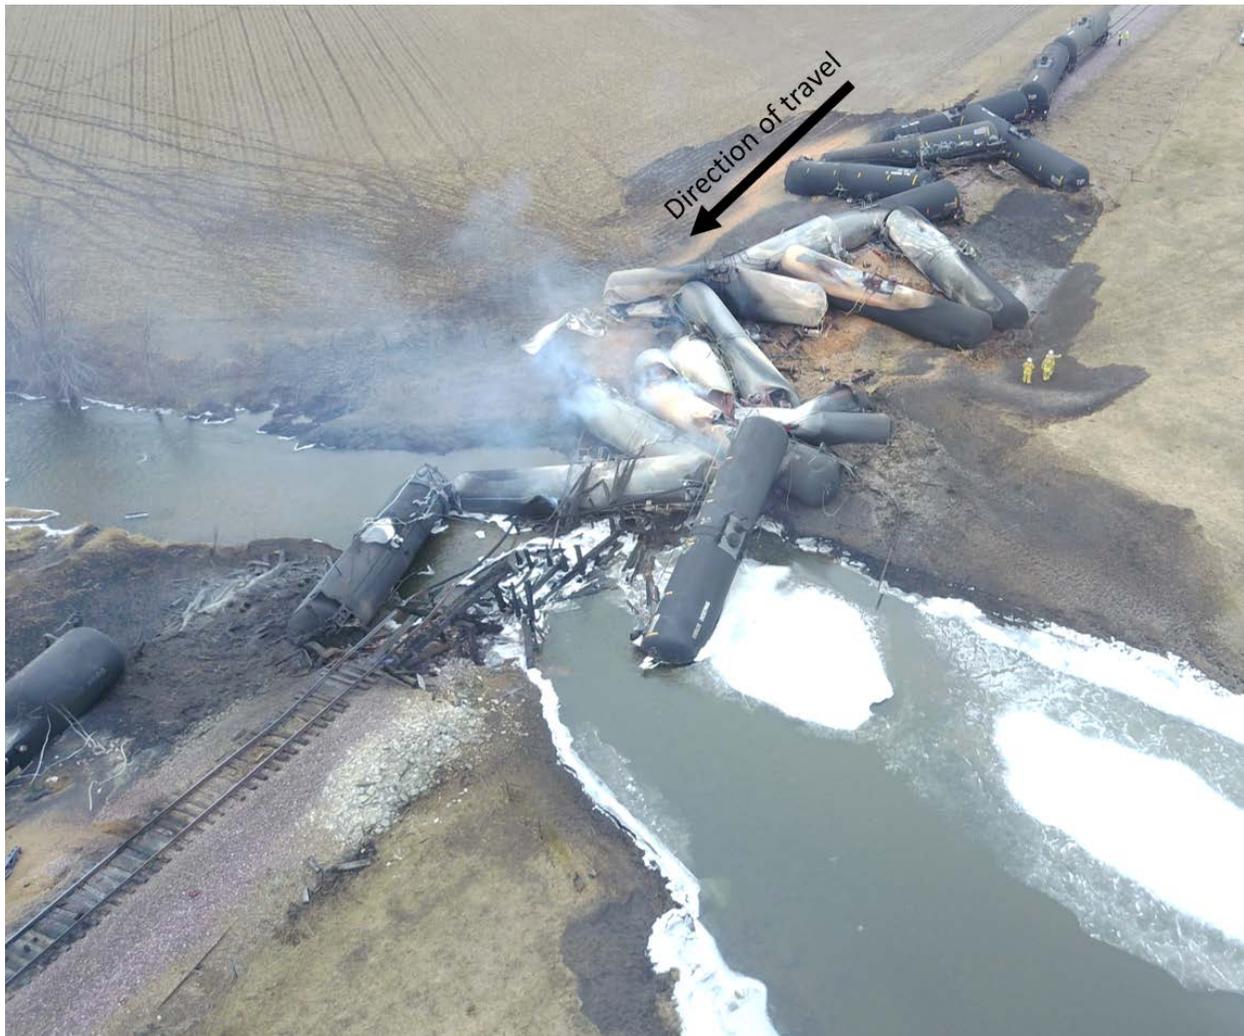
Significant track structure damage in the immediate area of the derailment prevented a comprehensive inspection of an intact track structure. The total amount of damaged and displaced rail was about 400 feet. (See figure 6.) NTSB investigators recovered, identified, and arranged about 390 feet of the damaged and displaced rail. The fractured pieces were “reassembled” based on the manufacturer, manufacture dates, and rail fracture characteristics. Each section was visually examined on scene, labeled, and inventoried. A total of 14 pieces were sent to NTSB’s Materials Laboratory in Washington, DC, for a metallurgical examination.

Figure 6. Aerial photograph of the derailed train and the damaged track.

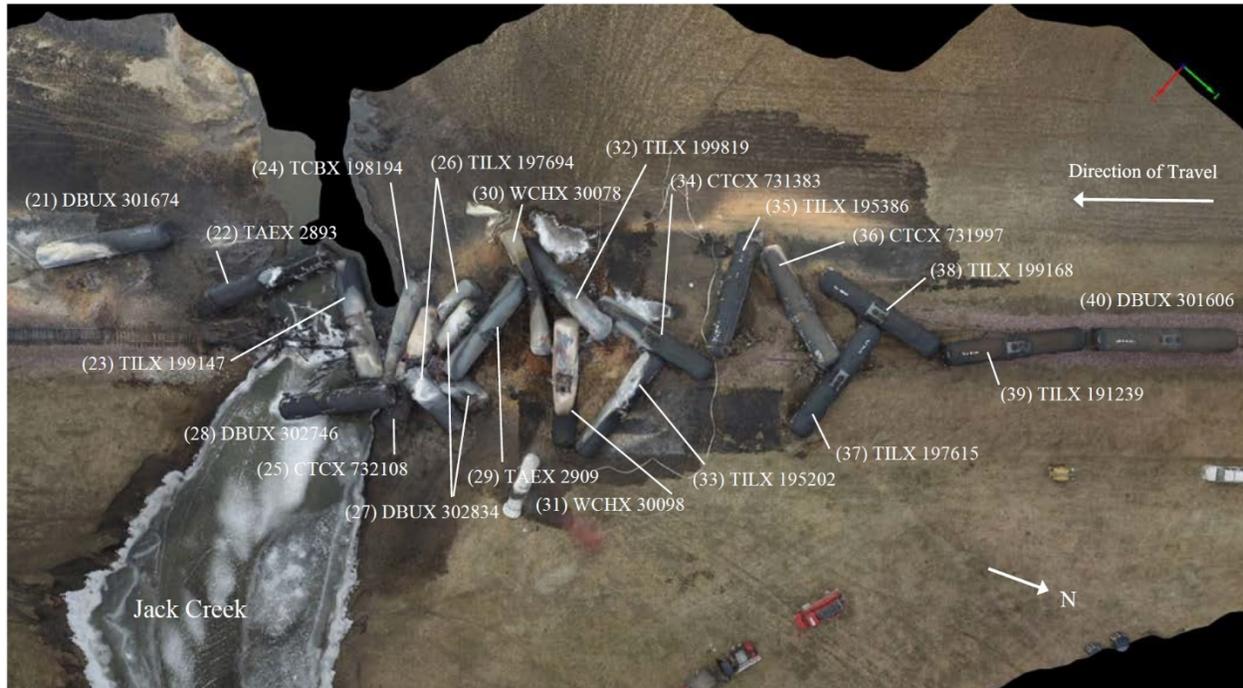
The orientation of the ethanol tank cars following the derailment is indicated in figure 7. After transloading the tank cars, crews staged them in a nearby farm field for examinations.

Figure 7. Derailment scene and tank car identification. The numbers in parentheses identify the location of the tank cars.

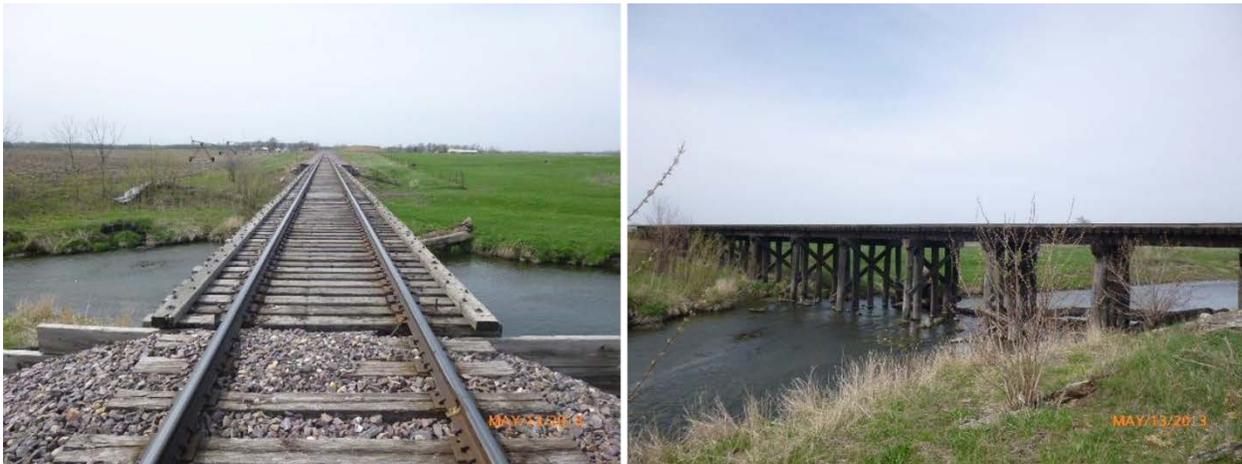
The Jack Creek Bridge was an 11-span, timber, open-deck bridge that measured 152 feet long. (See figure 8.) The bridge was destroyed by the derailment and ensuing fire.

Figure 8. Jack Creek Bridge in 2013. (Photographs courtesy of UP.)

According to UP documentation, this bridge was last inspected on October 11, 2016. The inspection record shows that the bridge was built in 1937 and the bridge deck ties were replaced in 1970. Although no defects or abnormalities were noted during this inspection, the UP bridge inspector mentioned in the report that there was insufficient ballast on the approach to the bridge with the comment, “high end, first tie off of bridge hanging 2 1/2 [inches].”²¹ UP was unable to provide any documentation that this condition had been corrected prior to this derailment.

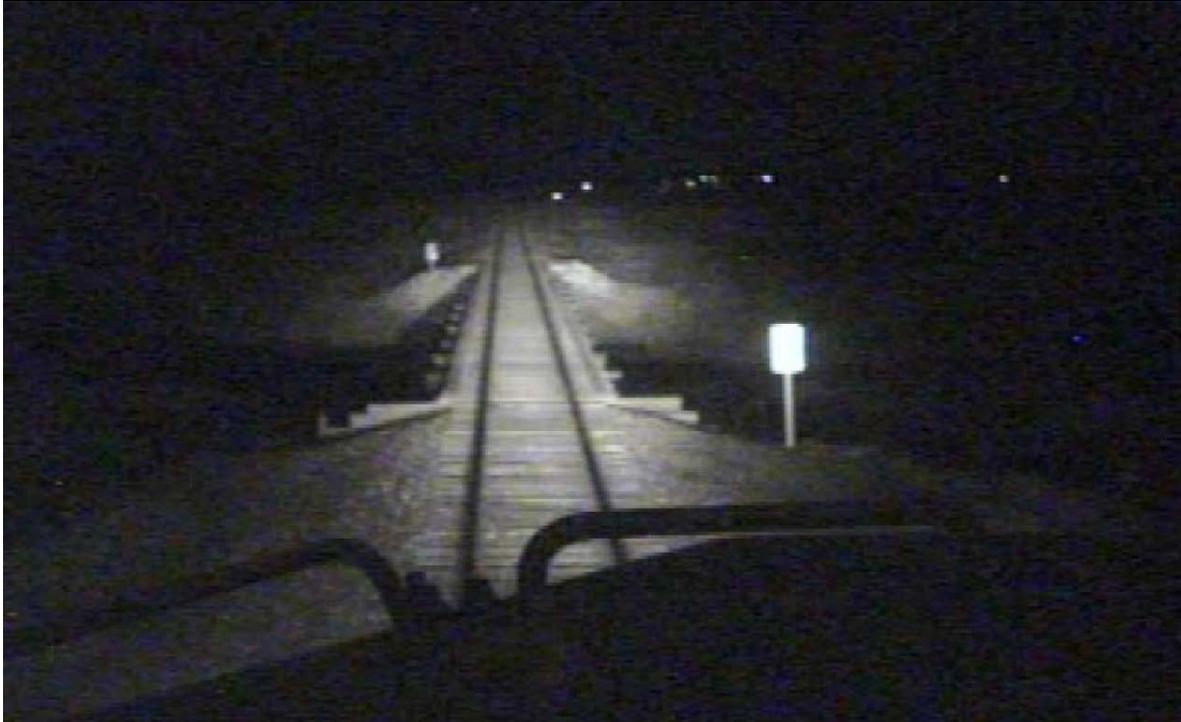
The lead locomotive in this accident was equipped with a forward-facing video camera and an on-board image recording system. NTSB investigators reviewed the video and did not observe any discontinuities in the rail on the approach to the Jack Creek Bridge. (See figure 9.)

Figure 9. Still image of the track on approach to the Jack Creek Bridge.

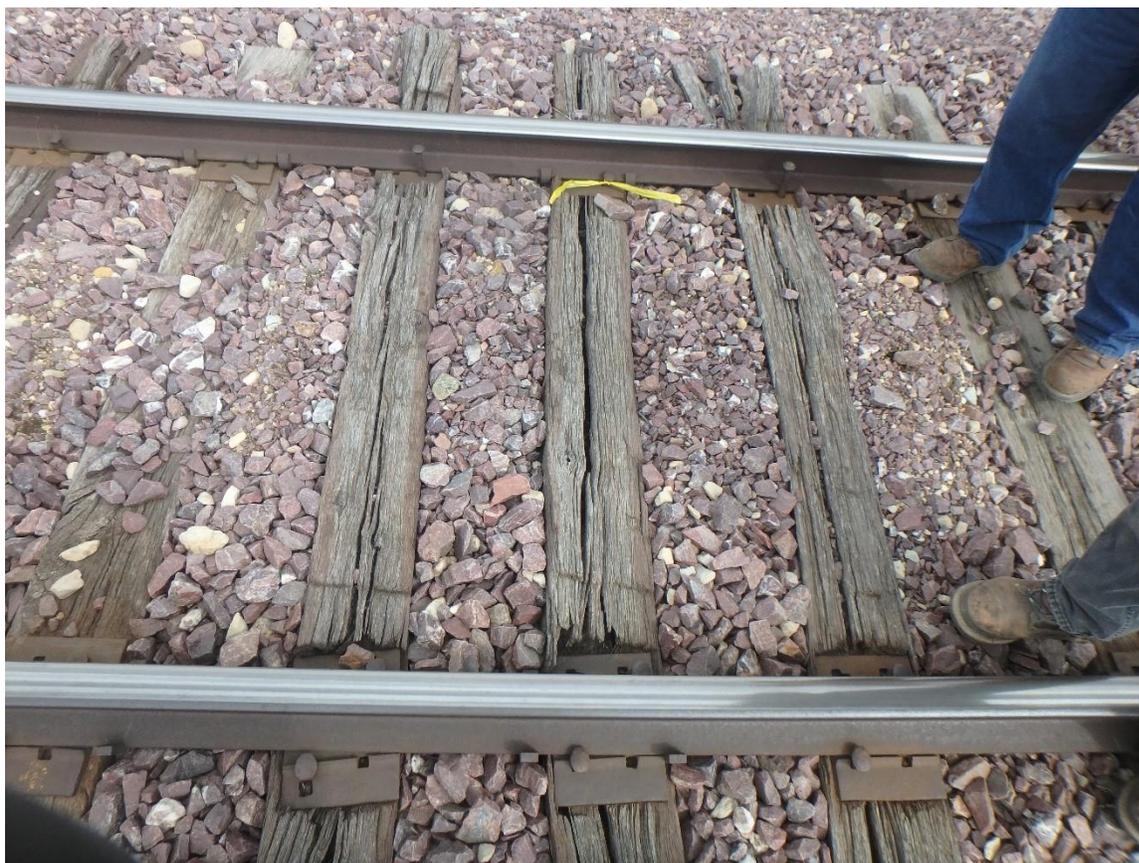
In the area of the derailment, the track structure was misaligned as a result of derailment forces. NTSB investigators took gage measurements, observed track alignment, and measured track surface leading into the disturbed track. No exceptions were taken to the track geometry in the track segment from MP 57.10 into the derailment area. NTSB investigators noted profile conditions ranging from 3/4 inch to 1-1/4 inches in the areas with defective crossties. (See figure 10.)

Figure 10. Split and broken crossties, that are not holding fasteners, immediately west of MP 56.9. The tie plates in the foreground have cut into the broken crossties.

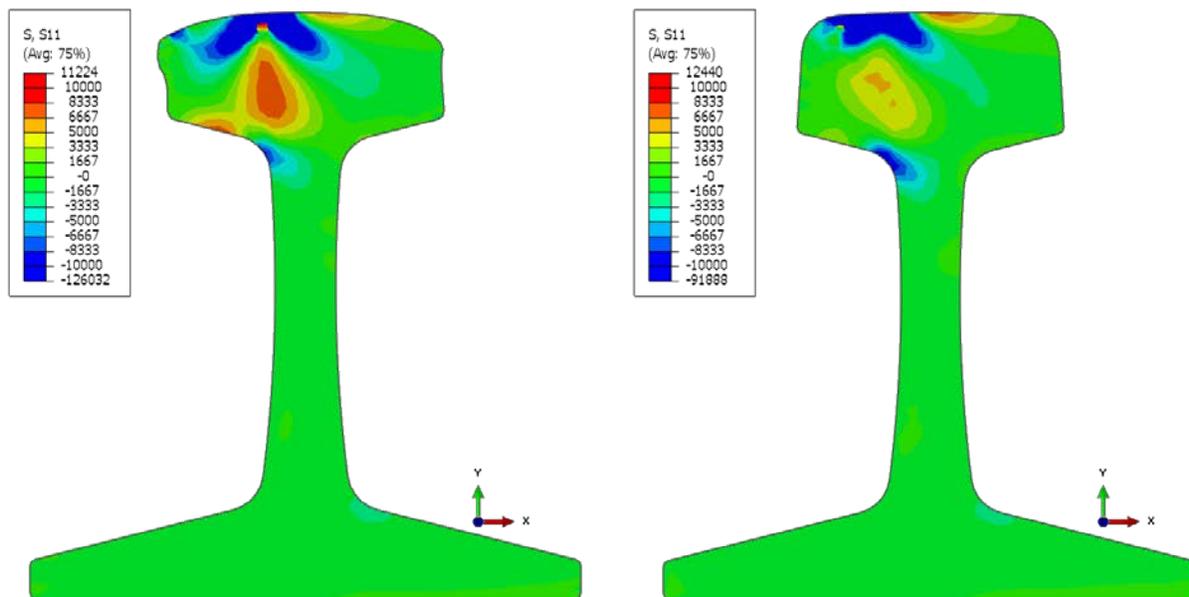
Finite element (FE) modeling was used to examine the effects of rail profile and track support conditions on the deformation and stresses in 90-pound rail under tank car wheel loads.⁵⁷ Two three-dimensional FE models of the 90-pound rail track were constructed. One model, based on drawings provided from UP, had a standard (unworn) rail profile and assumed stiff track support conditions. The other model had a worn rail profile based on measurements collected on rail profiles from the accident and assumed less stiff track support conditions.⁵⁸ Internal rail stresses and rail deformations from the two models were compared. (See figure 13.)

Figure 13. Comparison of the calculated internal transverse stresses of 90-pound rail supporting wheel loads using a worn rail profile with soft track support (left) and standard rail profile with stiff track support (right). In both illustrations, the gage side is on the left and the field side is on the right.

The model showed that the transverse stress in the rail head region was dependent on the head area of the rail cross-section and the track support conditions. A worn rail has less head area, which results in higher transverse stress in the head region. Comparing the two rail profiles

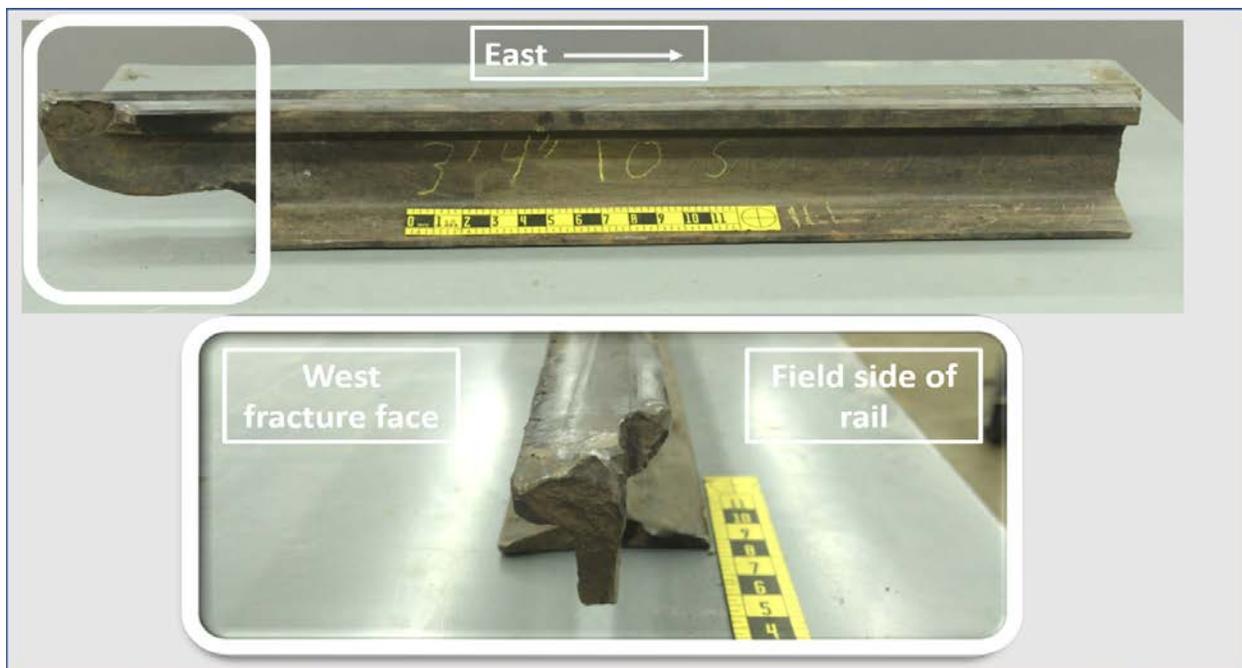
NTSB's Materials Laboratory Factual Report includes examination details on a particular section of the broken rail—a section of the south rail measuring 3 feet, 4 inches—that was located near the Jack Creek Bridge.⁶⁵ (See figure 14.)

Figure 14. Section 10S from the south rail that was recovered from the accident, showing the field side and the west fracture face.
