Amtrak Passenger Train Head-on Collision With Stationary
CSX Freight Train
Cayce, South Carolina
February 4, 2018

NTSB/RAR-19/02
PB2019-101308

Railroad Accident Report

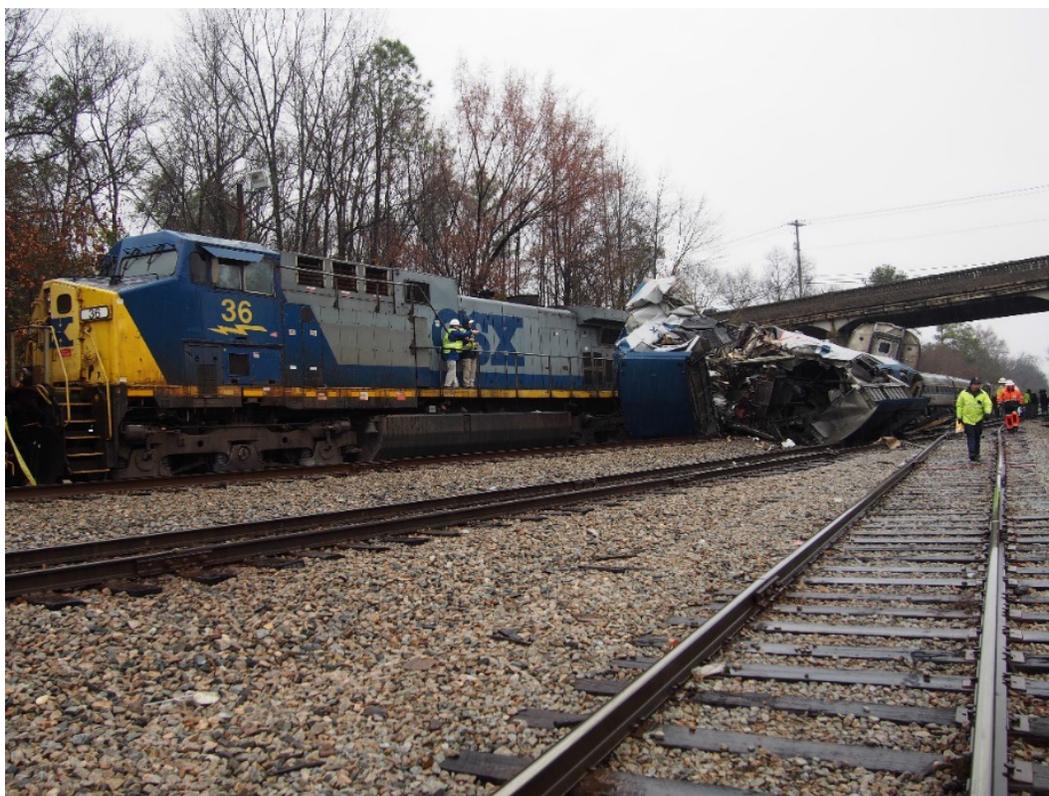
Figure 1. A view of the accident scene looking north.

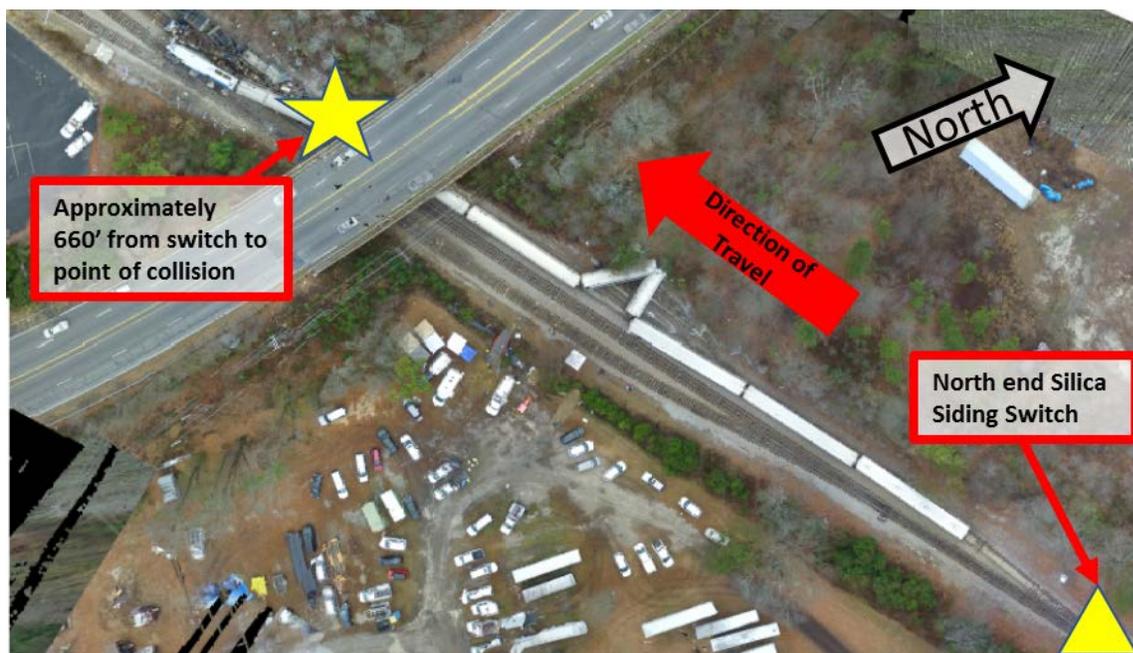
According to the locomotive event recorder, the train began movement again at 2:21:17 a.m. The train reached a maximum speed of 57 mph around MP S 366.5. At 2:27:21 a.m., the train's horn sounded. At this time, the train's speed was 56 mph. At 2:27:24 a.m., the throttle changed from throttle position 8 (T8) to idle. At 2:27:25 a.m., the train entered emergency braking via an "engineer-induced emergency." The train's speed was 53 mph. Due to the collision, the data ended at 2:27:27 a.m. Figure 6 shows the accident site, the path of the train from the entry point into the track from the north, and the approximate point of collision 660 feet south of there and just west of a four-lane highway.

Figure 6. Aerial drone image of accident location. (Photo courtesy of South Carolina Department of Public Safety.)

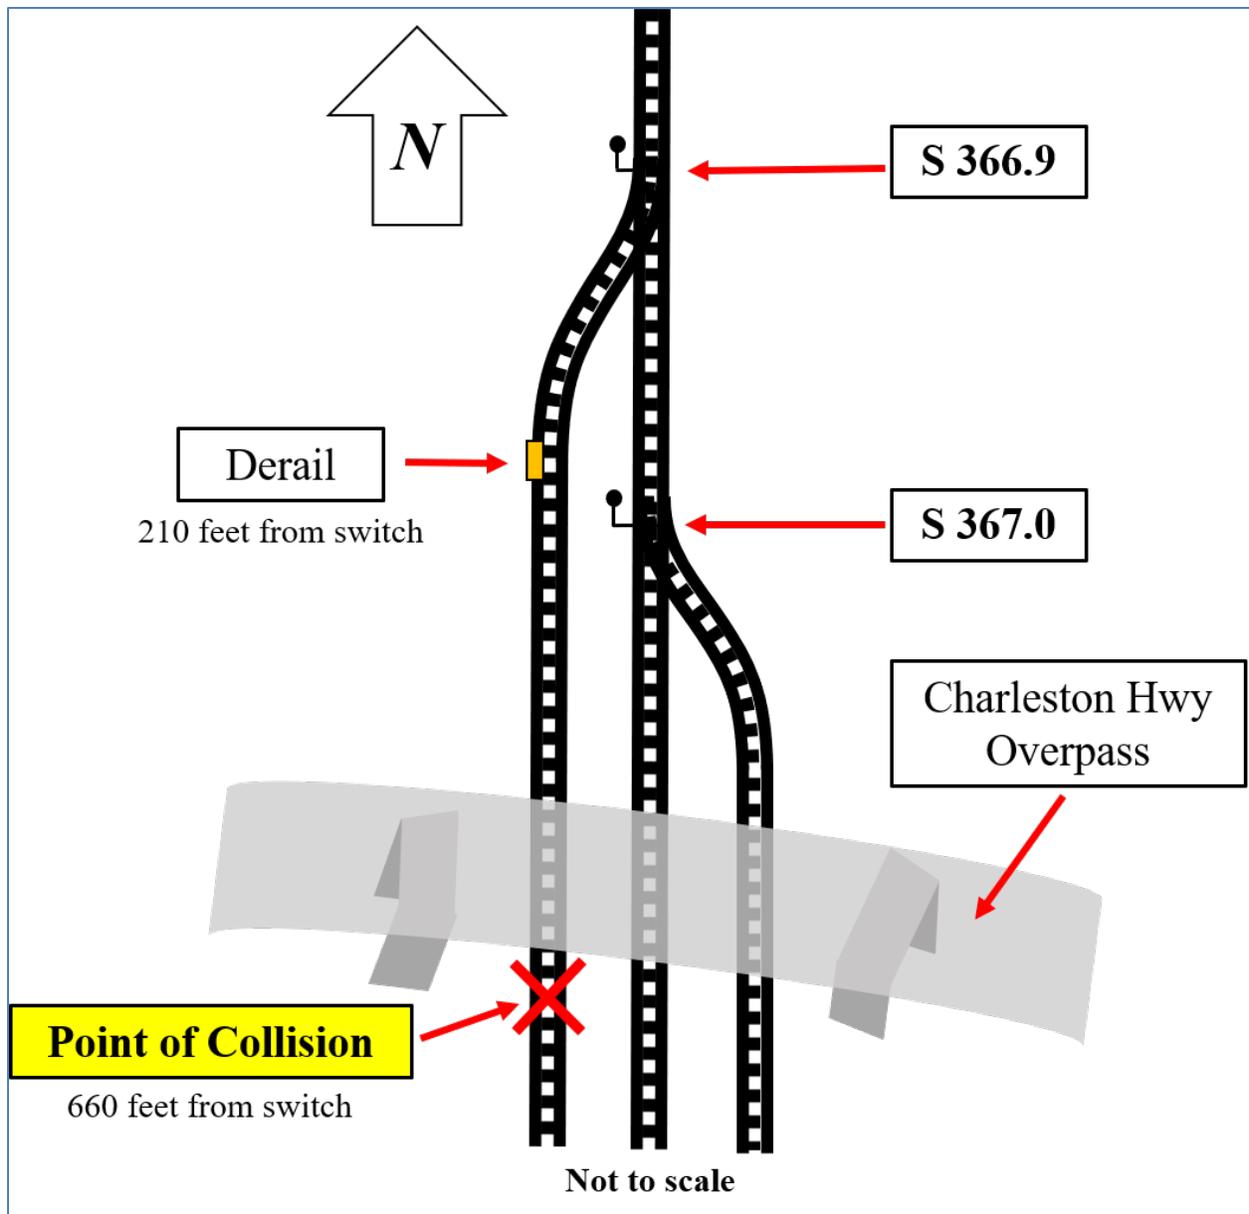
Figure 7 shows the north switch area for the Silica Storage track where train F777 made its last move into that track. The derail is located 215 feet from the switch, and the track is west of the main track. The crew was moving two locomotives into the track. The point of collision and overhead highway bridge are shown about 660 feet from the switch.

Figure 7. Close-up view of final move of F777 into Silica Storage track.

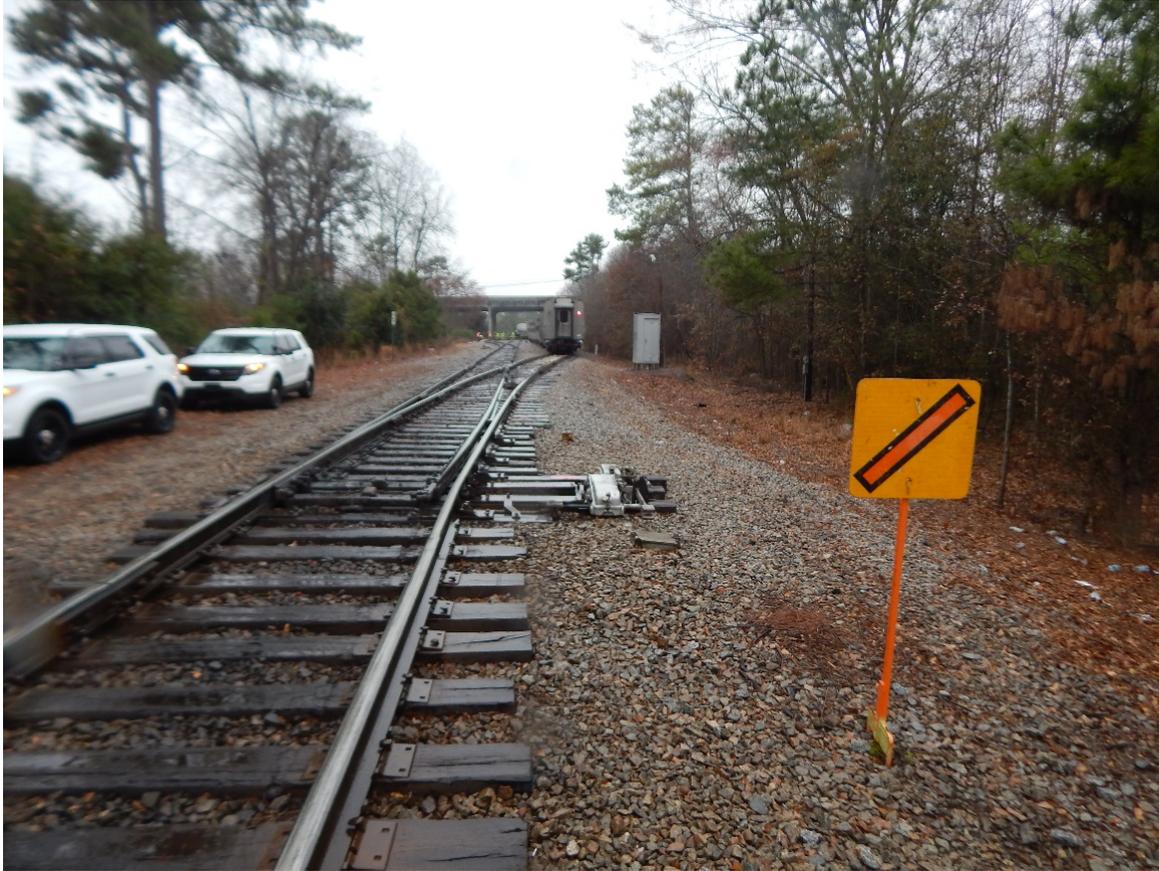
Figure 9 provides a view of the Silica Storage track looking south at the main track with the Silica Storage track switch in the foreground and the auxiliary track going off to the right of the main track. The switch is as found, lined in the reverse position (allowing movement into the Silica Storage track). The rear of the Amtrak accident train can be seen in the background about 100 feet from the switch.

Figure 9. South-facing view of the North End Silica Storage track switch.

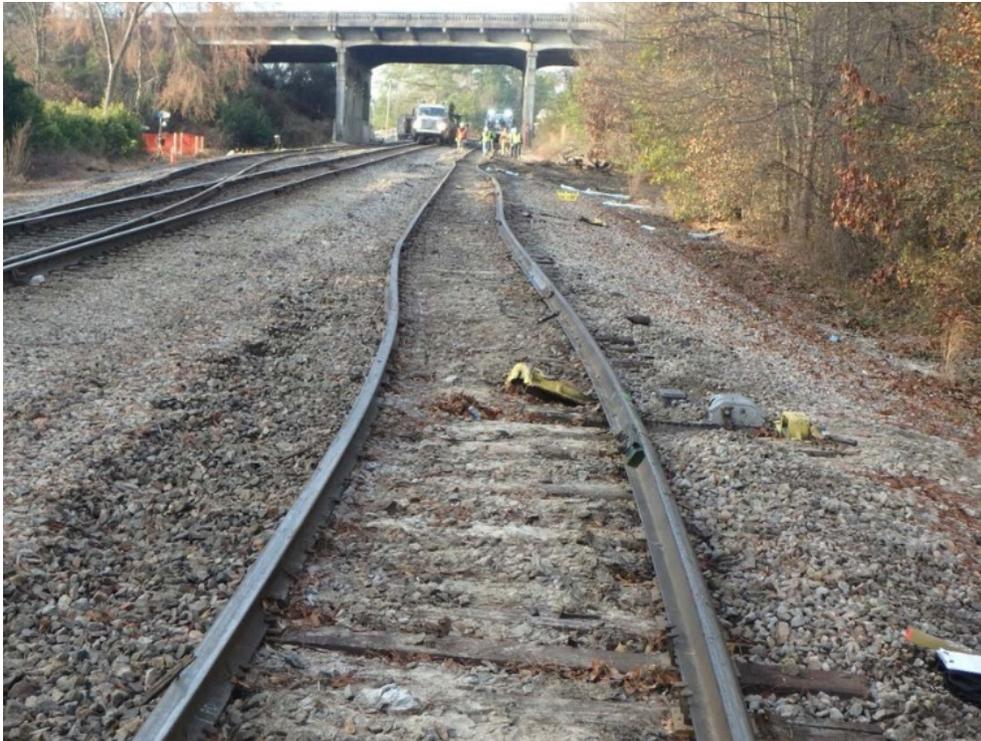
The Silica Storage track extends from MP S 366.9 (north switch) to MP S 367.9 (south switch) and is about 5,000 feet long. Investigators took track geometry measurements at this location, and the track gage was measured by documenting the location of the rail plates. Investigators found no evidence of noncompliance with the FRA and the CSX standards that existed prior to the accident. The photograph in Figure 10 shows the track damage and unseated rail near the derail at the north end of the Silica Storage track. The main track and the switch at the north end of the automobile lot runaround track are at the left in the photograph.

Figure 10. Track misalignment damage near derail at north end of the Silica Storage track.

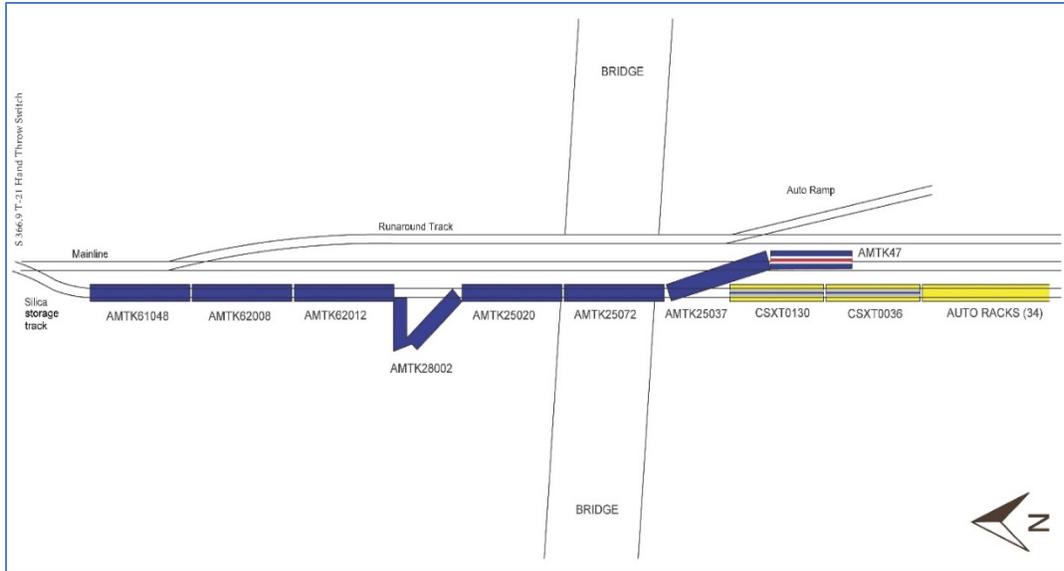
When the trains collided head on, the Amtrak locomotive, AMTK47, overrode the CSX locomotive, CSX130, toward the east side (or toward the main track). The lead truck and engineer's side of the cab of CSX130 were sheared off by the Amtrak locomotive as it came to rest on its left side. The cab of locomotive CSX130 was crushed, and the CSX train was pushed backward about 15 feet from the point of collision. Figure 11 shows the position of the two trains.

Figure 11. Illustration of the resting position of the trains.

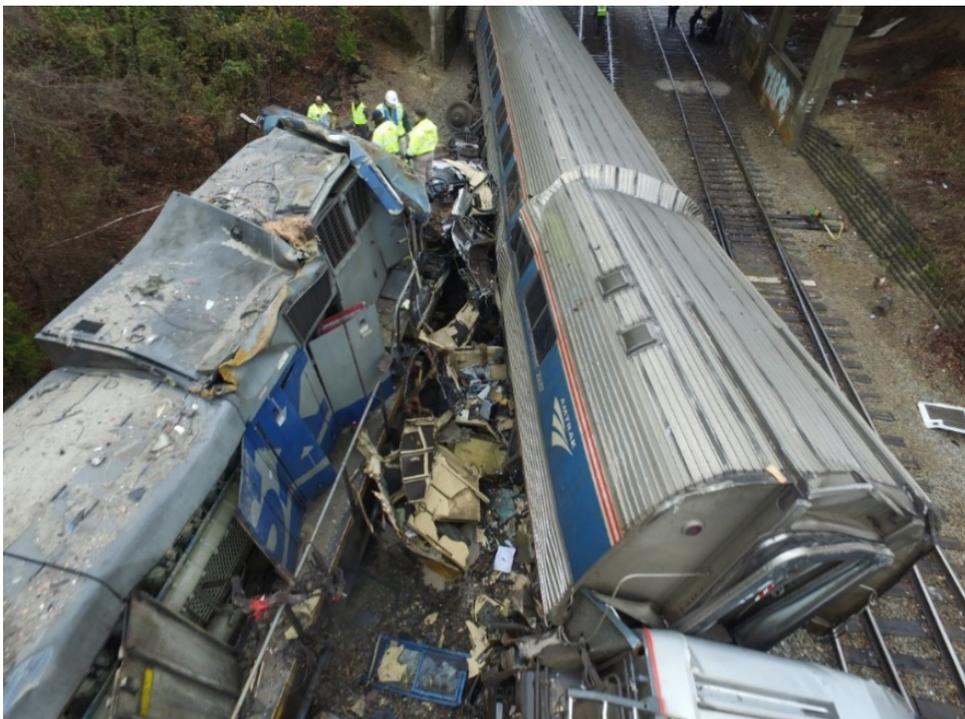
The Amtrak wreckage continued to decelerate for about 130 feet beyond the point of collision, shoving the lead coach car into the air as the Amtrak locomotive rolled left. The trucks of the first coach were broken off and came to rest under the car. Figure 12 shows the first passenger coach, which was not occupied at the time of the collision; the lead coach buckled slightly as it lodged into the rear of the Amtrak locomotive. The second coach remained upright but derailed and buckled. The third coach remained on the rail without significant damage.

Figure 12. Photograph showing first passenger coach.

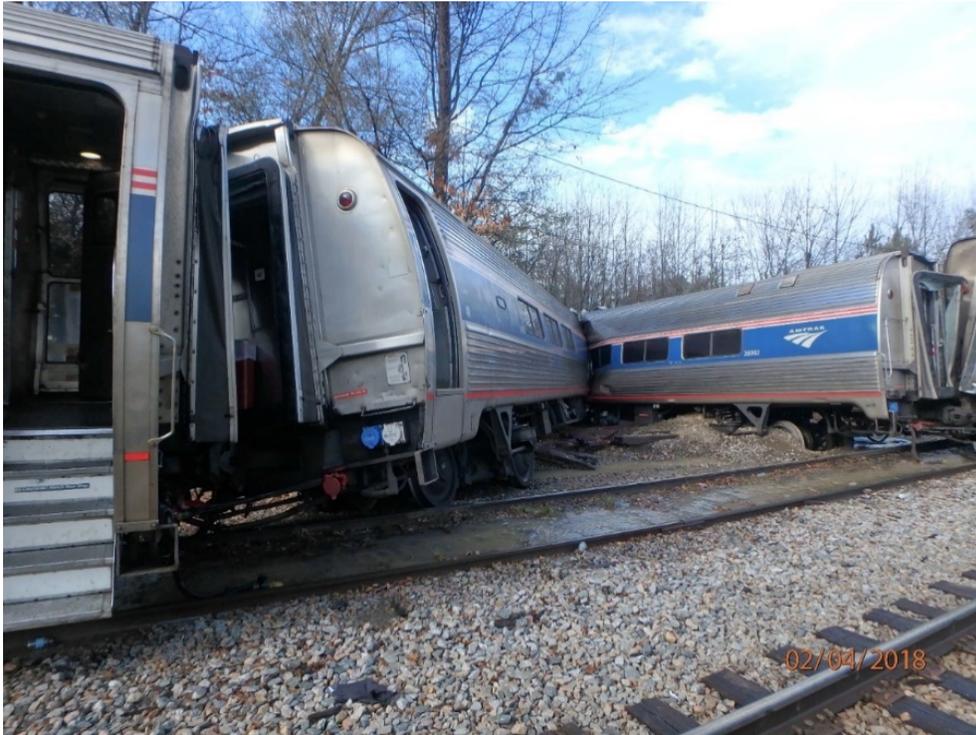
The lounge car, shown in figure 13, was forced off the Silica Storage track and bent laterally, shearing open the left side of the car and crumpling the right side.

Figure 13. Photograph of the lounge coach.

AMTK28002 (lounge) was bent in half and sustained full separation of the left-side sill, wall, and roof. The center sill of the car was significantly deformed but remained connected. The right-side sill was crushed at the interior of the bend. Both trucks derailed and had significant damage from the derailment but remained intact and connected to the carbody. The truck and carbody brake components all showed evidence of damage resulting from the derailment. Both couplers remained with the car and were intact. There were no notable defects to any of those components that appeared to have been present prior to the crash.
