Long Island Rail Road Roadway Worker Fatality
Queens Village, New York
June 10, 2017

Accident Report

NTSB/RAR-20/01
PB2020-101003

Railroad Accident Report

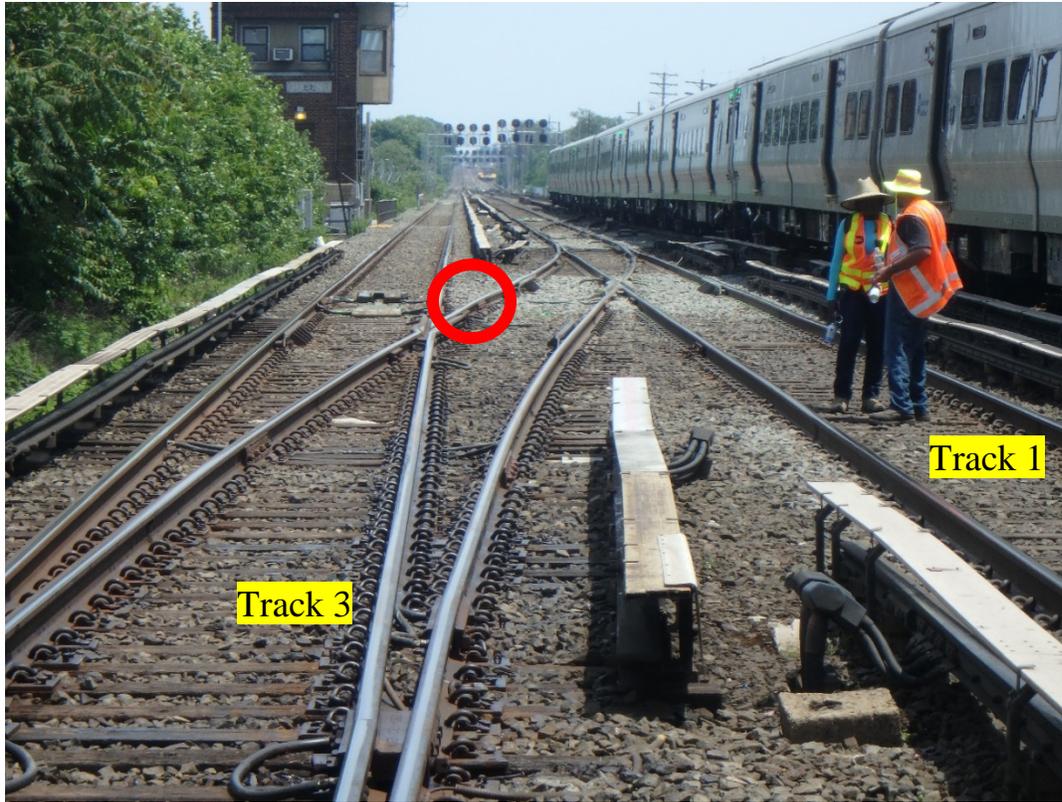
On June 10, 2017, at 10:12 a.m. eastern daylight time, Long Island Rail Road (LIRR) train 7623 on track 3 approached a five-member crew of roadway workers at the Queens Interlocking in Queens Village, New York.² The foreman and three roadway workers were inspecting and making minor repairs to track 1 within the Queens Interlocking. A fifth roadway worker was clear of the tracks, keeping pace with the work group. Upon seeing train 7623, the watchman/lookout sounded a handheld horn, yelled at the other workmen, and raised a disc that told the locomotive engineer to sound the train's horn.³ The locomotive engineer then sounded the train's horn. Three of the roadway workers remained in track 1, but the foreman stepped into the path of the train on track 3 and was killed. The train was traveling about 78 mph when the locomotive engineer applied the emergency brakes just before impact. Figure 1 shows the accident location.

Figure 1. Photo of the accident scene facing east. The site of the accident is marked with a red circle.

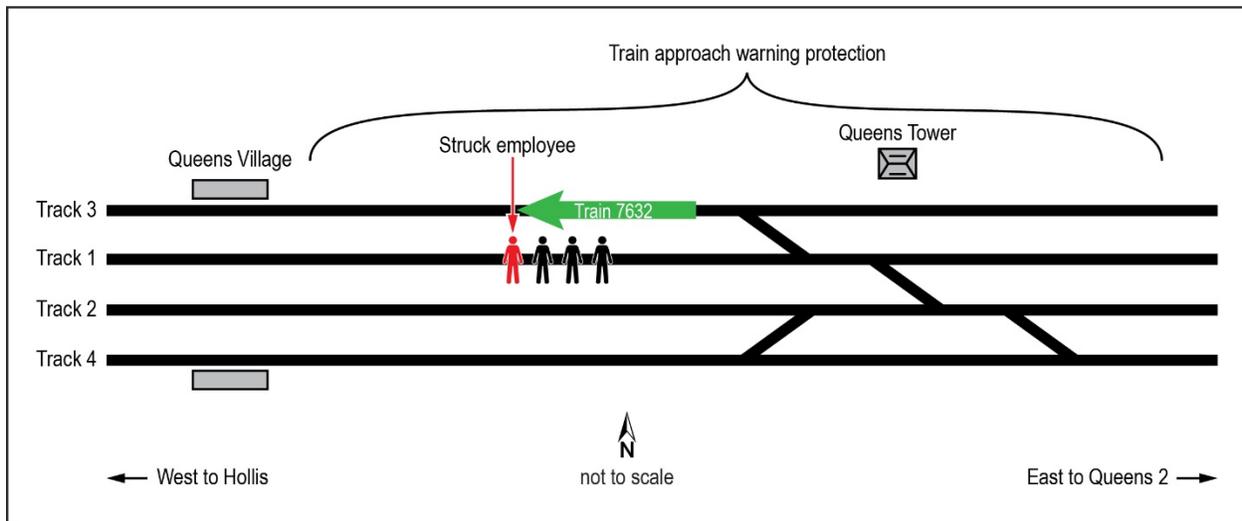
Figure 2. Queens Village track diagram.

There were four main tracks within the Queens Interlocking. The tracks ran east and west. Starting from the north to the south the tracks were numbered 3, 1, 2, and 4. The outside tracks serviced the Queens Village Station platforms (outside tracks 3 and 4) just west of the Queens Interlocking. Trains were authorized to operate at 80 mph on all four tracks at the Queens Interlocking. Figure 2 shows the location of the roadway workers in the Queens Village track. The fifth roadway worker was not in the track and, therefore, is not shown in the graphic.

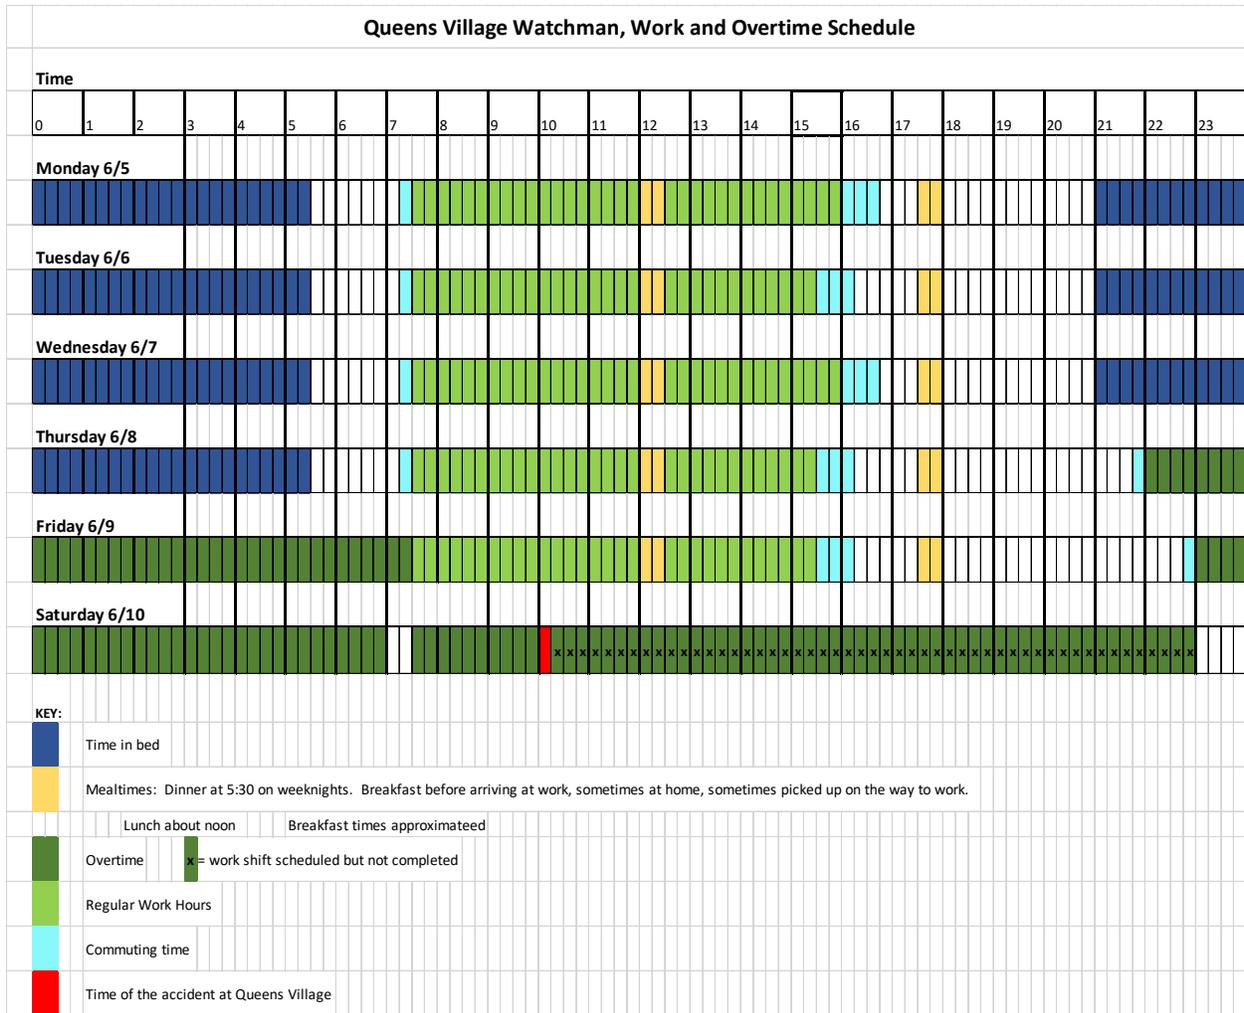
Figure 3. Queens Village watchman/lookout, work and overtime schedule.

As shown in figures 3 and 4, both the watchman/lookout and the foreman worked overnight overtime shifts starting on Thursday. Their sleeping, eating, and commuting hours are shown, where known. The information was consolidated from the LIRR timecards and interviews with the watchman/lookout.

The watchman/lookout worked and commuted for about 38 out of 50 hours leading up to the time of the accident. This schedule did not allow him to sleep as usual; specifically, for the 2 nights prior to the accident, his opportunities for sleep were reduced in duration and shifted to early evening periods. This change in schedule is an acute disruption to his circadian rhythm, which likely caused him to be fatigued on the day of the accident.¹³

Therefore, the NTSB concludes that the LIRR and SMART allowed workers to schedule overtime hours without consideration of fatigue, which exposed employees and the public to unnecessary risk. Therefore, the NTSB recommends that MTA work with SMART to develop and implement a work scheduling program for roadway workers using a validated biomathematical model of fatigue avoidance to ensure that roadway workers at risk of being fatigued are not eligible for overtime. Because this issue should be addressed from both the management and union perspective, the NTSB also recommends that SMART work with MTA management to develop and implement a work scheduling program for roadway workers using a validated biomathematical model of fatigue avoidance to ensure that roadway workers at risk of being fatigued are not eligible for overtime.

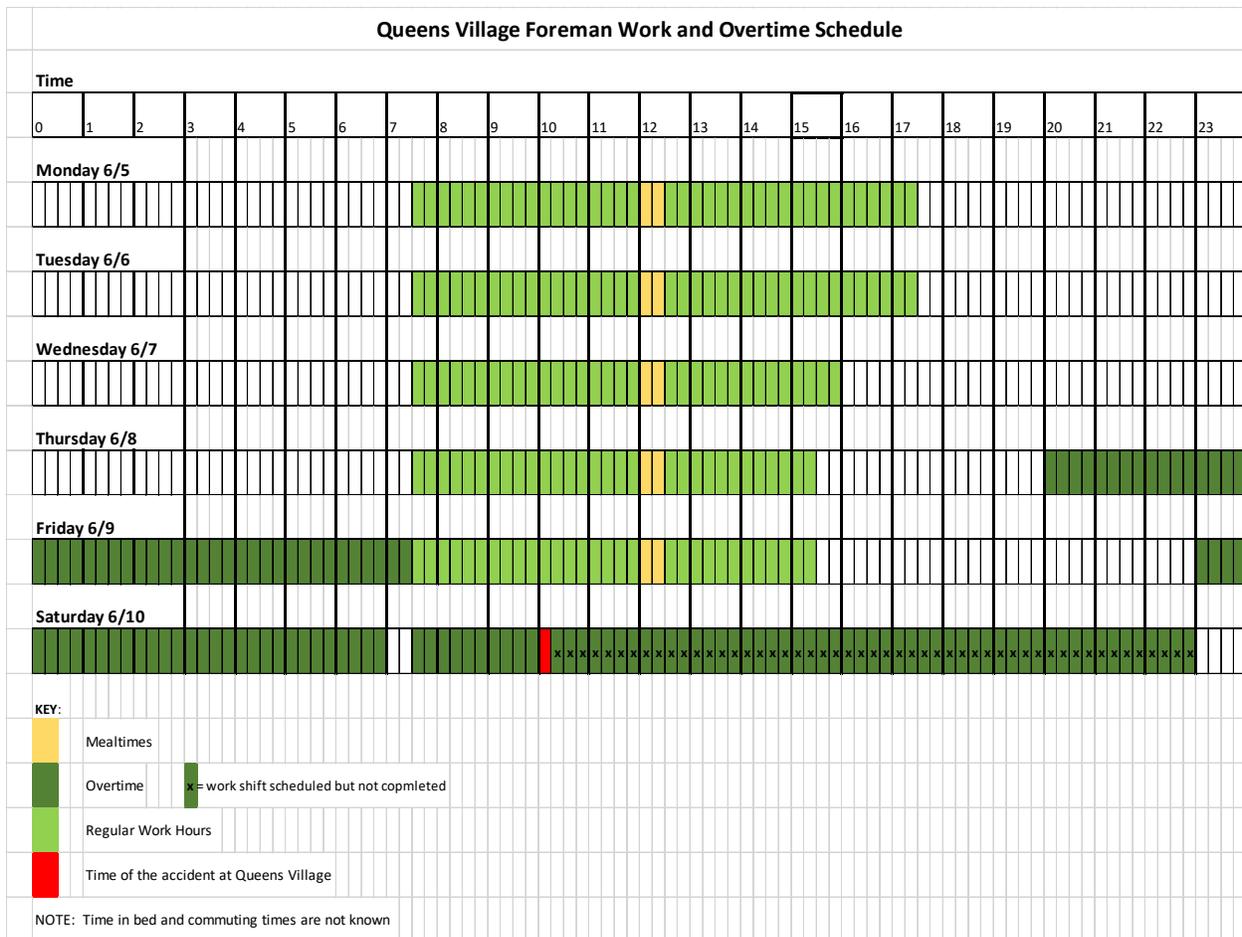
Figure 4. Queens Village foreman, work and overtime schedule.

The foreman’s work schedule was similar. Unfortunately, because of the foreman’s death, NTSB investigators could not determine his routine in the days prior to the accident; however, he was on duty for 38 of the 50 hours prior to the accident. Like the watchman/lookout, this schedule did not allow adequate restorative sleep for the 2 nights prior to the accident.

Based on the foreman’s and the watchman/lookout’s work schedules for 2 days prior to the accident, they were unable to receive restorative sleep for 2 consecutive nights prior to the day of the accident. The FRA analyzed these work schedules and found that both employees were in a fatigued state prior to the accident. Fatigue can cause workers to take shortcuts (workload shedding), delay reactions, and make poor decisions. The NTSB has noted the effect of fatigue in previous accident investigations, such as a collision of two Union Pacific Railroad freight trains in Hoxie, Arkansas, on August 17, 2014 (NTSB 2016). In that report, NTSB cited a 2014 FRA study that examined the effects of fatigue on human performance and noted that fatigue decreases a person’s alertness and ability to work safely. Therefore, the NTSB concludes that the watchman/lookout and the foreman were likely fatigued because their overtime shifts did not allow for adequate periods of restorative sleep during the 2 nights before the accident.
