Collision of Two CSX Transportation Freight Trains
Carey, Ohio
August 12, 2019

Accident Report

NTSB/RAR-20/03
PB2020-101009

National
Transportation
Safety Board

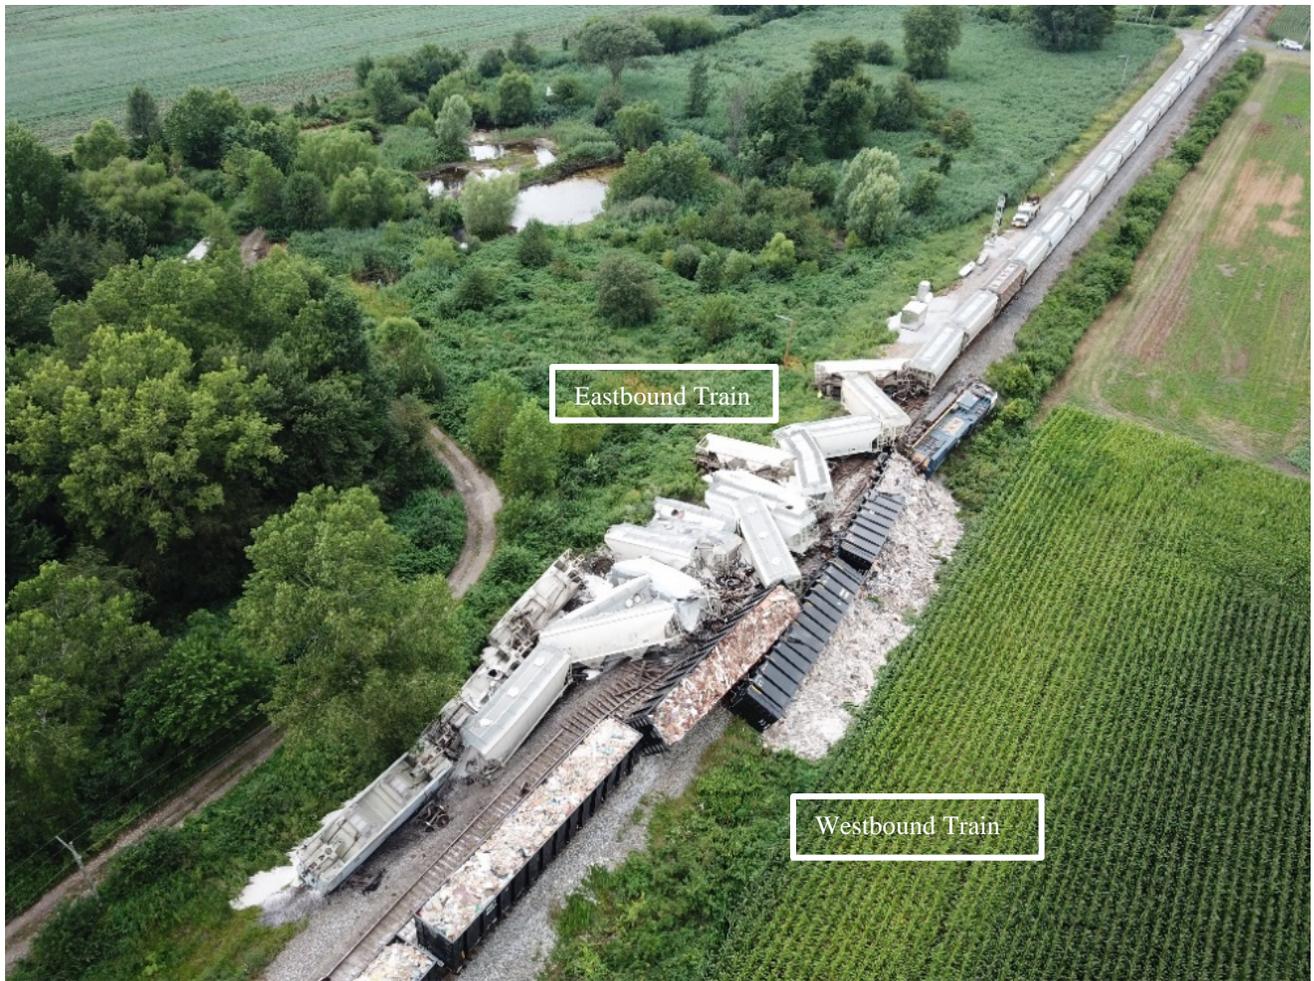
Figure 1. Aerial view of collision location. (Photograph courtesy of CSX.)

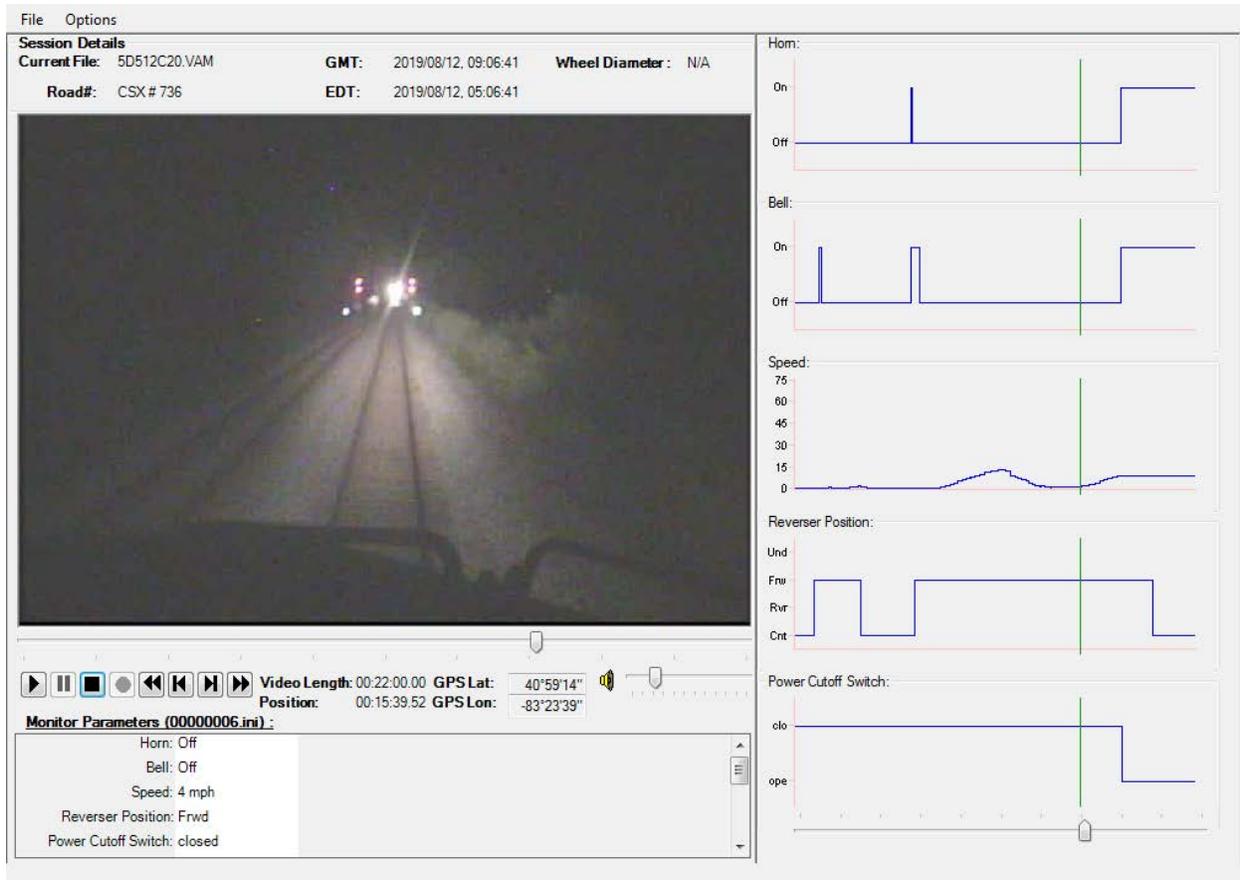
was also visible. The image data showed, at 5:03:18 a.m., the westbound train engineer turned off the locomotive headlight while still moving. At 5:06:41 a.m., the westbound train engineer turned on the locomotive headlight and continued increasing speed while approaching the wayside signal at CP Springs. (See figure 3.)

Figure 3. Data from westbound forward-facing train image recorder.

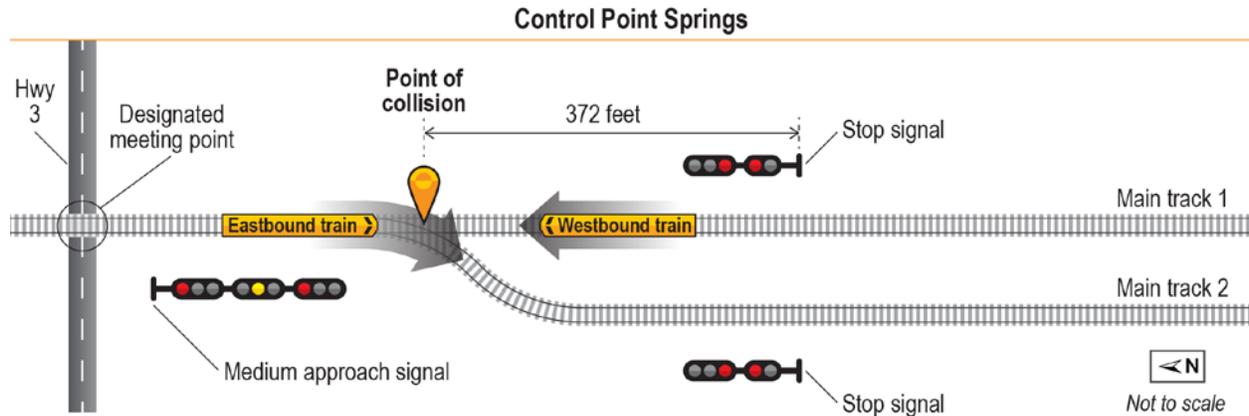
Figure 4. Illustration of the track and signal indicators at CP Springs at the time of the collision.

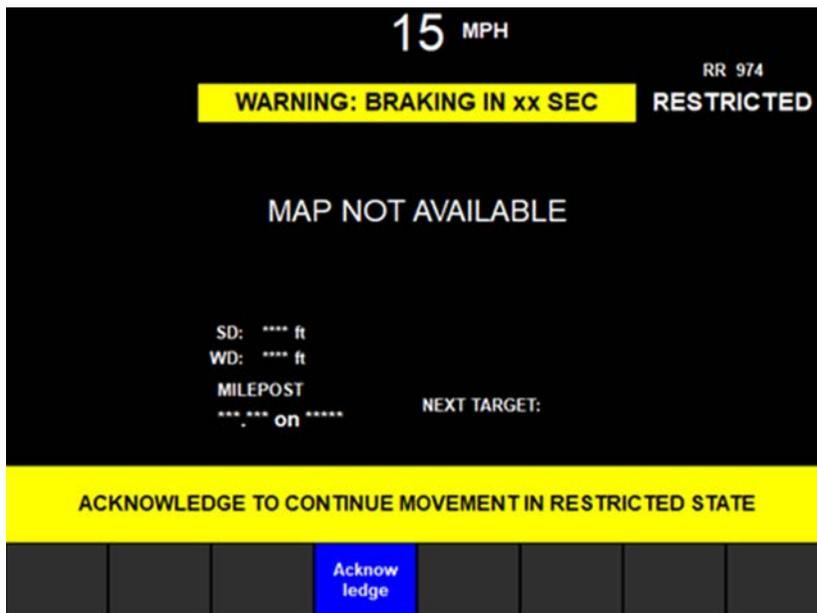
Figure 5. PTC display prototype of the proposed warning prompt. (Graphic courtesy of CSX.)

The Interoperable Train Control Application Committee (ITC), which is composed of four Class I railroads (CSX, BNSF Railroad, Norfolk Southern Railroad, and Union Pacific Railroad) is developing such an engineering control to address risks associated with PTC switching between active mode and restricted mode. The ITC coordinates PTC interoperability specifications and technical protocols using the Association of American Railroads (AAR) PTC design standards. Through this railroad industry committee, CSX officials are developing software changes to the PTC restricted mode. The changes will be centered around the acknowledgement of continued movement in restricted mode. The ITC is establishing a threshold based on time and/or distance before the train engineer will receive a prompt that displays “ACKNOWLEDGEMENT TO CONTINUE MOVEMENT IN RESTRICTED MODE.” (See figure 5.)

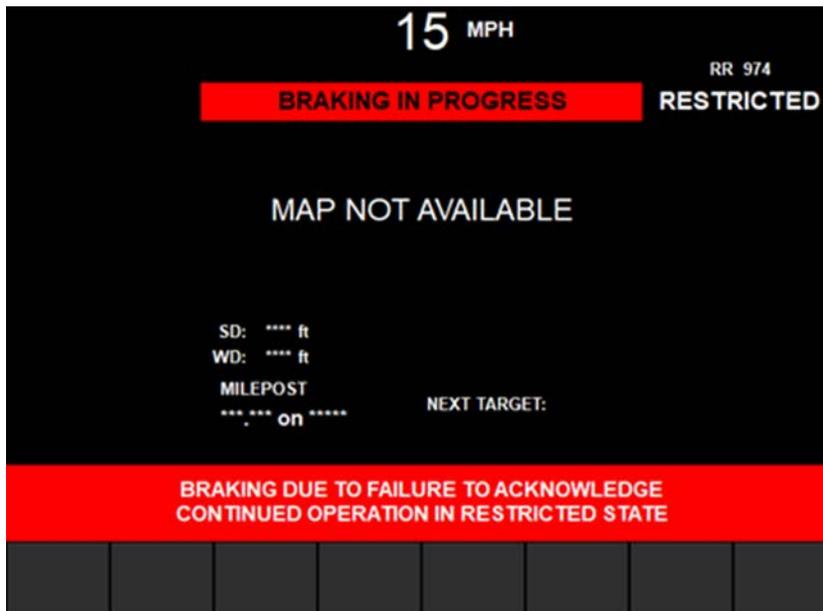
Figure 6. PTC display prototype of the proposed enforcement notification to the operator. (Graphic courtesy of CSX.)

If the train engineer does not acknowledge the prompt, the system will automatically initiate a penalty brake application. (See figure 6.)²⁶
