BNSF Railroad Collision  
Kingman, Arizona  
June 5, 2018

NTSB/RAR-21/01  
PB2021-100919

# Railroad Accident Report

BNSF Railroad Collision

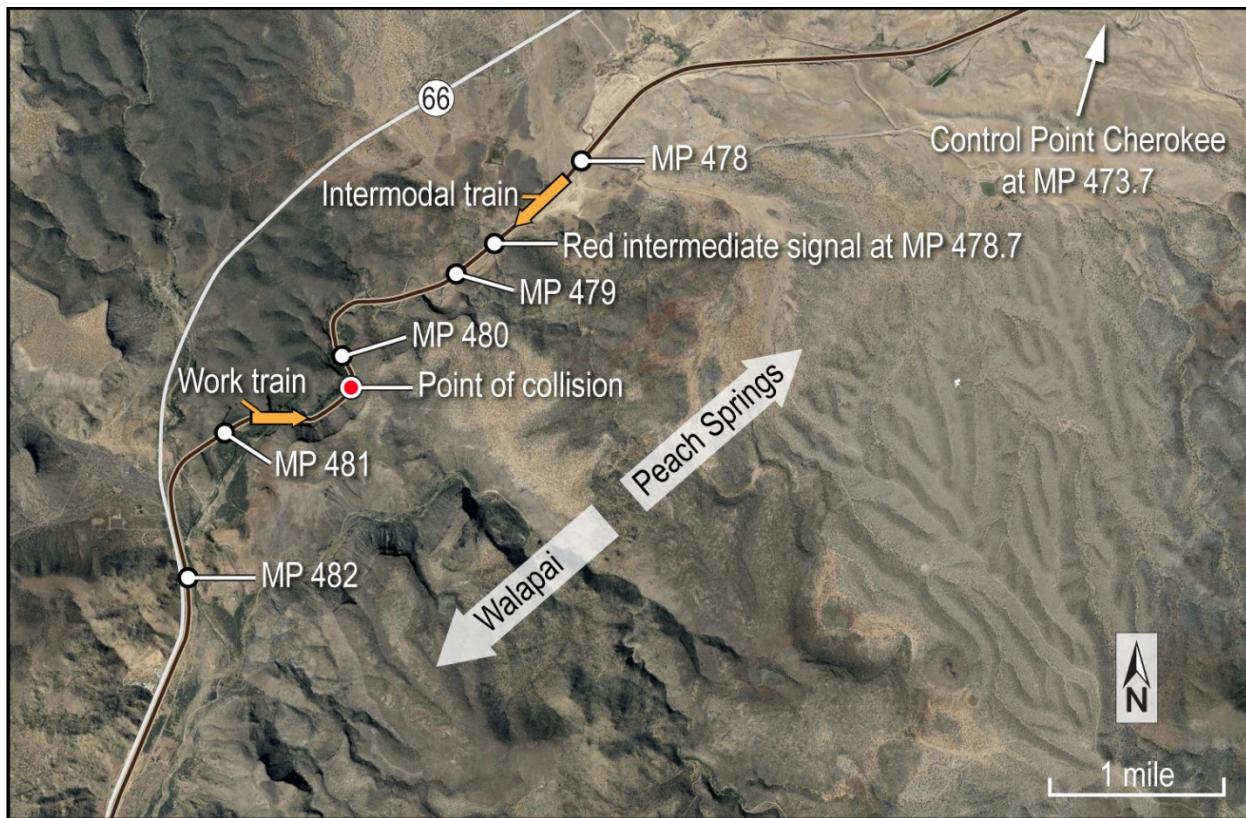
**Figure 1.** Layout of Crozier Canyon.

The loaded 29-car work train was operating in reverse (shoving) up an ascending 1.5 percent grade at about 9 mph in Crozier Canyon when the accident occurred. The train's operating crew consisted of an engineer, conductor, and brakeman.<sup>4</sup> The brakeman was positioned in the driver's seat in the cab of the rail unloading machine (RUM) at the rear of the train to watch for hazards during the shoving move.<sup>5</sup> There were two Herzog employees in a separate control cab of the RUM who operate the rail-unloading attachments. (See figure 2.) BNSF contracts out the Herzog RUM unit for its continuous welded rail (CWR) unloading operations.<sup>6</sup> See Section 1.7 for specific details on RUM operations. There were three other BNSF employees occupying the rail cars on tie-down platforms, which are walkways used to cross from one side of the rail cars to the other while unloading rail.

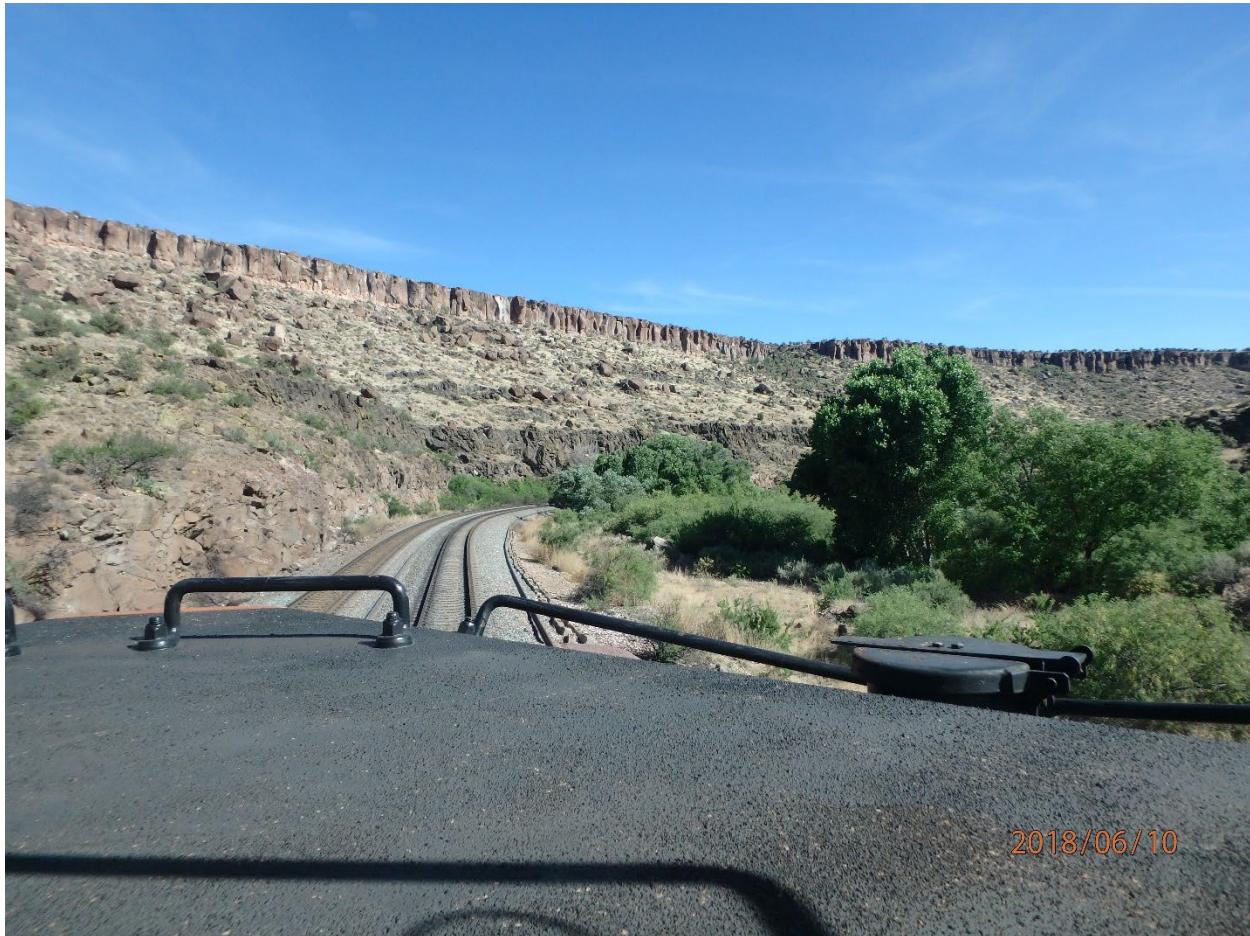
at a speed of 15 mph prior to reaching an 8° curve in Crozier Canyon.<sup>10</sup> Although the maximum authorized restricted speed can be up to 20 mph, restricted speed requires the train crew be able to stop the train in one half the range of vision (Title 49 *Code of Federal Regulation* [CFR] 236.812). In interviews with National Transportation Safety Board (NTSB) investigators, the conductor and engineer said that they felt that 15 mph was a safe speed.<sup>11</sup> Sight distance in the location of the accident was restricted by tall trees on the inside (west) of the curve as shown in figure 3.

**Figure 3.** Photo from train approaching accident curve from the east and facing west.

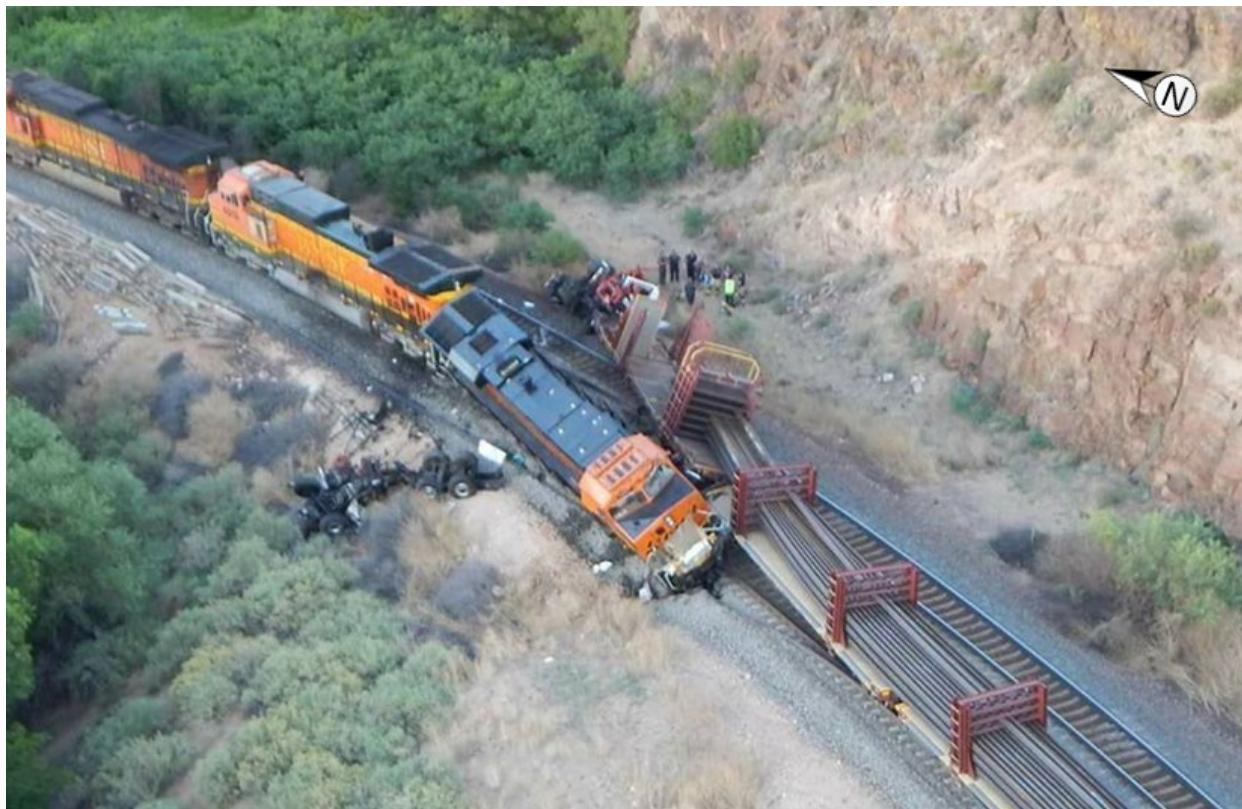
According to event recorder data, the crew of the westbound intermodal train applied the emergency brake while moving at 14 mph, and in 24 seconds, after traveling about 363 feet, it collided with the work train. The crew of the eastbound work train applied its emergency brake while moving at 9 mph 15 seconds after the westbound intermodal train applied its brakes. At the time of collision, the westbound intermodal train was traveling at 10 mph while the eastbound work train was traveling at 5 mph. (See figure 4.)

**Figure 4.** Overhead view of collision point. (Source: BNSF)

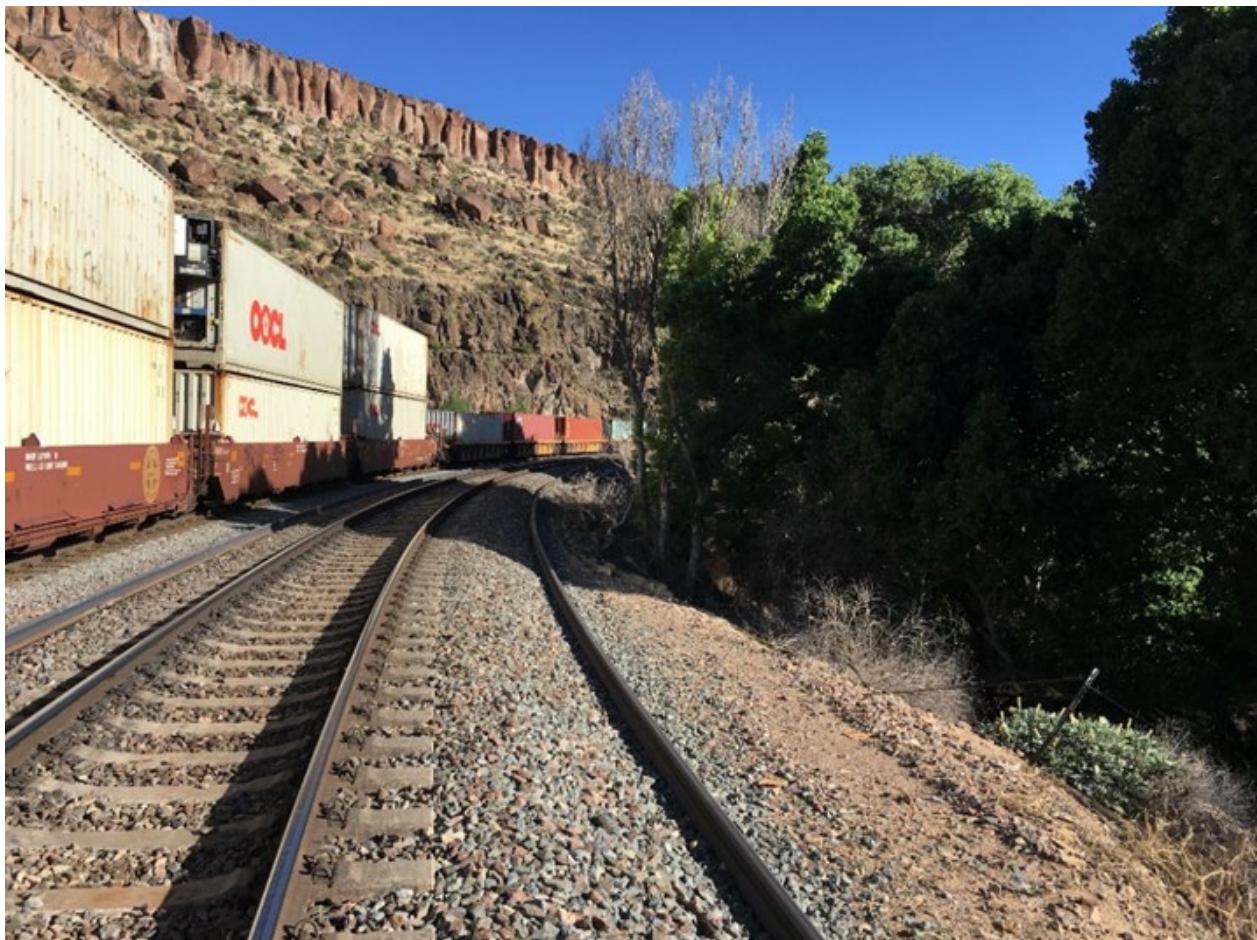
After the train crew departed Peach Springs on track 1, they encountered three signal indications that required them to respond. The first was an approach medium (flashing yellow aspect) at control point Cherokee at MP 473.7. Their second signal indication was an approach (yellow aspect) at an intermediate signal at MP 476.6. The third signal was an intermediate signal displaying a restricting aspect (red aspect) at MP 478.7.<sup>16</sup> Operating rules allow train crews to proceed past a red intermediate signal at restricted speed, which is not to exceed 20 mph on BNSF tracks. The train crew stopped the train at the red signal instead of continuing at restricted speed because they stated, “Crozier Canyon is almost 3 miles long with blind curves.” (See figure 7.)

**Figure 7.** View from two main tracks looking west toward the collision point.

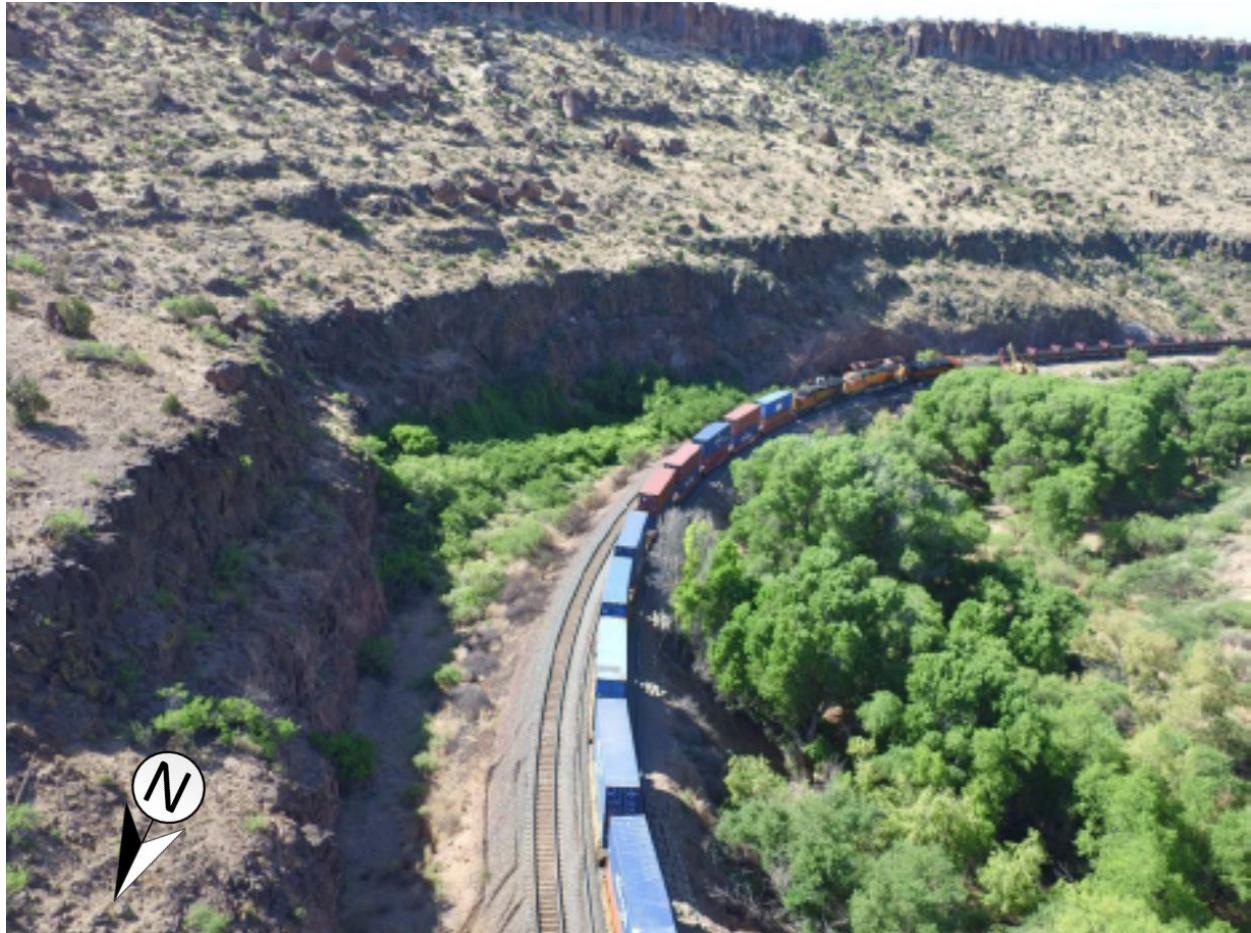
**Figure 8.** Western view of westbound intermodal train looking toward the collision point.  
(Source: BNSF)

When the trains collided, the conductor on the intermodal train landed on top of the engineer. The lead locomotive of the intermodal train came to rest leaning to the right, and diesel fuel started to leak into the locomotive cab. Both crewmembers exited the locomotive and started looking for the crewmembers of the work train. They immediately found the brakeman of the work train who jumped before the collision. An employee that was part of the work train notified the engineer and conductor that there were two other employees trapped in the RUM on the south side of the tracks. The conductor said he pulled one of the employees out of the cab of the RUM. The deceased employee remained in the cab until he was removed by emergency responders.

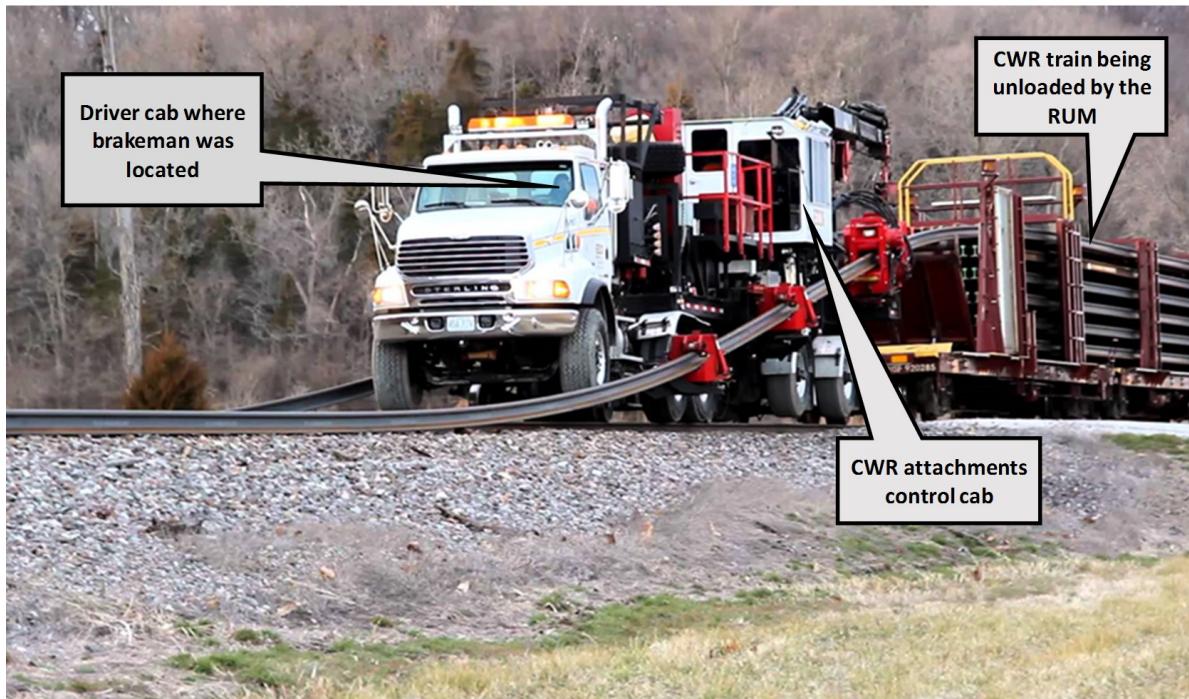
BNSF uses a freight train with specialized coupled flat cars for transporting long lengths of CWR to locations for loading and unloading operations. The CWR sections are positioned and stacked on the flatcars 6 rails high and 12 rails wide. The last flatcar in the CWR train is equipped with two working platforms or catwalks that span over the rails, where MOW employees are stationed to prepare the rails for either transport or unloading operations. (See figure 9.)

**Figure 9.** RUM unloading rail from CWR work train. (Source: BNSF)

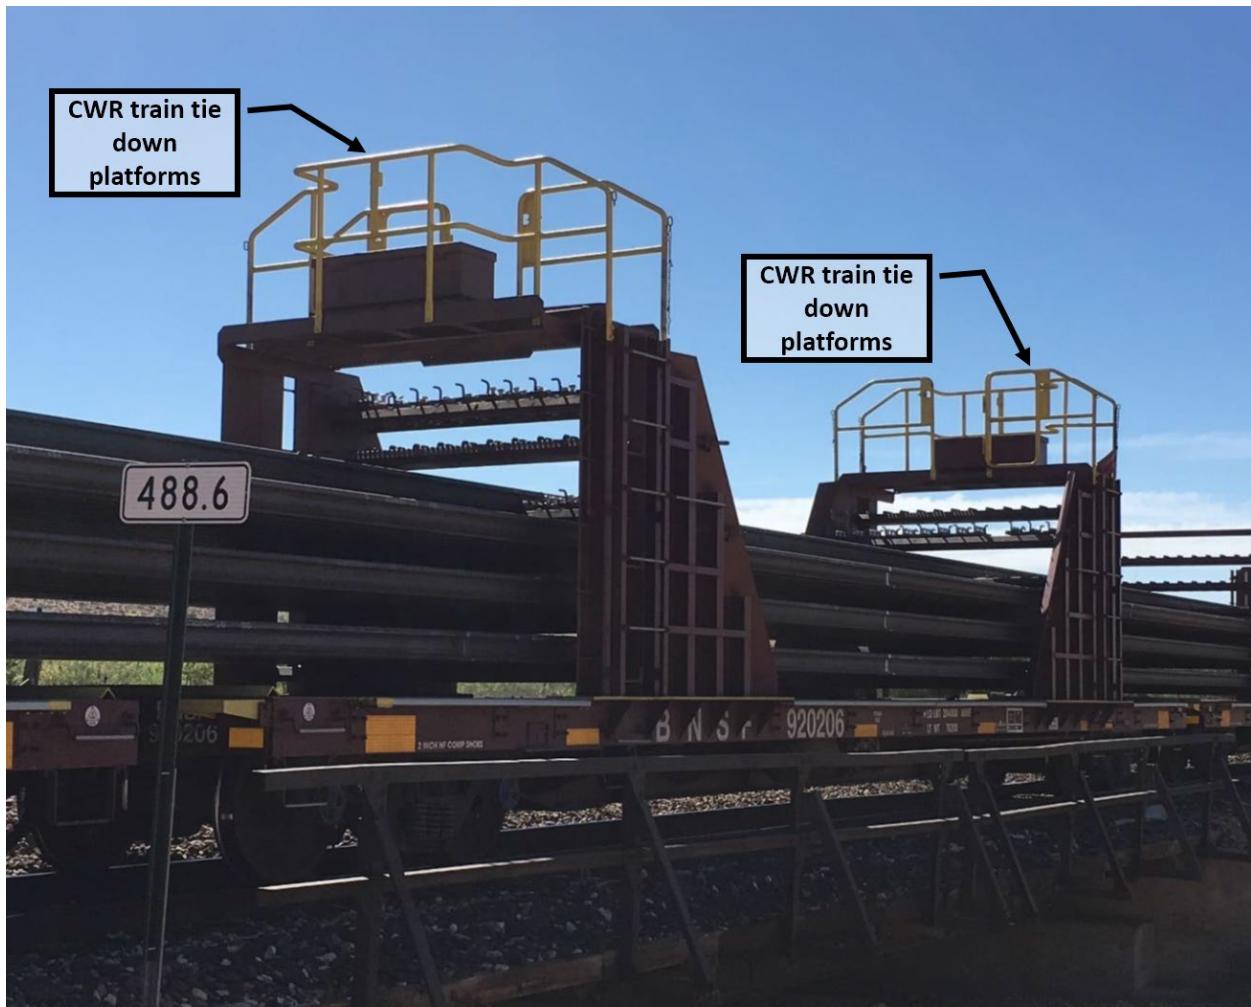
**Figure 10.** Tie-down platform on rail cars.

At the time of the collision, eight workers were positioned on the work train (shown in figure 10) as follows:

- 1 BNSF engineer located in the front locomotive
- 1 BNSF conductor located in the front locomotive
- 3 BNSF MOW employees located on the flatcar platforms/catwalks
- 2 Herzog employees located in the RUM trailer cab (1 fatal and 1 severely injured)
- 1 BNSF brakeman located in the RUM's semi-cab driver seat
