RAILROAD ACCIDENT REPORT

PENN CENTRAL COMPANY

COLLISION OF TRAINS

**N-48 AND N-49 AT
DARIEN, CONNECTICUT**

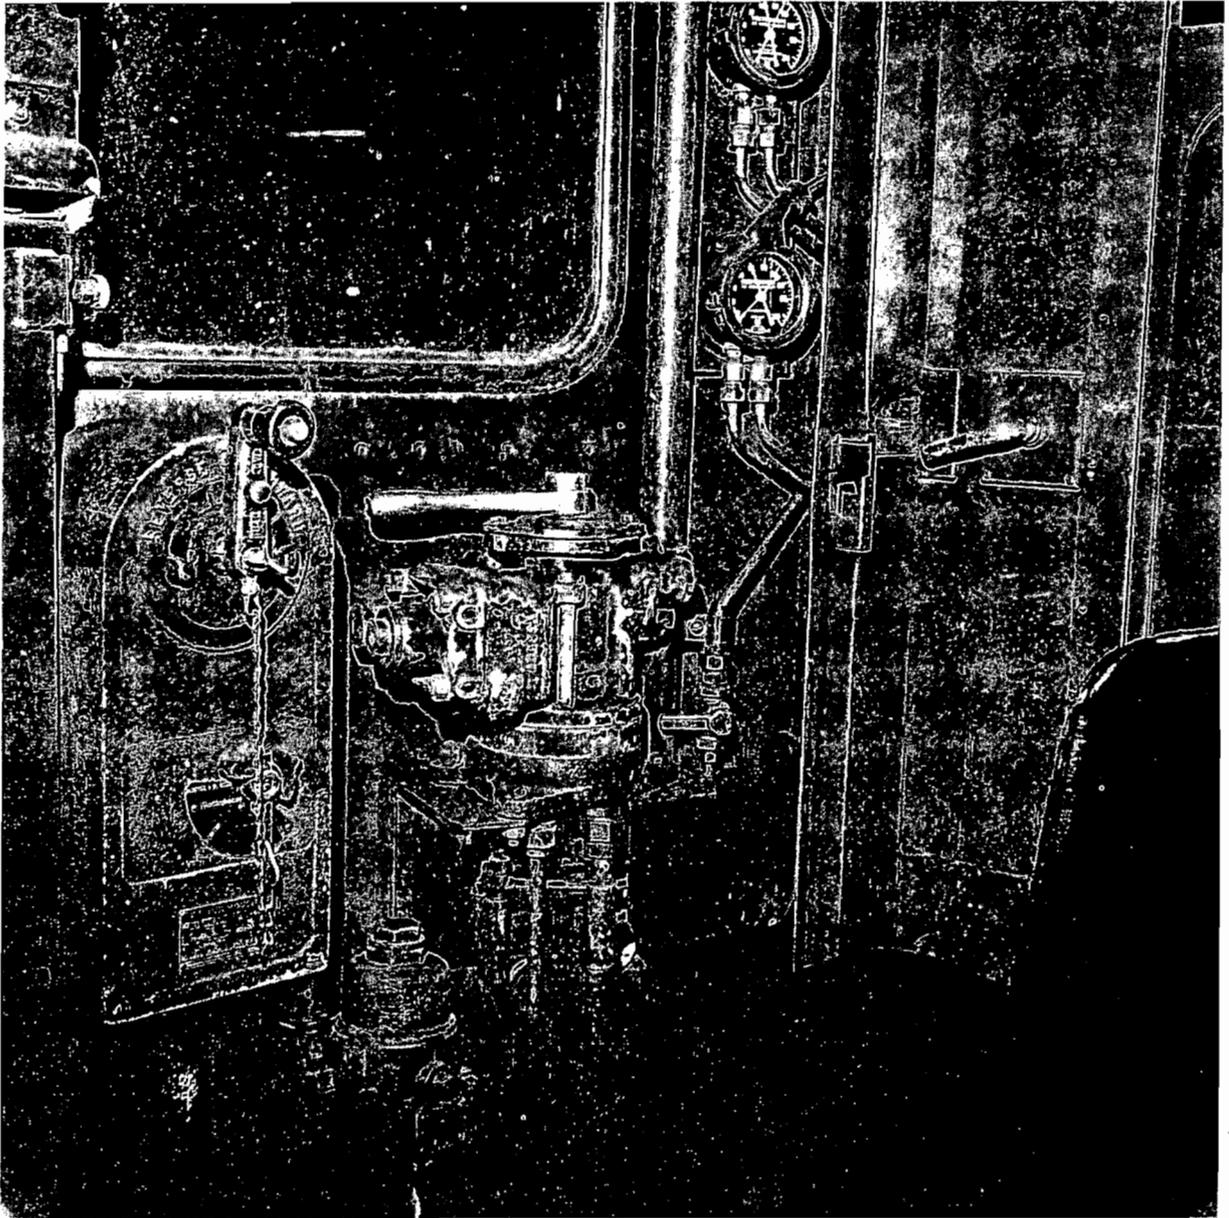
Figure No. 4

Interior view of engineer's operating compartment

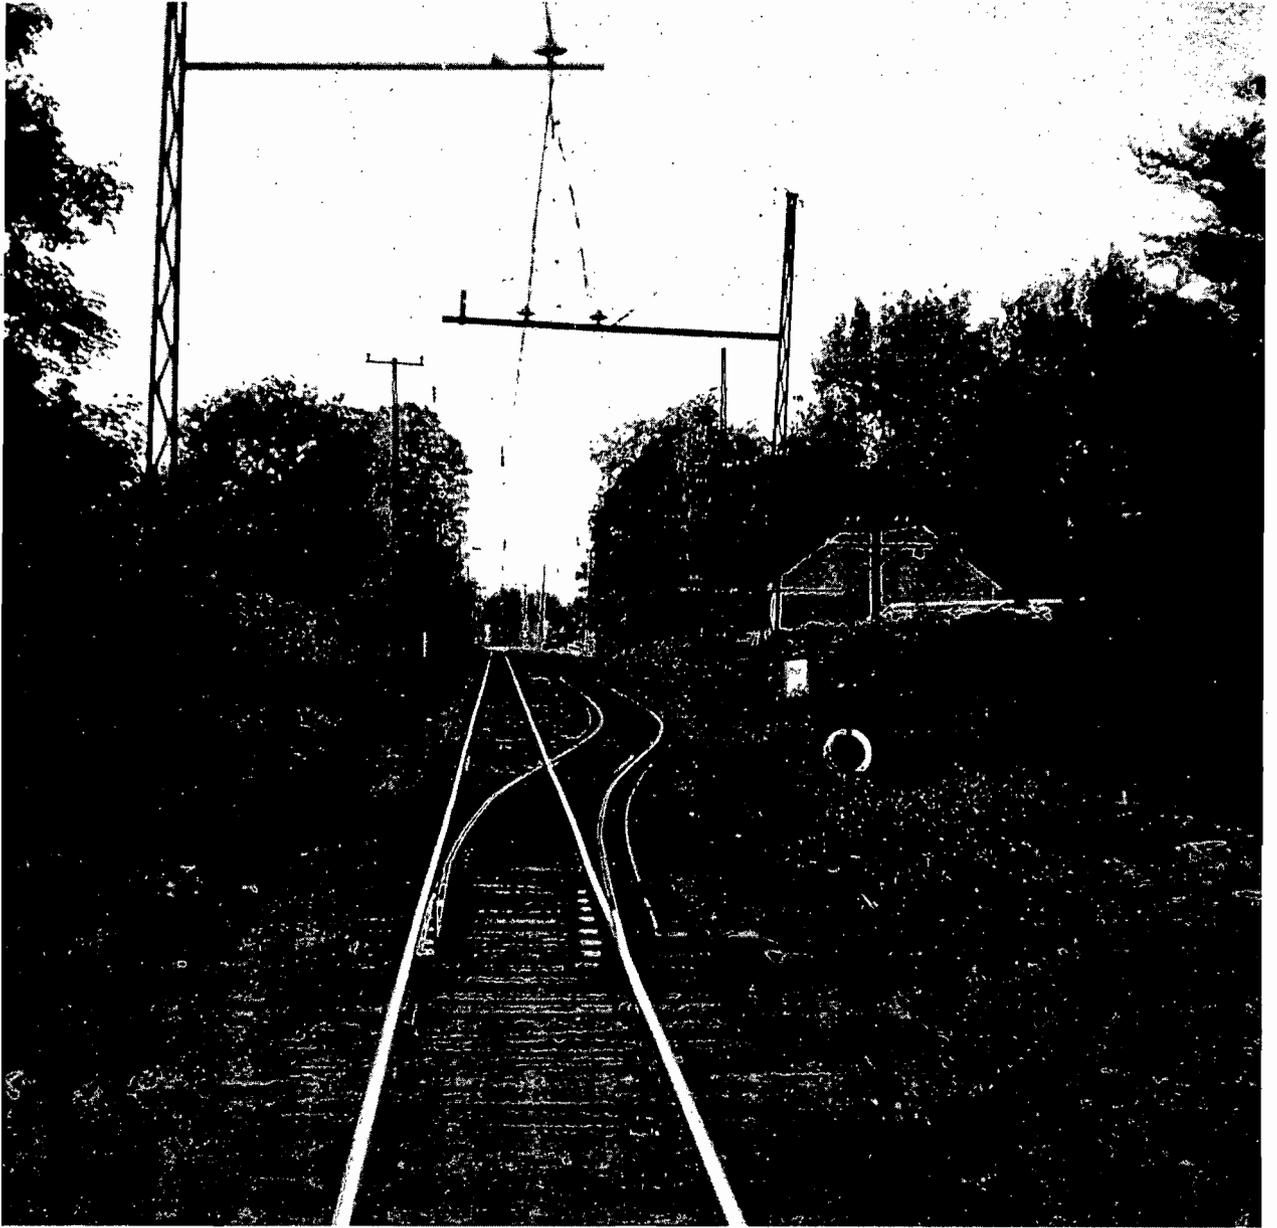
Figure No. 4-2

West switch of Dale siding
Lined for the Main track

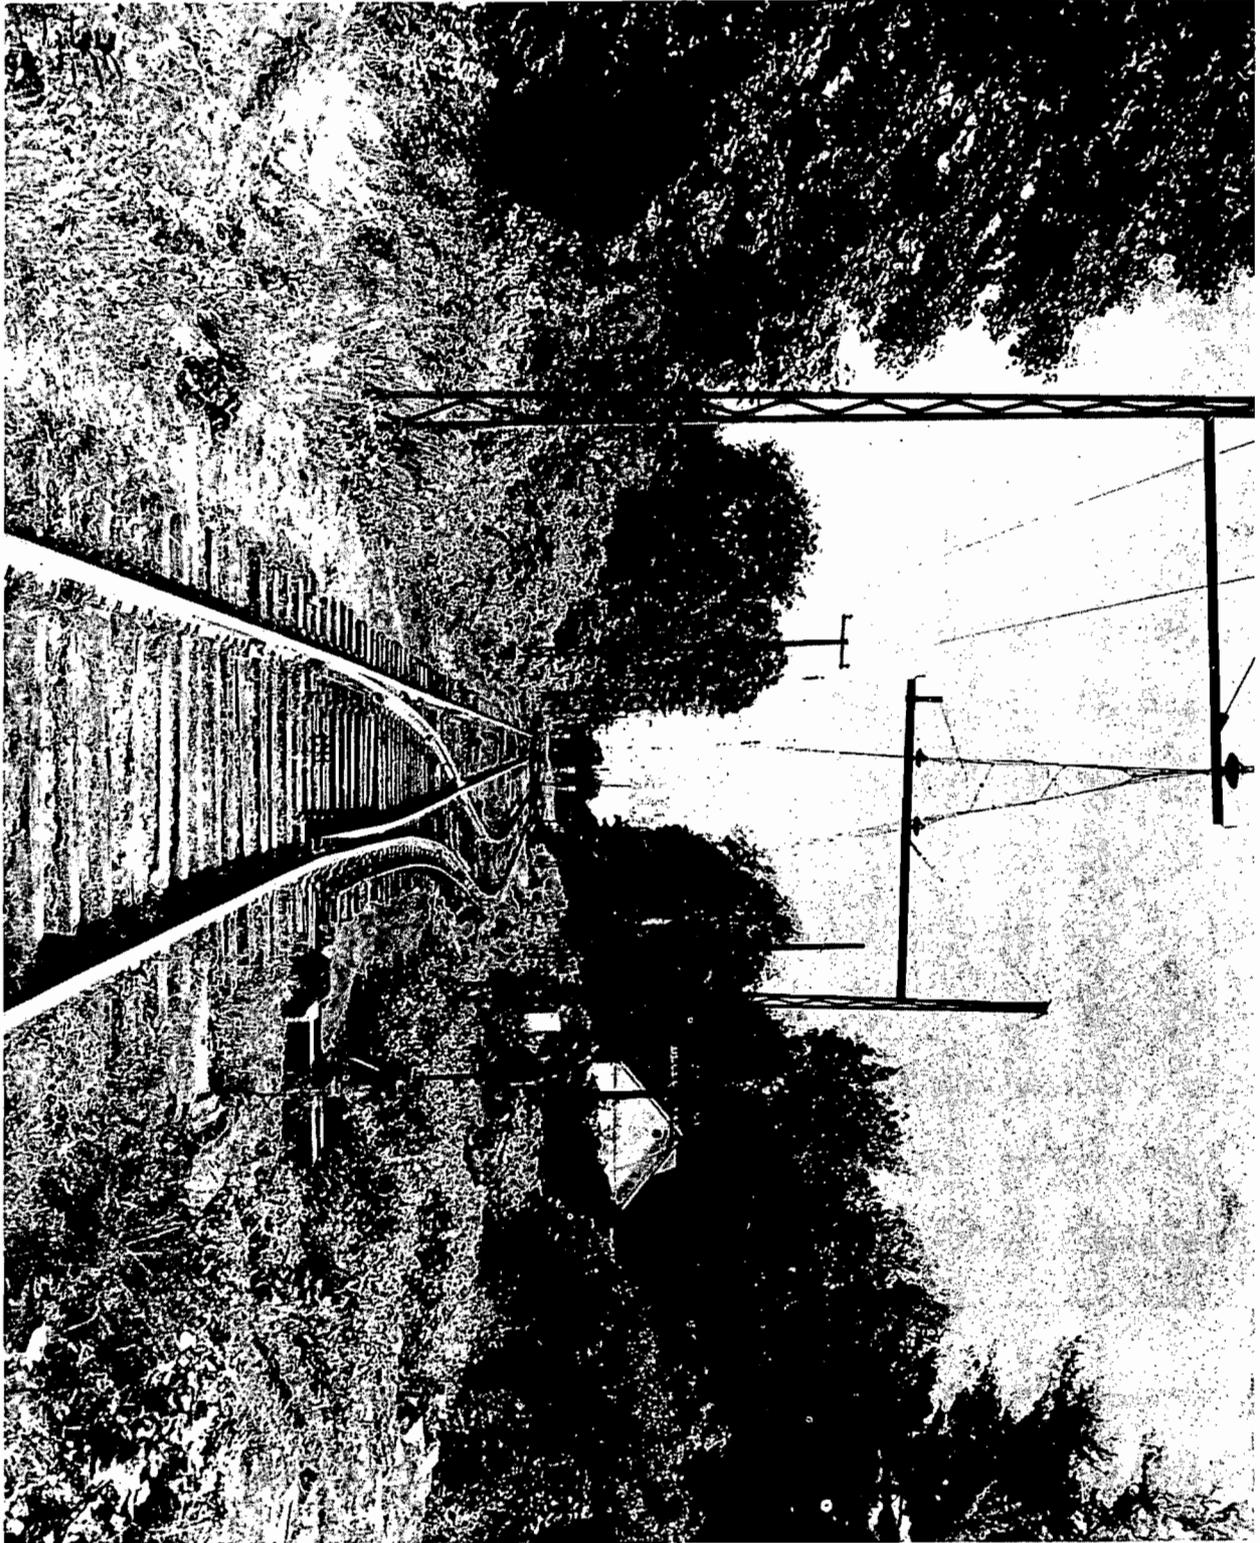
Figure No. 4-3, West switch of Dale siding lined for the siding

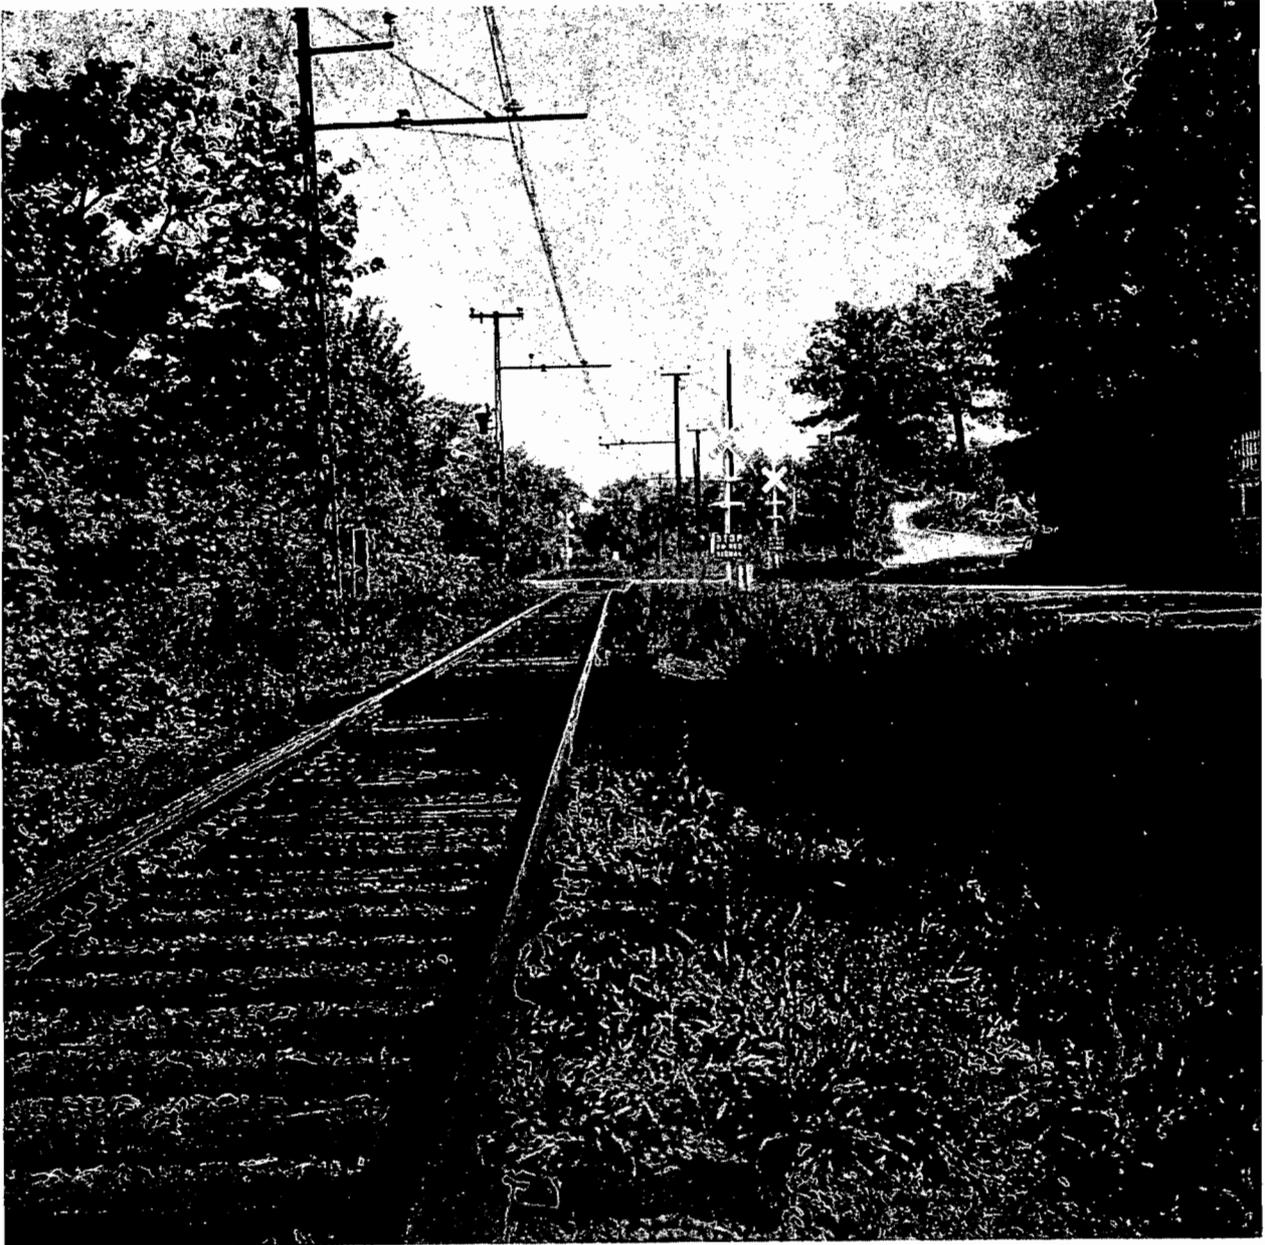
Figure No. 4-6

Hoyt Street crosses the main track from south to north at an angle of about 20° . The center of this crossing is located about 340 feet east of the east siding switch of Dale siding. Another street, which approximately parallels the main line on the south, intersects with the east side of Hoyt Street. This junction is located just south of the railroad crossing. These roads and crossings are surfaced with bituminous material. Apparently due to the angle of the intersection and the additional road intersecting Hoyt Street close to the crossing, four automatic red-flashing light protection devices are provided, one on each corner. Due to the angle of the crossing and the installation of the devices, the red-flashing lights can be more easily seen by persons on the train than those signals protecting roadways crossing the track at right angles. (See Figure 4-6.)

Hoyt Street Crossing as seen by the engineer of an eastbound train after passing Dale siding.
