RAILROAD ACCIDENT REPORT

Deraiment of
TOLEDO, PEORIA and WESTERN RAILROAD COMPANY'S
Train No. 20 With Resultant Fire
and Tank Car Ruptures
Crescent City, Illinois

June 21, 1970

NATIONAL TRANSPORTATION SAFETY BOARD
Washington, D. C. 20591
REPORT NUMBER: NTSB-RAR-72-2

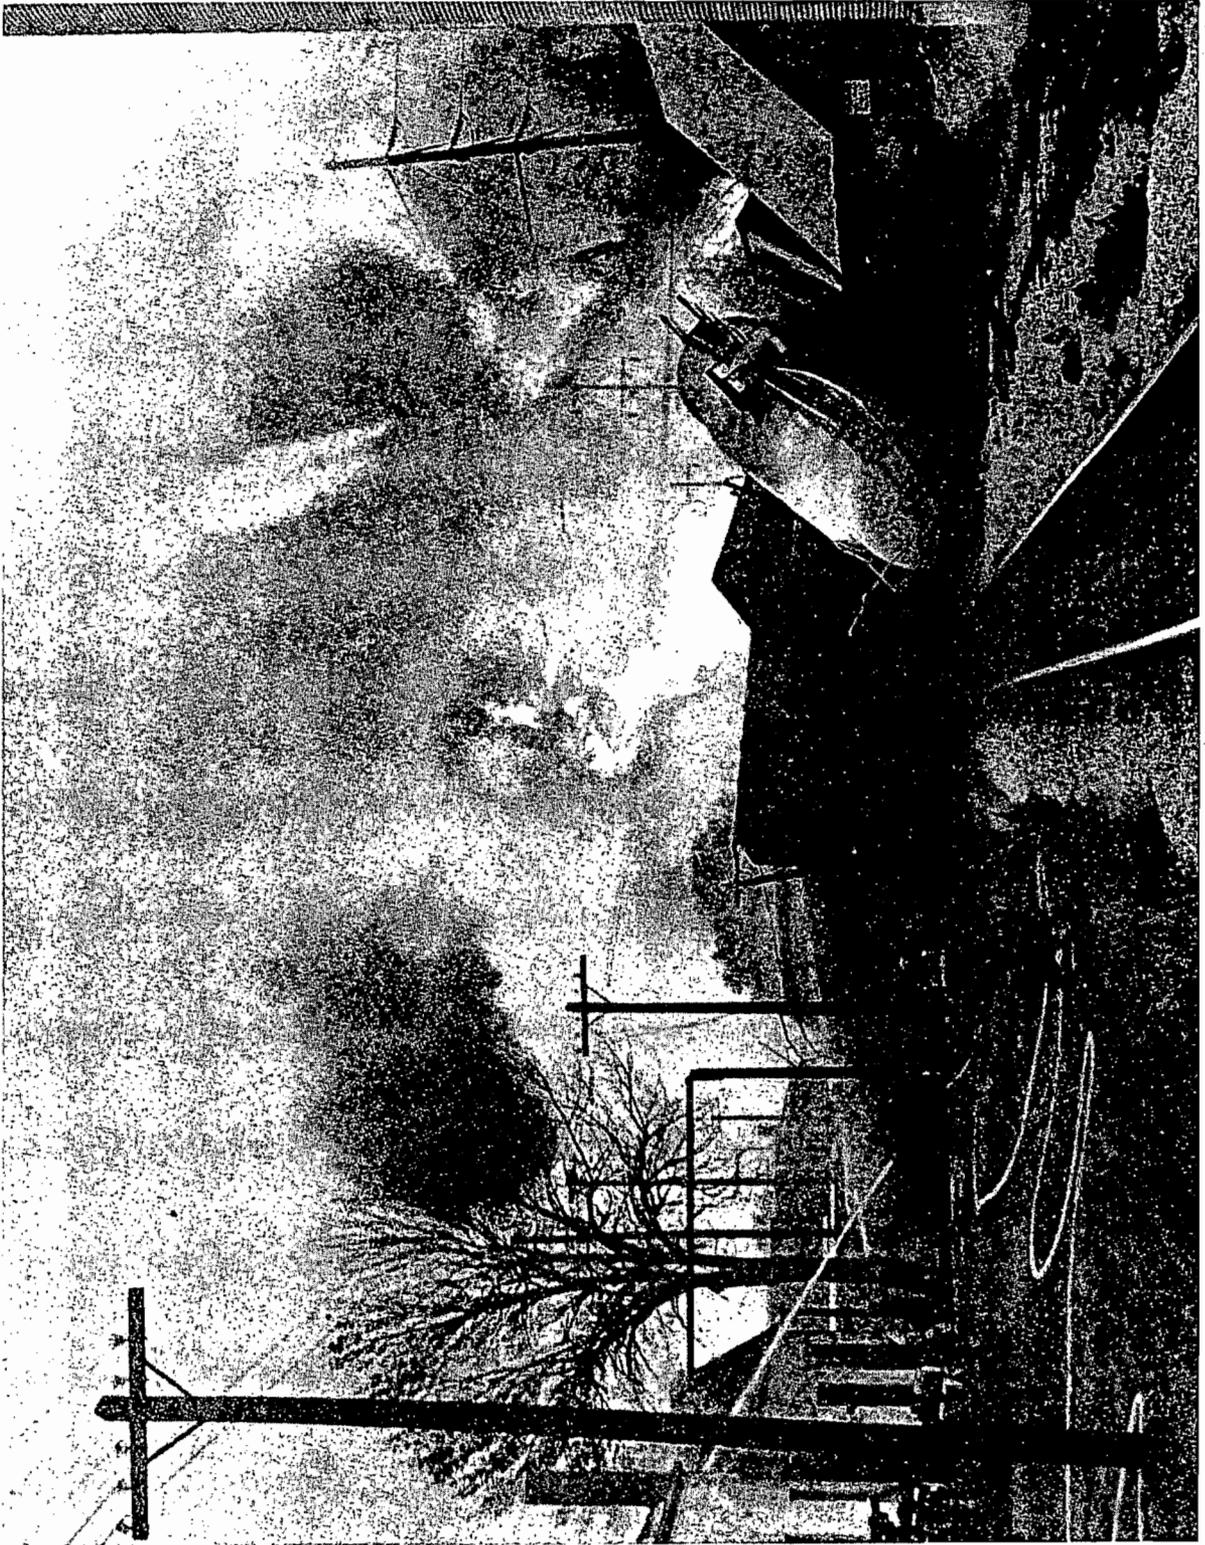
Figure 3. Location of tank car NATX 32025 on the East End of the General Derailment

When NATX 32025 ruptured, the force caused the next car (SOEX 3252) to rotate so that the manway was changed from a 2 o'clock position to a 4 o'clock position. The car was lying in a north-south direction, with the north end of the tank elevated about 10 feet higher than the south end. The fire was directed against the car.

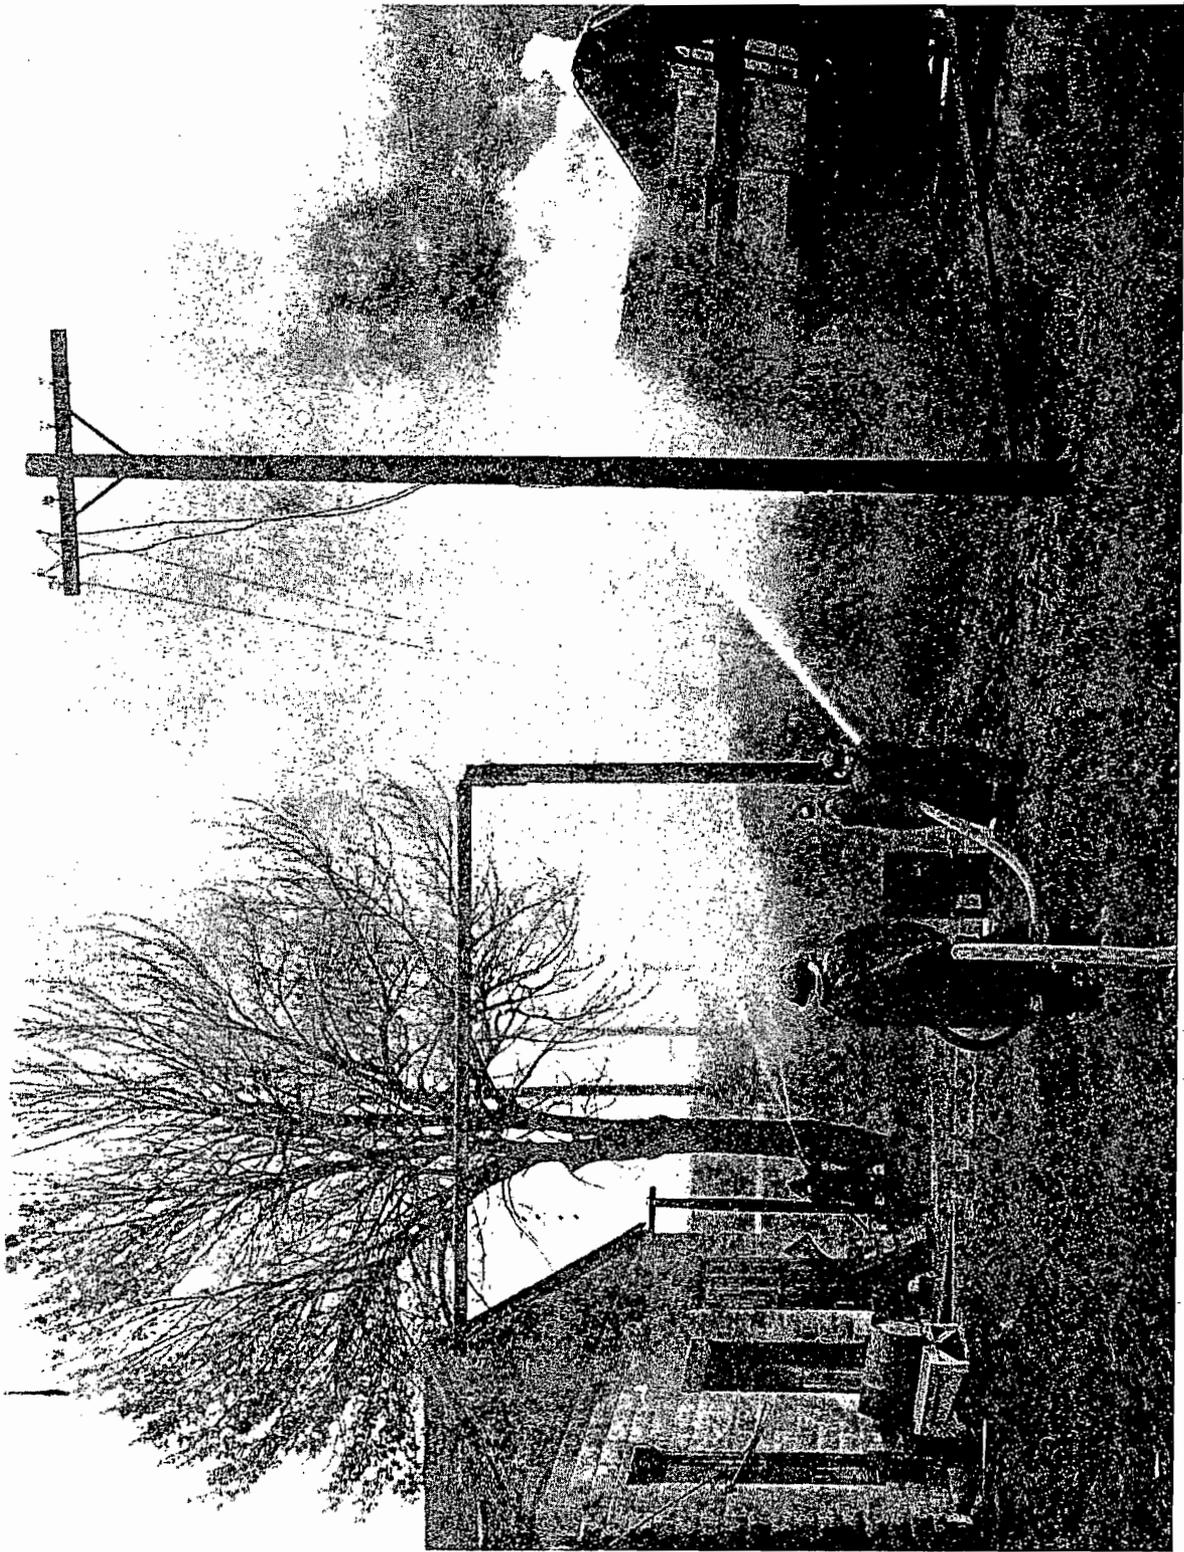
Figure 4. Location of Firemen before the Tank Cars Ruptured

Immediately following the ignition of the propane, the volunteer firemen of Crescent City responded to the emergency and attempted to control the fires. After the first flareup, the flames died down and appeared to be confined in the areas of the general derailment. Because the firemen assumed at this time that the fire could be contained within the general derailment area, they proceeded to extinguish fires in the surrounding buildings which had been started during the initial flareup. In doing this, the firemen took positions which were very hazardous if the tanks had exploded. (See Figure 4.)

the commodity on the cardboard placards placed on the side of the tank cars or by obtaining the information from the traincrew. However, the intensity of the fire probably precluded the reading of the placards or destroyed them, and the traincrew was not readily available to provide the information. If the first explosion had occurred before the State Police sergeant had warned the firemen to move back to a safer position, and before he had started the evacuation of the town, many more of the firemen and the townspeople could have been injured seriously. The photograph in Figure 12 was taken after the first explosion and shows the devastation to the area where the firemen were located prior to the explosion, as shown in figure 4.

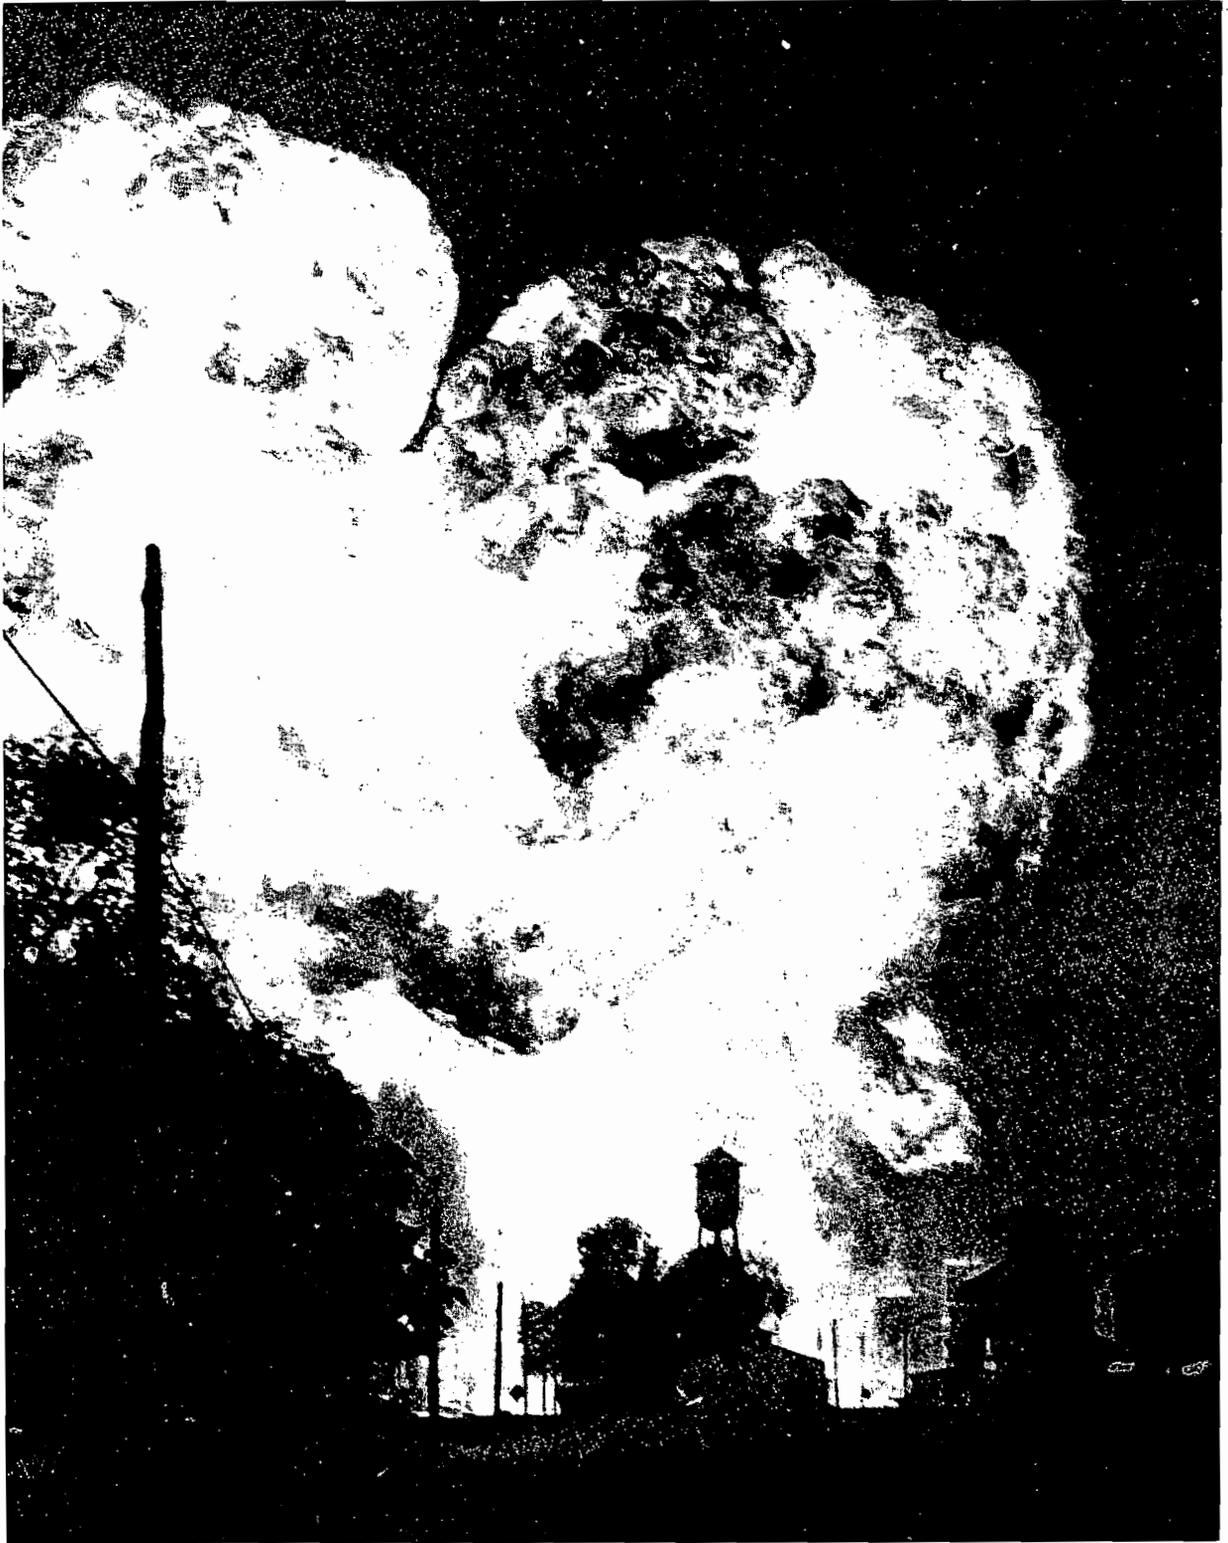
**Figure 5. A Fireball Emitted from Ruptured Tank Car NATX 32025
Extended Upwards about 1000 feet.**

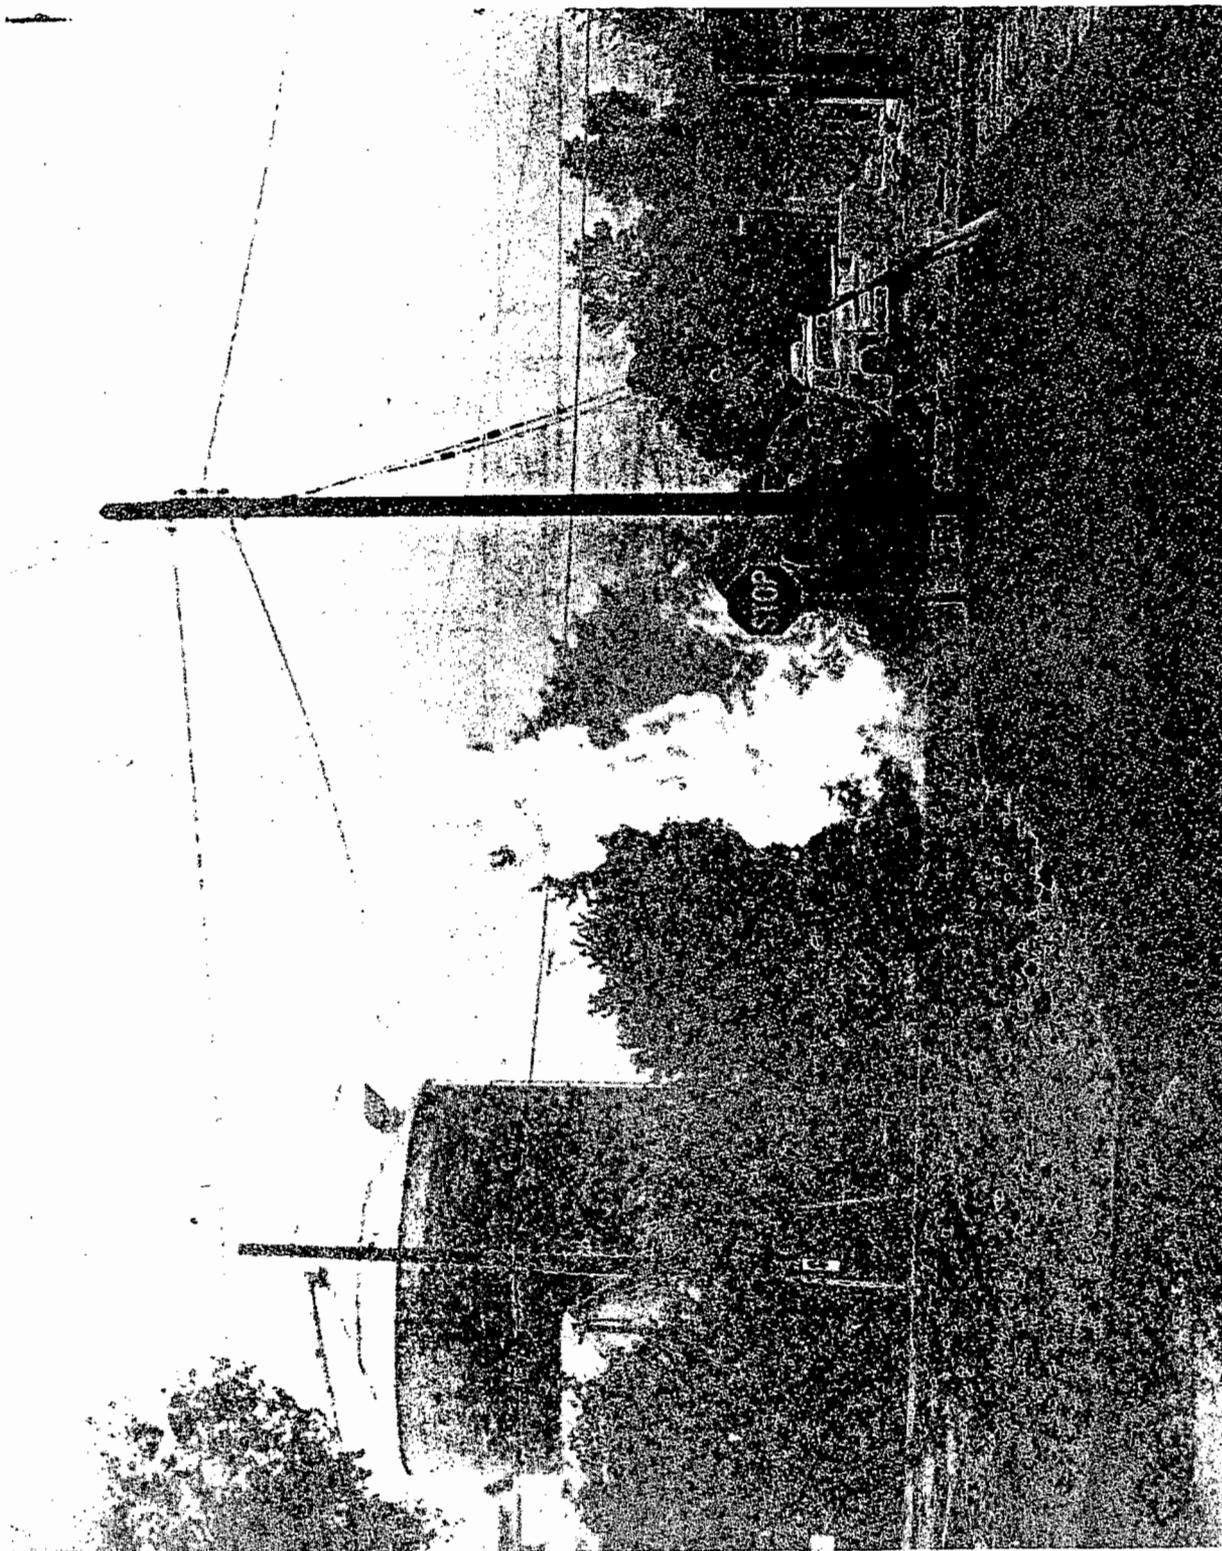
Figure 6. The East End of Tank Car NATX 32025, following its Rupture, was Propelled about 600 Feet to the Inter Section of Maple and Main Streets

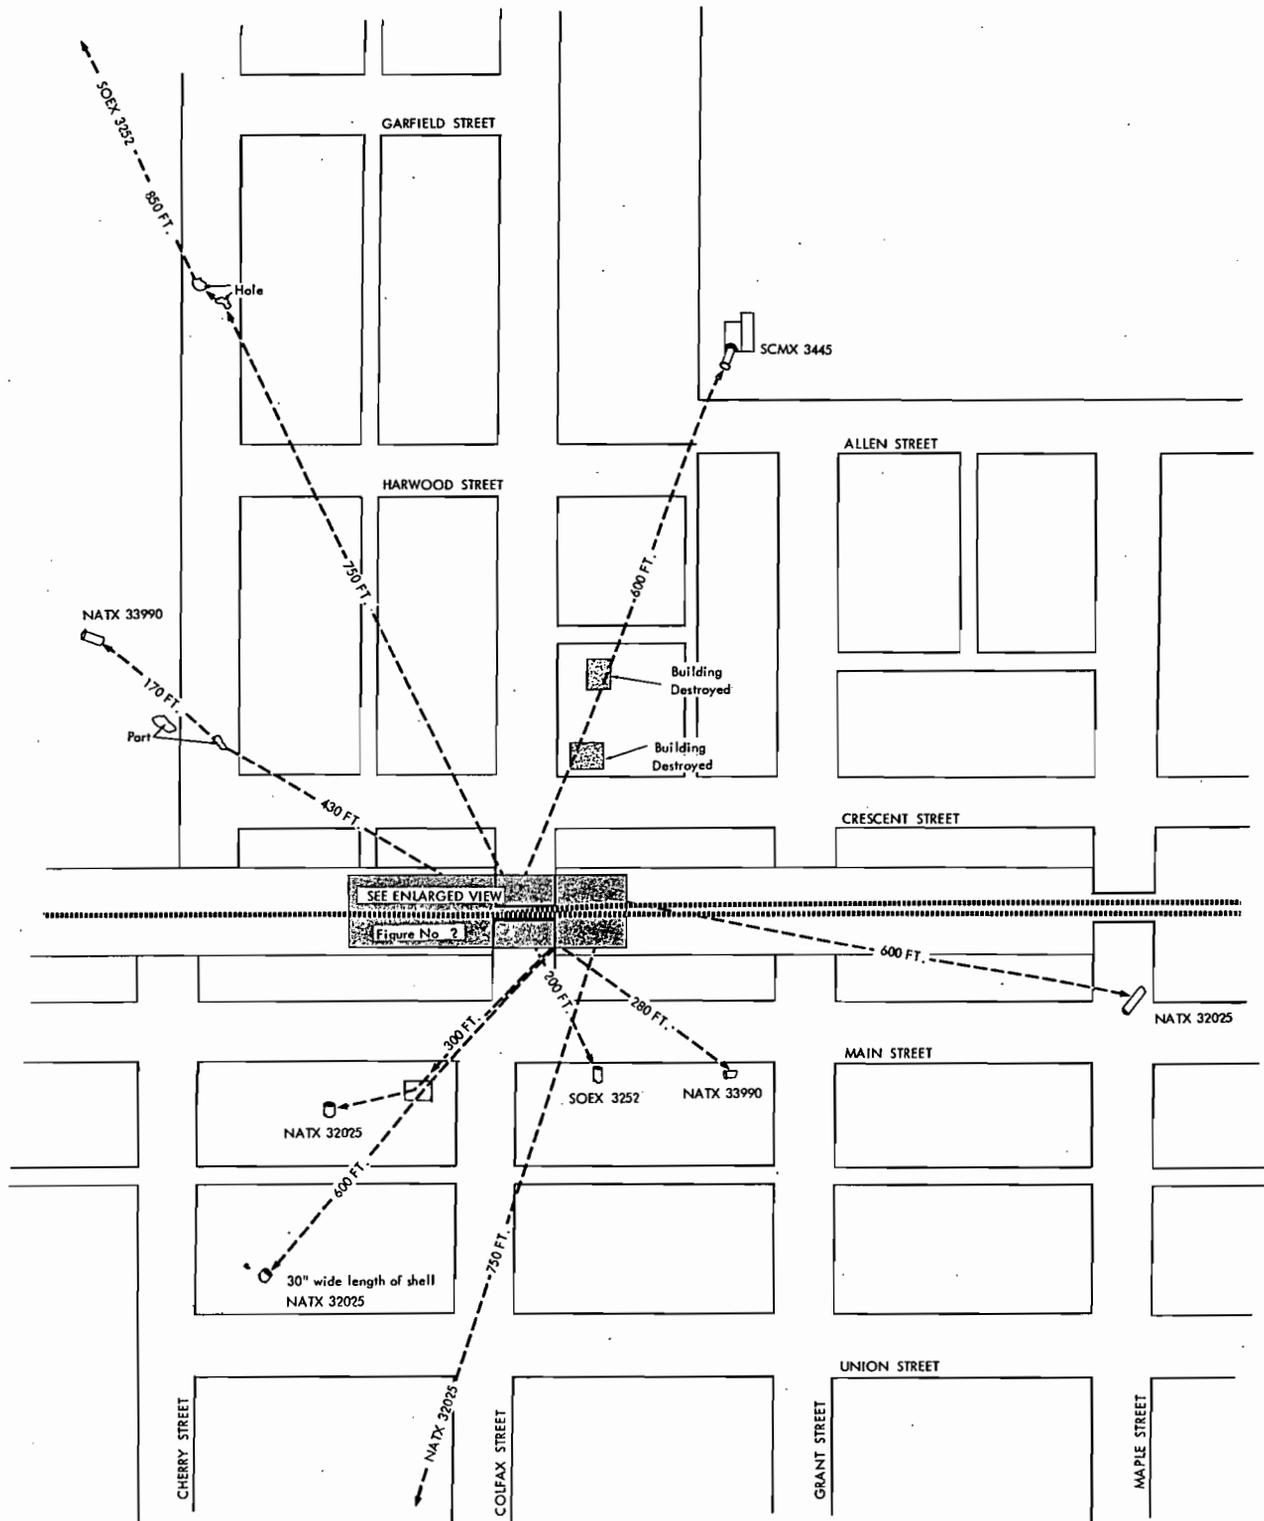
Figure No. 7

roofs of several houses and landed in an open field. It continued to roll and finally stopped after traveling about 1,600 feet. (See Figures 7 and 8.)

About 5 minutes later, at approximately 9:45 a.m. the 30th car in the train (SCMX 3445) ruptured. This car had been lying in a generally north-south position. The north end of the car, which included about one half of the tank, was propelled along the ground in a northeasterly direction for about 600 feet. This portion of the tank passed through and completely destroyed two buildings and came to rest within the third. The other end of the tank stayed in the vicinity of the general derailment site. (See Figure 7.)
