RAILROAD ACCIDENT REPORT

SOUTHERN PACIFIC TRANSPORTATION CO.

FREIGHT TRAIN 2ND BSM 22 MUNITIONS EXPLOSION

BENSON, ARIZONA

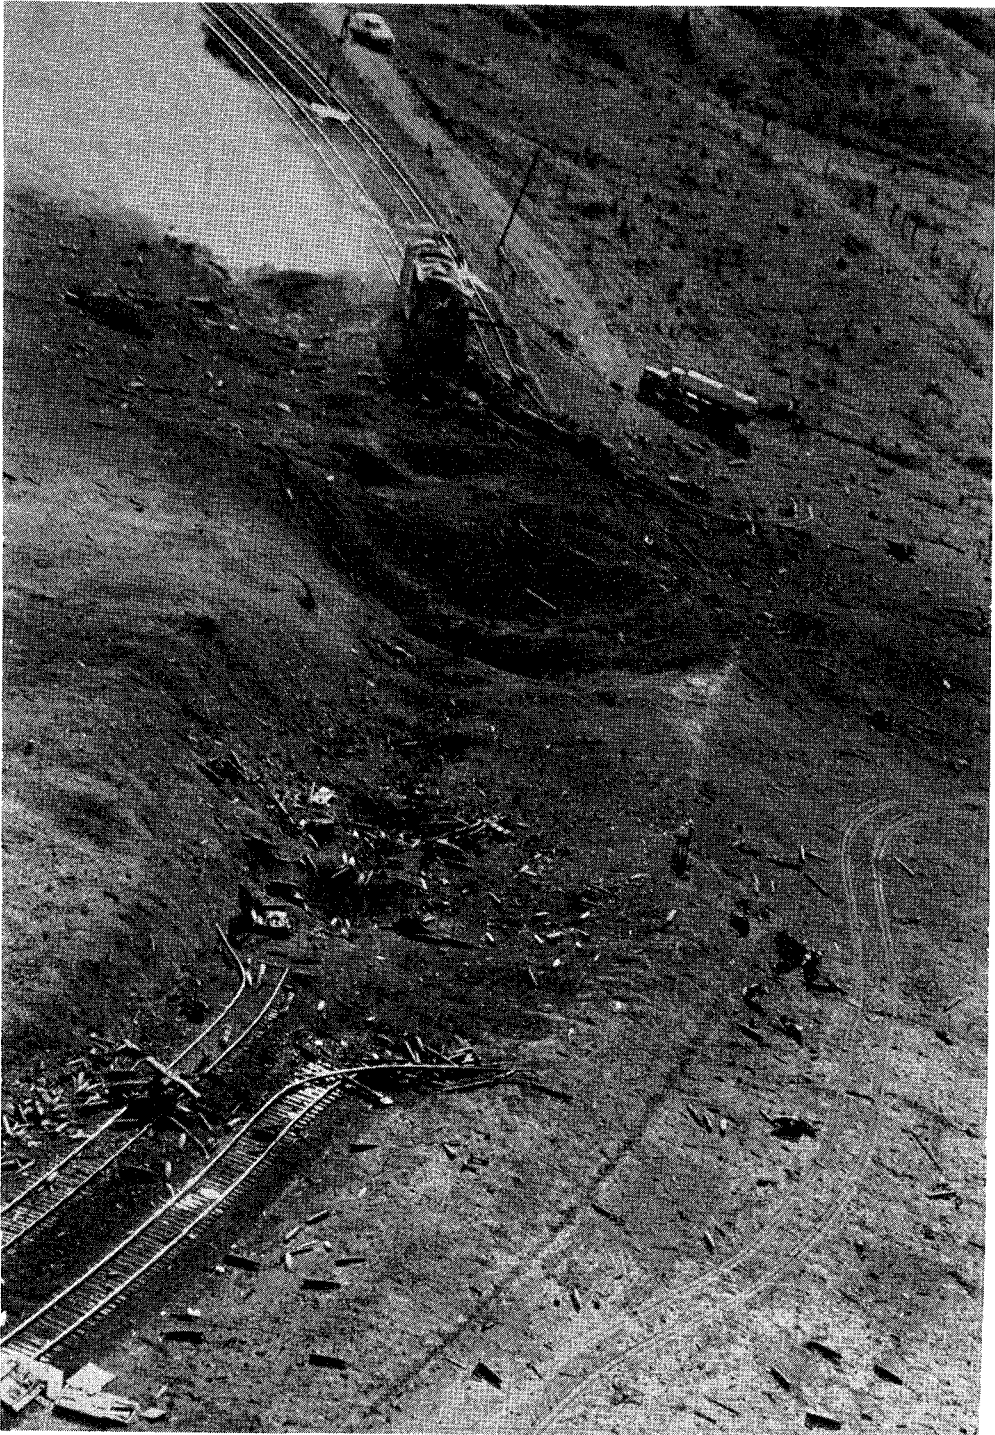
Figure 1. Main Crater Area.

As Car 98 passed MP 1048.4, a low-order explosion of one of the bombs that had been expelled from Car 38 produced a small crater and other damage. The train then separated between Car 35, the lead munitions car, and Car 34, a covered hopper car of starch (CCLX 80009). The force of the explosion blew starch from this car and debris from other cars onto the railroad right-of-way. Explosions of varying intensity continued until 1:15 a.m. on May 25, 1973.

The cars which followed the last car of bombs, containing zinc ash, clays, fiberboard, water heaters, auto tires, and asbestos, were severely damaged, and most of their cargoes spilled onto the right-of-way. The locomotives stopped at MP 1046.7; the caboose stopped at MP 1047.8. (See Figures 1 and 2.)

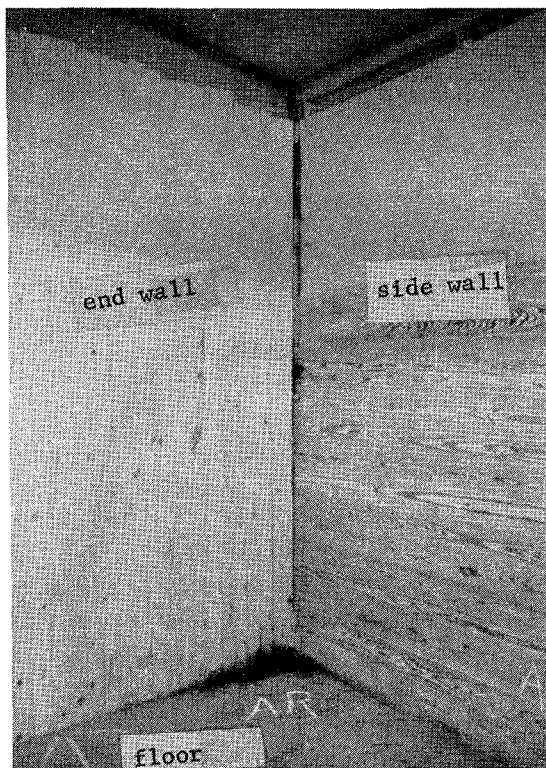
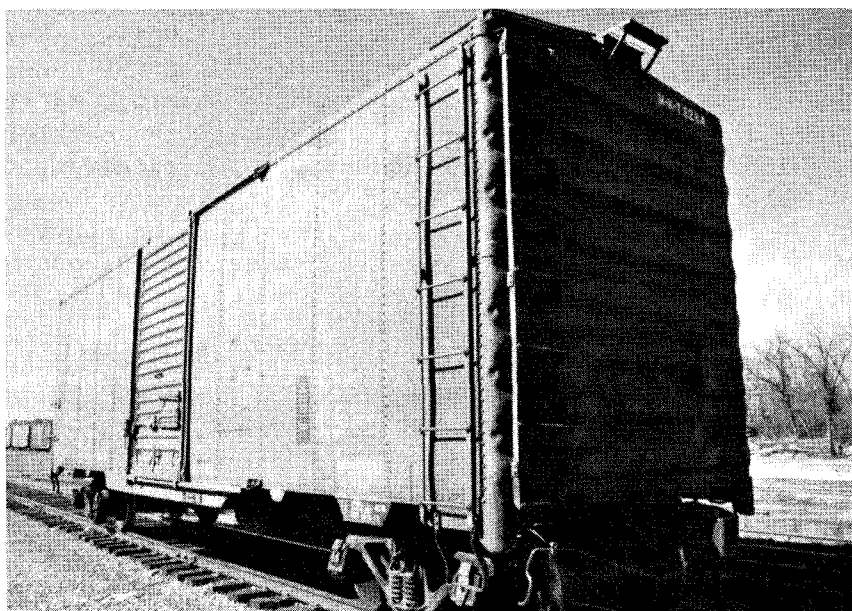
Figure 3. Interior and exterior views of a car similar in design to Car 38.

The cars -- Cars 35 through 46 were railroad-owned, general-purpose boxcars. Car 38 was built in 1950 by the American Car and Foundry Company for the MKT Railroad. The car was not equipped with spark shields to prevent sparks from the brakeshoes from contacting the car floor. It was equipped with friction bearings. Nineteen lining boards were replaced in its interior in 1970. (See Figure 3.)

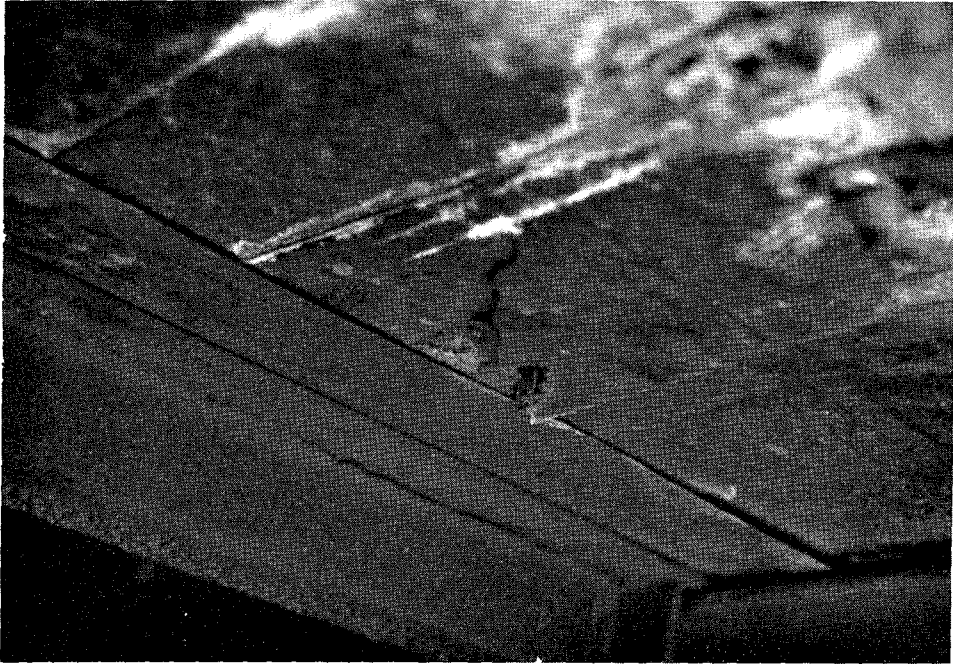
Figure 4. Broken floorboard of MKT 5394.

Another car, MKT 5394, which was not involved in this accident, was taken out of the train at Waco, Texas, for repairs. The car and its lading of bombs were examined at El Paso after the accident. Bracing in the car had shifted and was loose at one end wall, but the pallets were intact. Some of the plastic nose plugs were missing from bombs, and an exterior examination of the car disclosed a broken floor. (See Figure 4.)

Further examination of the load after the car had been returned to McAlester showed that the blocking and bracing were damaged and loosened. Some of the banding on the pallets was loosened and others had shifted. Several of the bombs had contacted one another.

The shifting of the lading in MKT 5394 resulted either from improper blocking or high-speed impacts. There was some indication that both had occurred. The maximum impact to be expected in normal rail transportation has never been defined. However, the Navy designed the blocking and bracing of munitions to withstand impacts of 8 mph. Either this standard was not met in MKT 5394, or the car was subjected to a potentially damaging impact which was not reported.

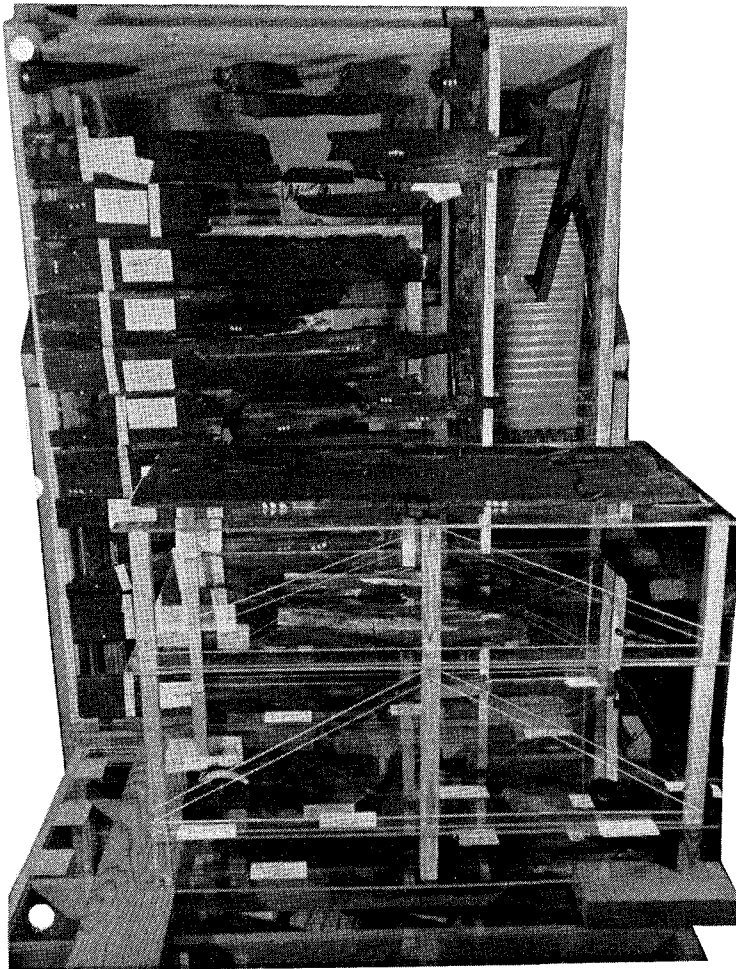
Figure 6. Interior view of reconstructed debris from the northwest corner of Car 38.

Car 38 -- All identifiable car debris recovered from MP 1052.6 and MP 1048 was assembled into a partial mockup which indicated that the car involved in the first explosion was Car 38; the events which occurred at MP 1052.6 were in the right forward corner of the car; the piece of board which was found at MP 1051 was from this corner of the car; and the explosion which occurred at MP 1048 was in the same location in Car 38. (See Figure 6.)

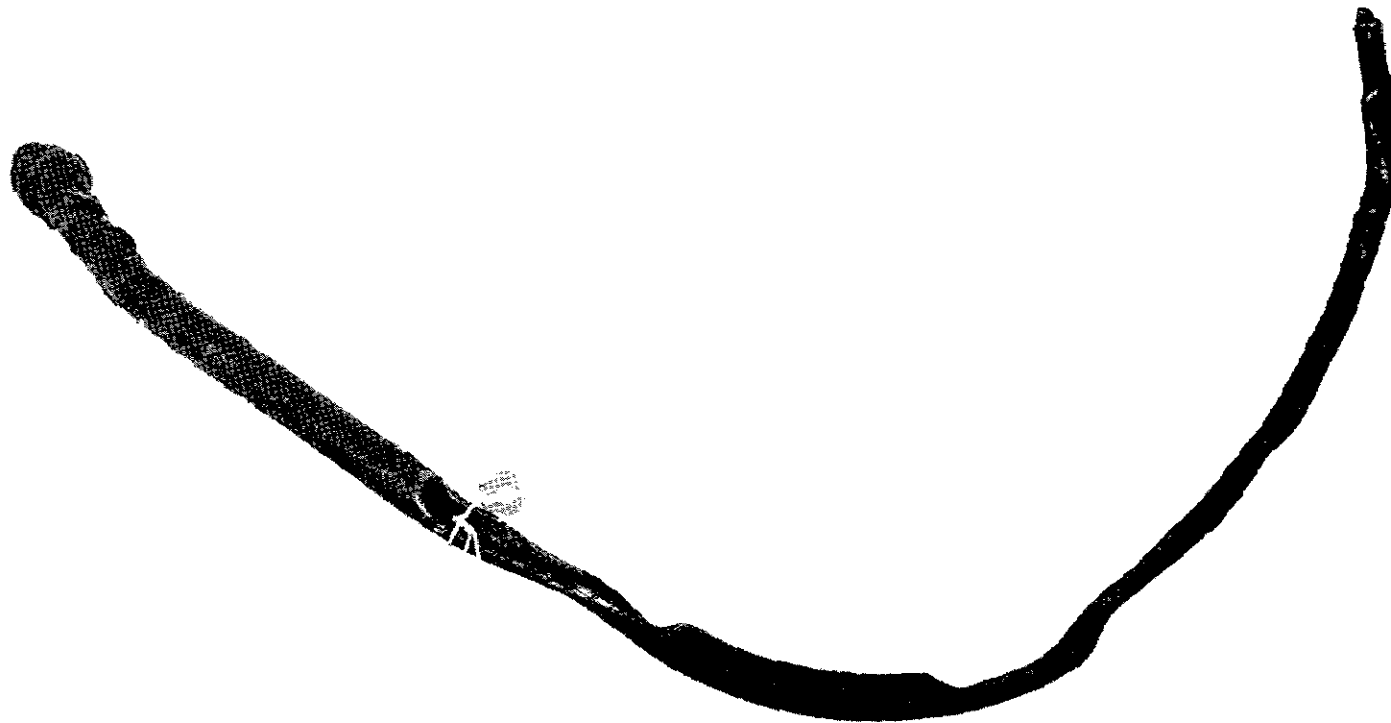
Figure 7. Charging Tube Found at MP 1052.6.

Charging Tube (See Figure 7).

- . Crystals of TNT were found on the outside of the tube, especially in the collapsed portions of the tube. These crystals contained unreacted aluminum particles.
- . "Hot melt" coating was found on the outside surface, some of which appeared to have been affected by heat. One small piece of charred wood was embedded in the coating.
- . The collapsed portions of the tube appeared to have been heated above the melting point of the "hot melt" in several locations.
- . The tube was twisted along its longitudinal axis, but retained an approximation of its original contour.
- . The tube had been pulled out of its center and end connections.

The condition of the charging tube found at MP 1052.6 is significant. If an internal reaction spewed flames out of the nose or tail fuse liner over a 25-minute period, it would probably have overheated or consumed the charging tube in that bomb. The tube found at MP 1052.6 was not significantly overheated; in fact the conditions of the hot melt and the crystals indicate that the charging tube remained relatively cool during the explosion. The crystals on the tube indicated an exposure to vaporized tritonal, which would occur if the tritonal was overheated rather than reacting. The similarity between the appearance of the recovered tube and a tube recovered during the slow heating tests suggests that external overheating was more likely.

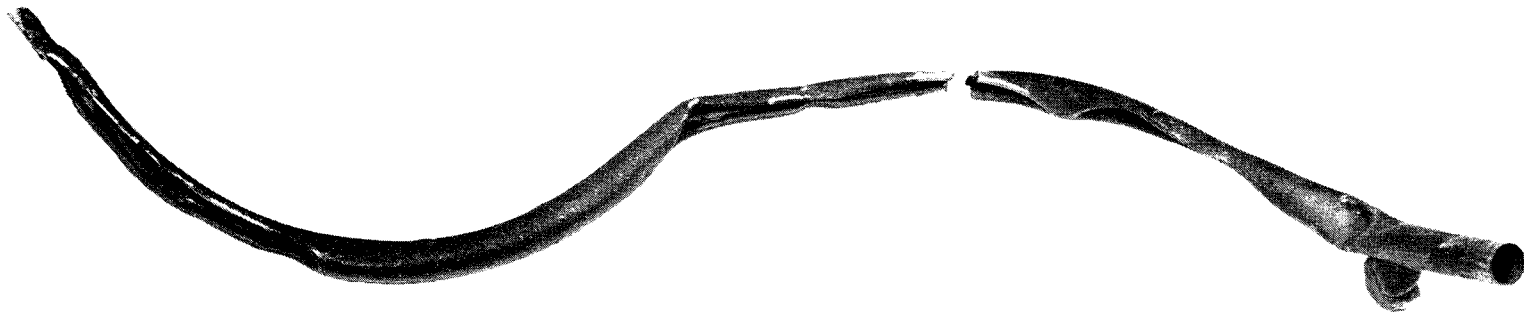
Figure 8. Charging Tubes Found at MP 1048.

Examination and tests disclosed that two of the fragments were similar in numerous details, and that external residues and appearances of both tubes were similar, except for the mass of "hot melt" at the straight end of the charging tube found in MP 1052.6.

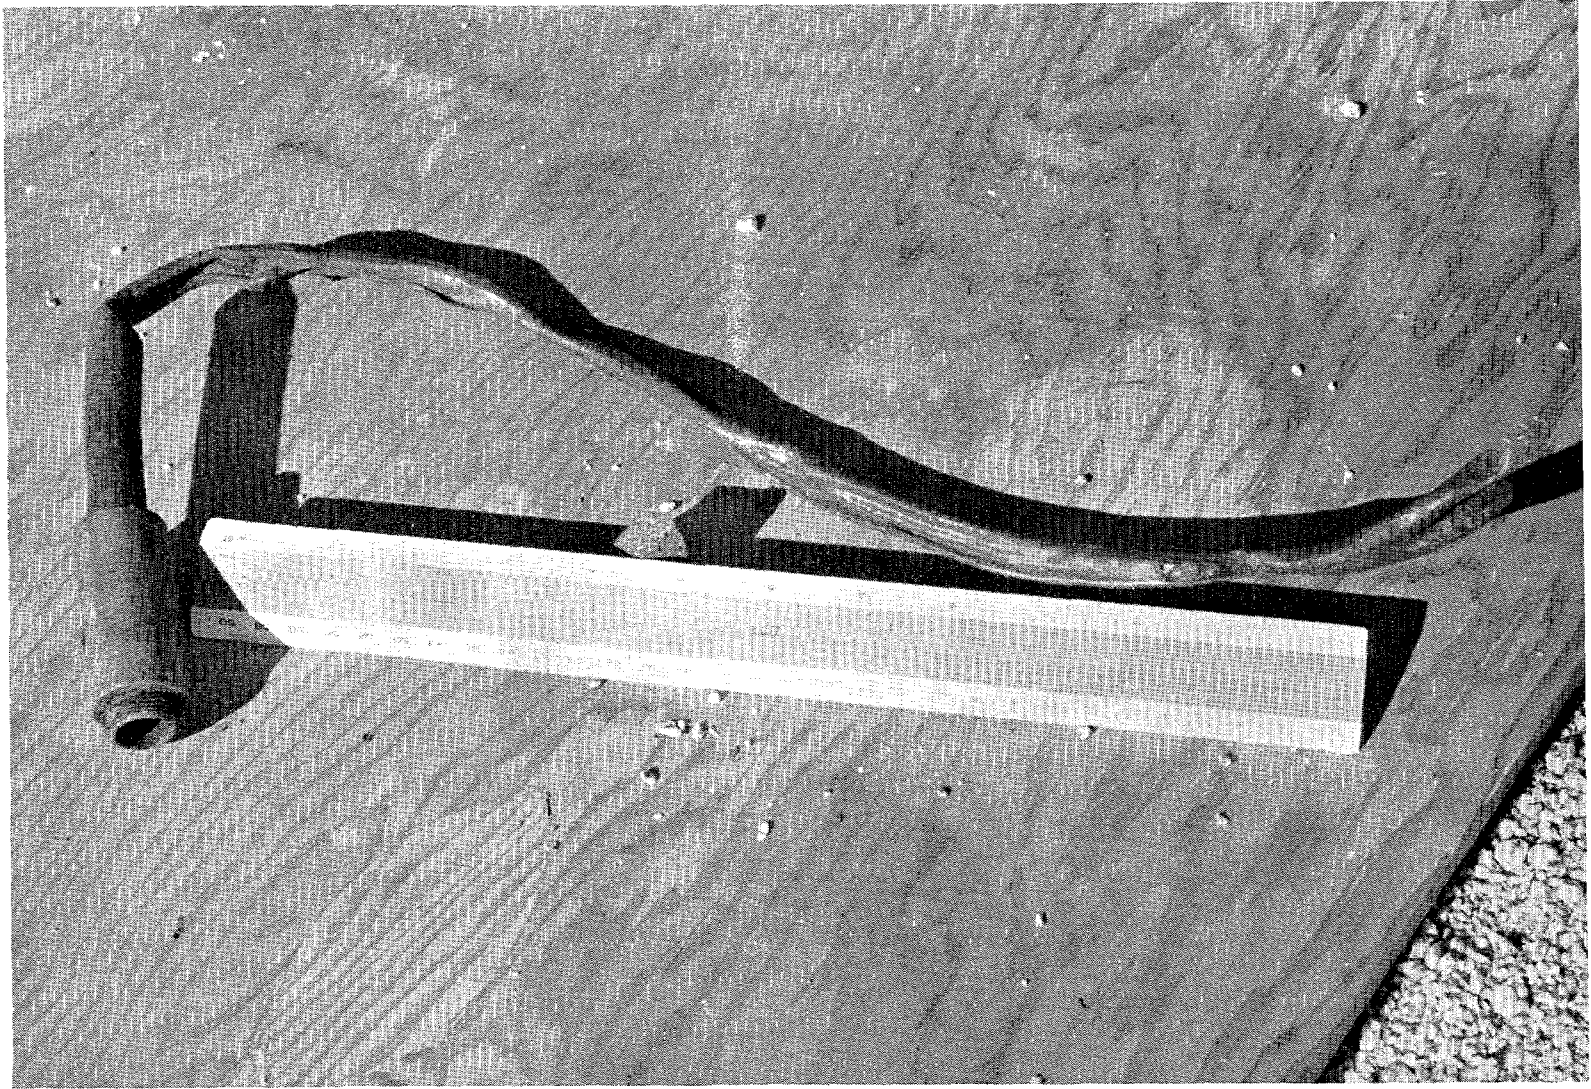
Figure 9. Debris Recovered from Externally Heated Test Bomb.

These tests resulted in the bursting of some of the test bombs, intensification of fire and smoke, and detonation of bombs. Resultant debris consisting of collapsed sections, hot melt, and crystal residues was similar to that found at the accident area. (See Figure 9.)

The conditions of the charging tubes found at MP 1052.6 and those from the Navy's slow heating tests indicate that the bombs involved experienced similar heat exposures. Crushing and crumpling patterns were found on both tubes, and crystalline TNT was discovered on the exteriors of both.

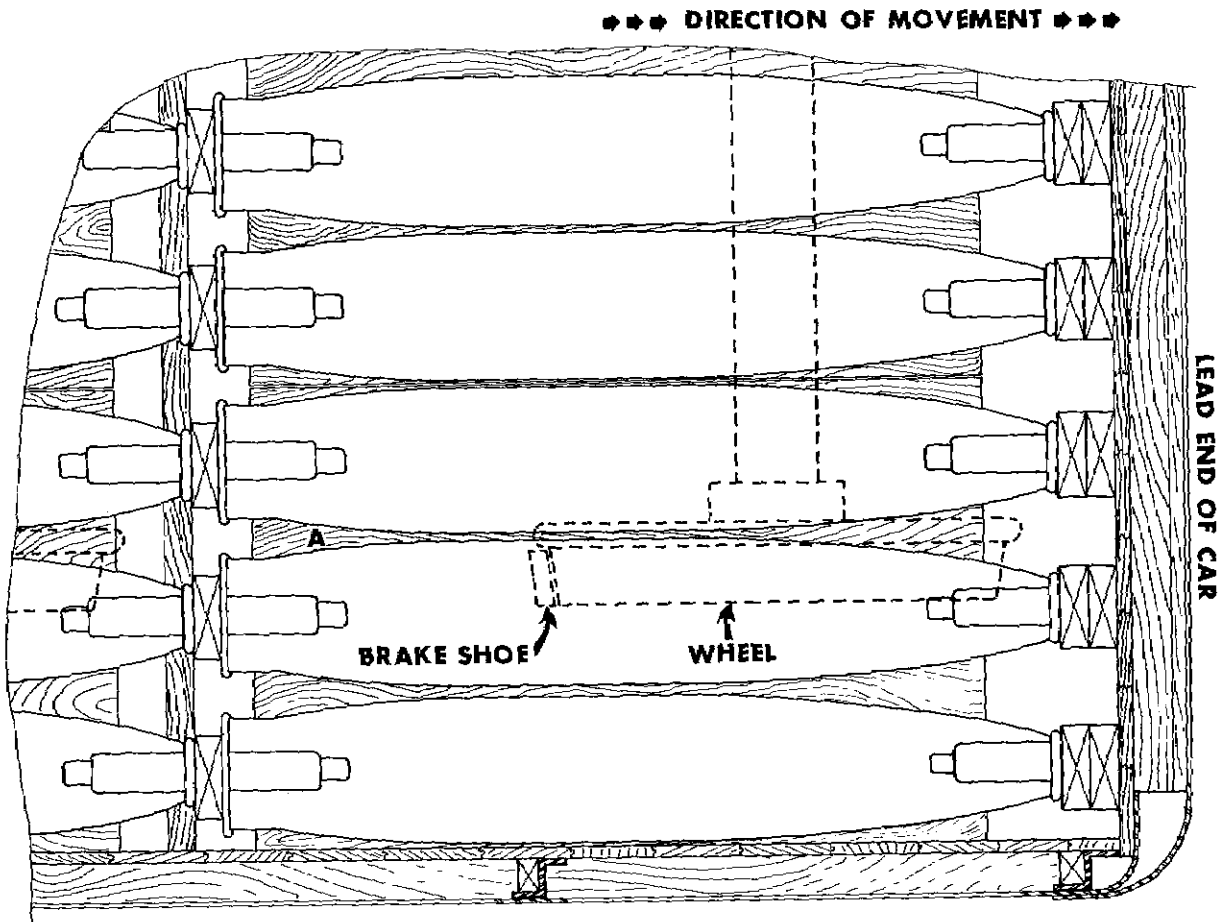
Figure 10.
CROSS SECTION PLAN VIEW AT NORTH WEST CORNER OF CAR
BOTTOM ROW OF MK 82 MOD I G.P. BOMBS ON PALLET SHOWN
AS LOADED ON BOX CAR MKT 6259

The location of the 25-minute char on the floorboard was in the vicinity of the tail of the center, bottom bomb on the pallet in the right forward corner of Car 38 (see Figure 10), and under and slightly ahead of the nose of the bottom, center bomb on the adjacent pallet. If either of these bombs had experienced an internal chemical reaction, the hot reaction products would have had to escape from the nose or tail fuse liner area of one of the bombs to have burned the floor in this area. A flame of this type would be accompanied by dense black smoke. No such smoke was observed until the train was well beyond MP 1052.6.

An examination of the charring on the recovered floorboards, on the pallet components, and on the other recovered fragments disclosed that the fire was most intense at floor level in the body bolster area and burned toward the end wall. In addition, the condition of the pallet parts indicates that the center bomb on the bottom row of the pallet in the right forward corner of the car split open at MP 1052.6. The Safety Board believes that the initial fire was localized between the floor and the bottom surface of the pallet in the vicinity of the center bomb. (See Figure 10.)

The debris pattern indicated that the center bomb in the bottom row of the corner pallet in Car 38 burst at MP 1052.6. It was probably exposed to the fire for the longest time. Therefore, the fire must have been most intense at, or near, the floor of the car in the area of the rear pallet chocks and the car body bolster. The location was almost directly above the leading wheel of the lead truck. The rear of the pallet was above the area where sparks from the brakeshoes could impinge the sodium-nitrate impregnated floor. While none of the floorboards recovered showed conclusive evidence of burning through from the bottom of the floor, the location of the bomb which first reacted, the location of the impingement area for brakeshoe sparks, and the location of the most extensively charred car floor and pallet all coincide.
