RAILROAD ACCIDENT REPORT

**COLLISION OF READING COMPANY
COMMUTER TRAIN AND
TRACTOR-SEMITRAILER**

NEAR YARDLEY, PENNSYLVANIA

REPORT NUMBER: NTSB-RAR-76-4

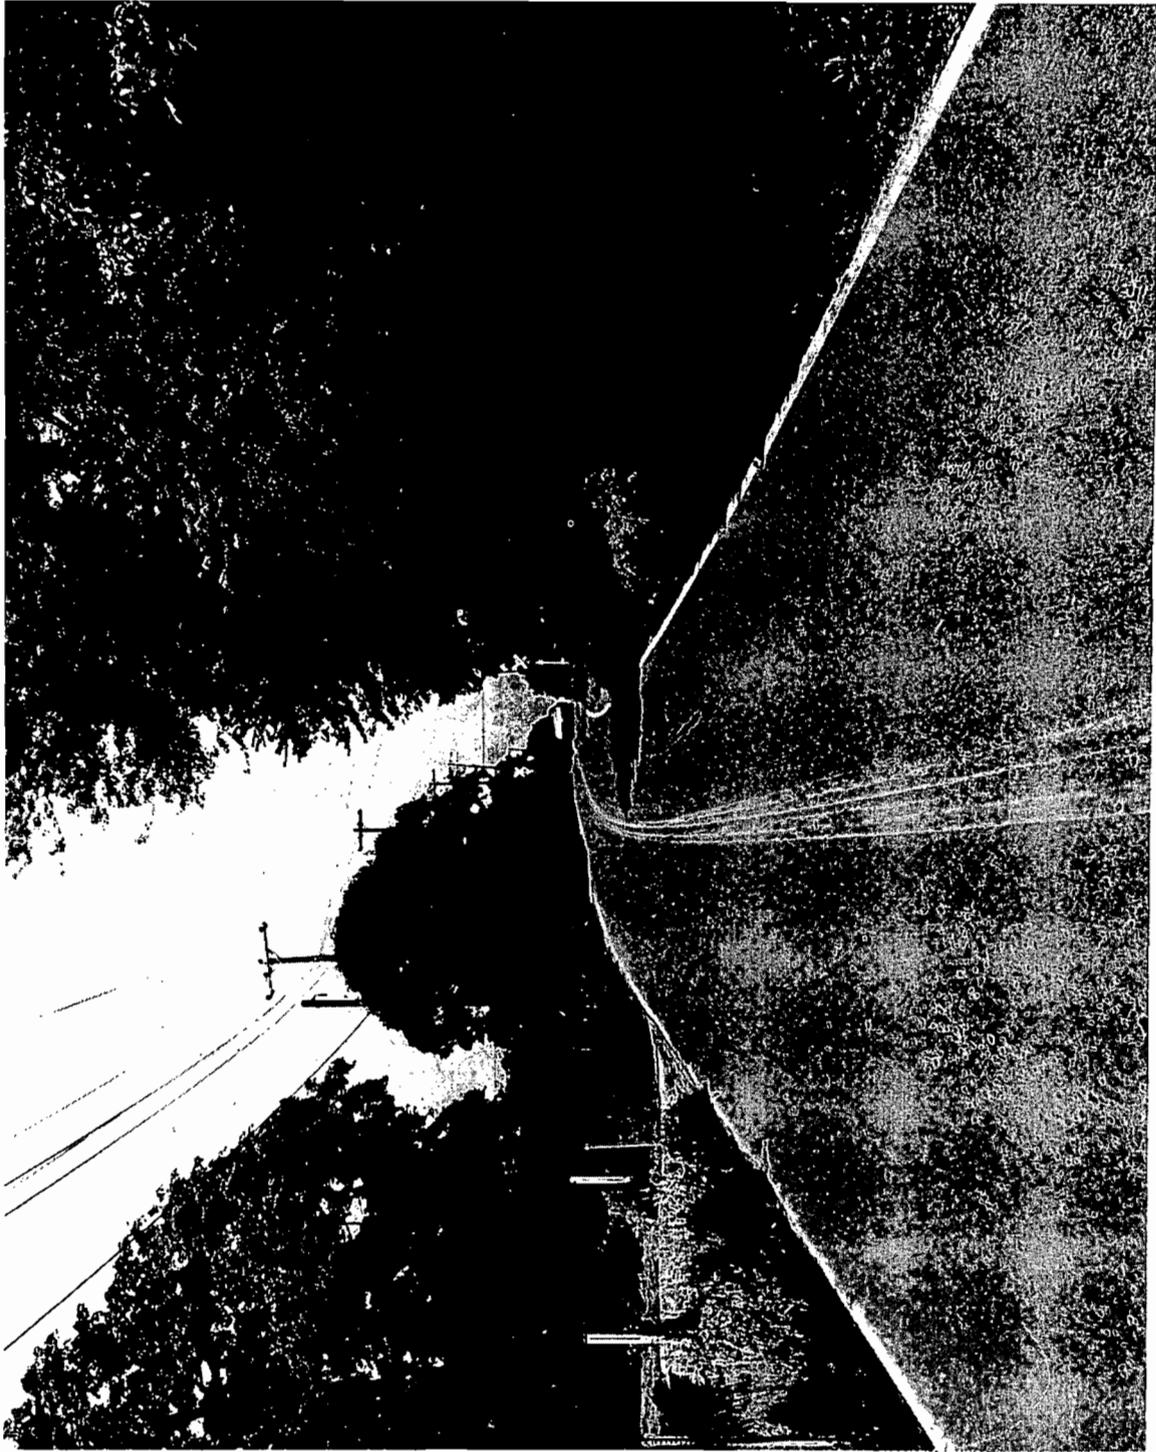
The automatic railroad flasher signal and crossbuck, located on the left side of Stony Hill Road, are visible to motorists approaching from the south about 500 feet from the crossing. The automatic flasher and crossbuck, located on the right side of the crossing, are visible from the south about 300 feet from the crossing.

Figure 2. Stony Hill grade crossing from direction of truck.

As the driver approached the crossing from the south, the driver's view east along the tracks was obscured by trees, bushes, a hedge, and a residence up to a point 110 feet south of the nearest rail. For the next 80 feet, his view east was obscured intermittently by bushes and trees. He did not have an unobstructed view to the east until 30 feet south of the nearest rail. At that point, the truckdriver could have seen about 250 feet east along the track. His view to the west was obstructed almost totally until he was about 25 feet south of the nearest rail.

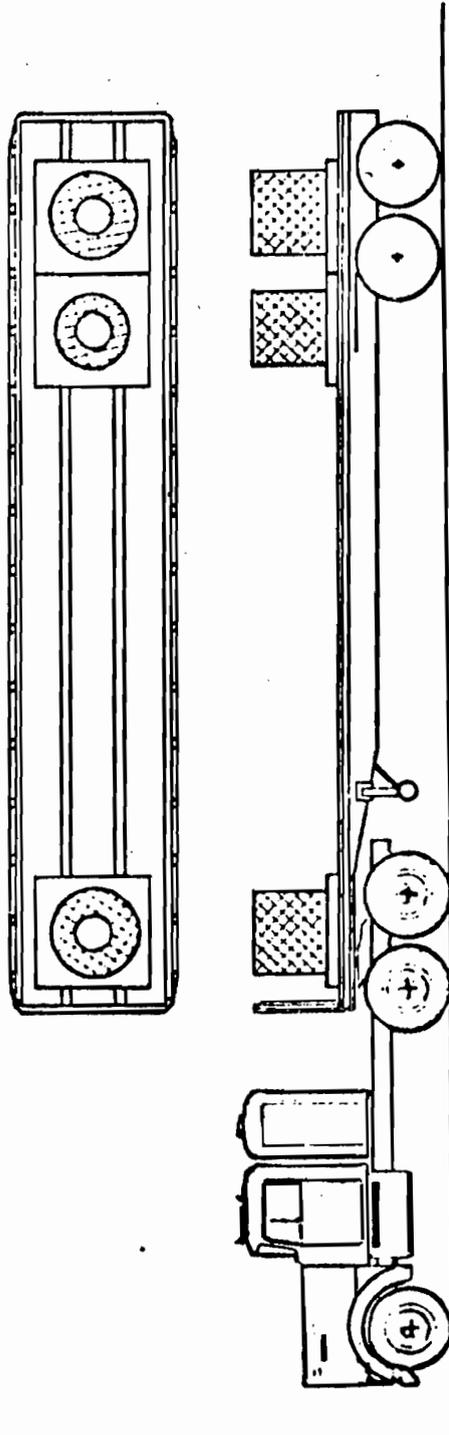
The driver secured the palletized coils individually to the trailer bed with chains and chain binders and covered the coils with tarpaulins, which were secured. (See Figure 3.) Upon departure from U.S. Steel at 10:50 p.m., June 5, 1975, the load was inspected at the gate by company personnel for compliance with U.S. Steel loading requirements.

Figure 3. Plan view and profile of truck and cargo, representing typical loading method.

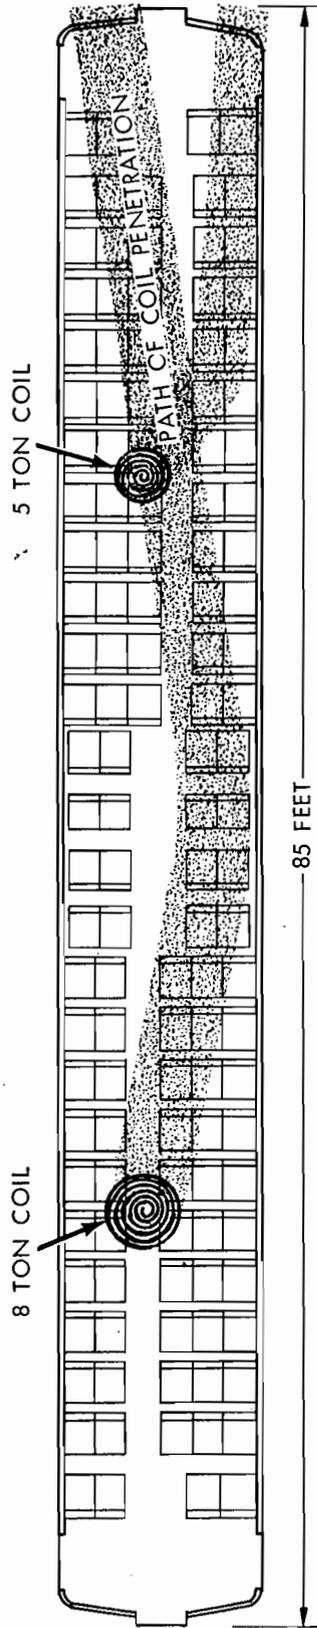
car floor, shearing the post at its base. The coil entered the front of the car, passed through the control vestibule, dislodged the front passenger compartment bulkhead, and entered the passenger compartment, damaging seats along the front left side of the car. Across the aisle, it dislodged seats and deformed the car wall along the front right side of the car. It struck the center vestibule partition, collapsed it upon the trainman and passenger, and continued into the rear passenger compartment, where it came to rest in the 22nd row of seats, 66 feet from the front of the car.

The 5-ton coil entered the front of the car just to the right of the first coil's point of entry. The second coil dislodged seats along the right front side of the car, crossed the aisle, and came to rest in the ninth row of seats, about 22 feet from the front of the car. (See Figures 4, 5, and 6.)

Figure 4. Plan view - Reading Company commuter car and coil penetration.

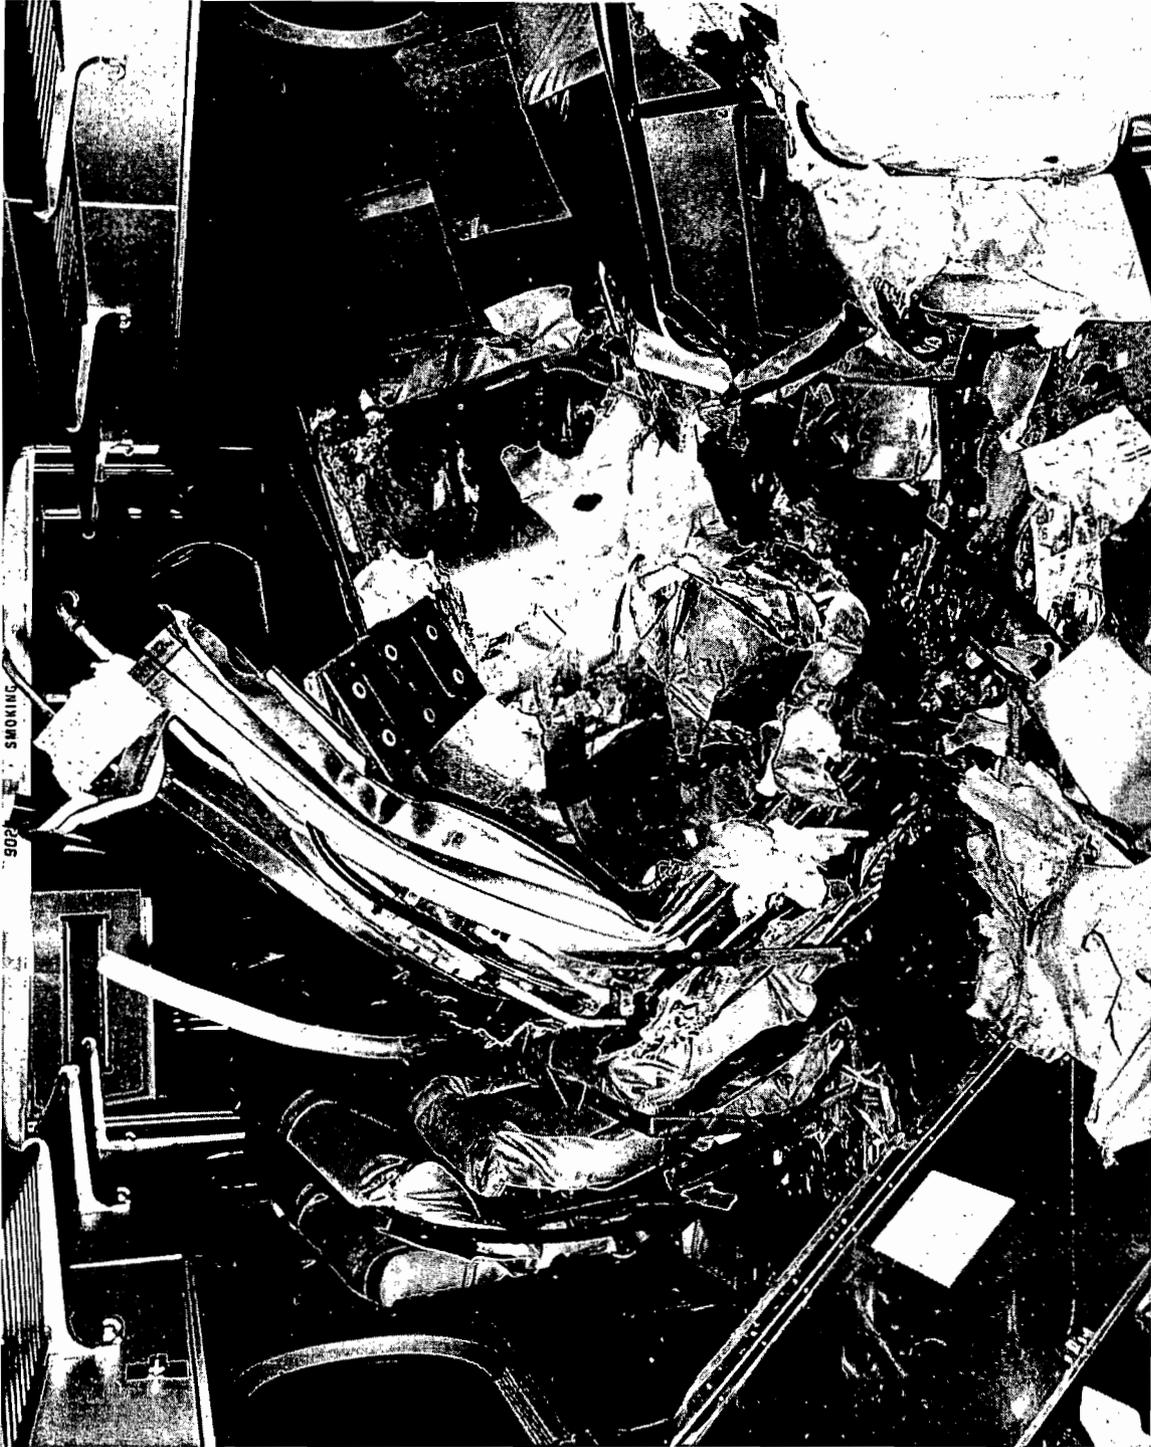
Figure 5. Interior of railcar 9024 after 8-ton coil penetration.

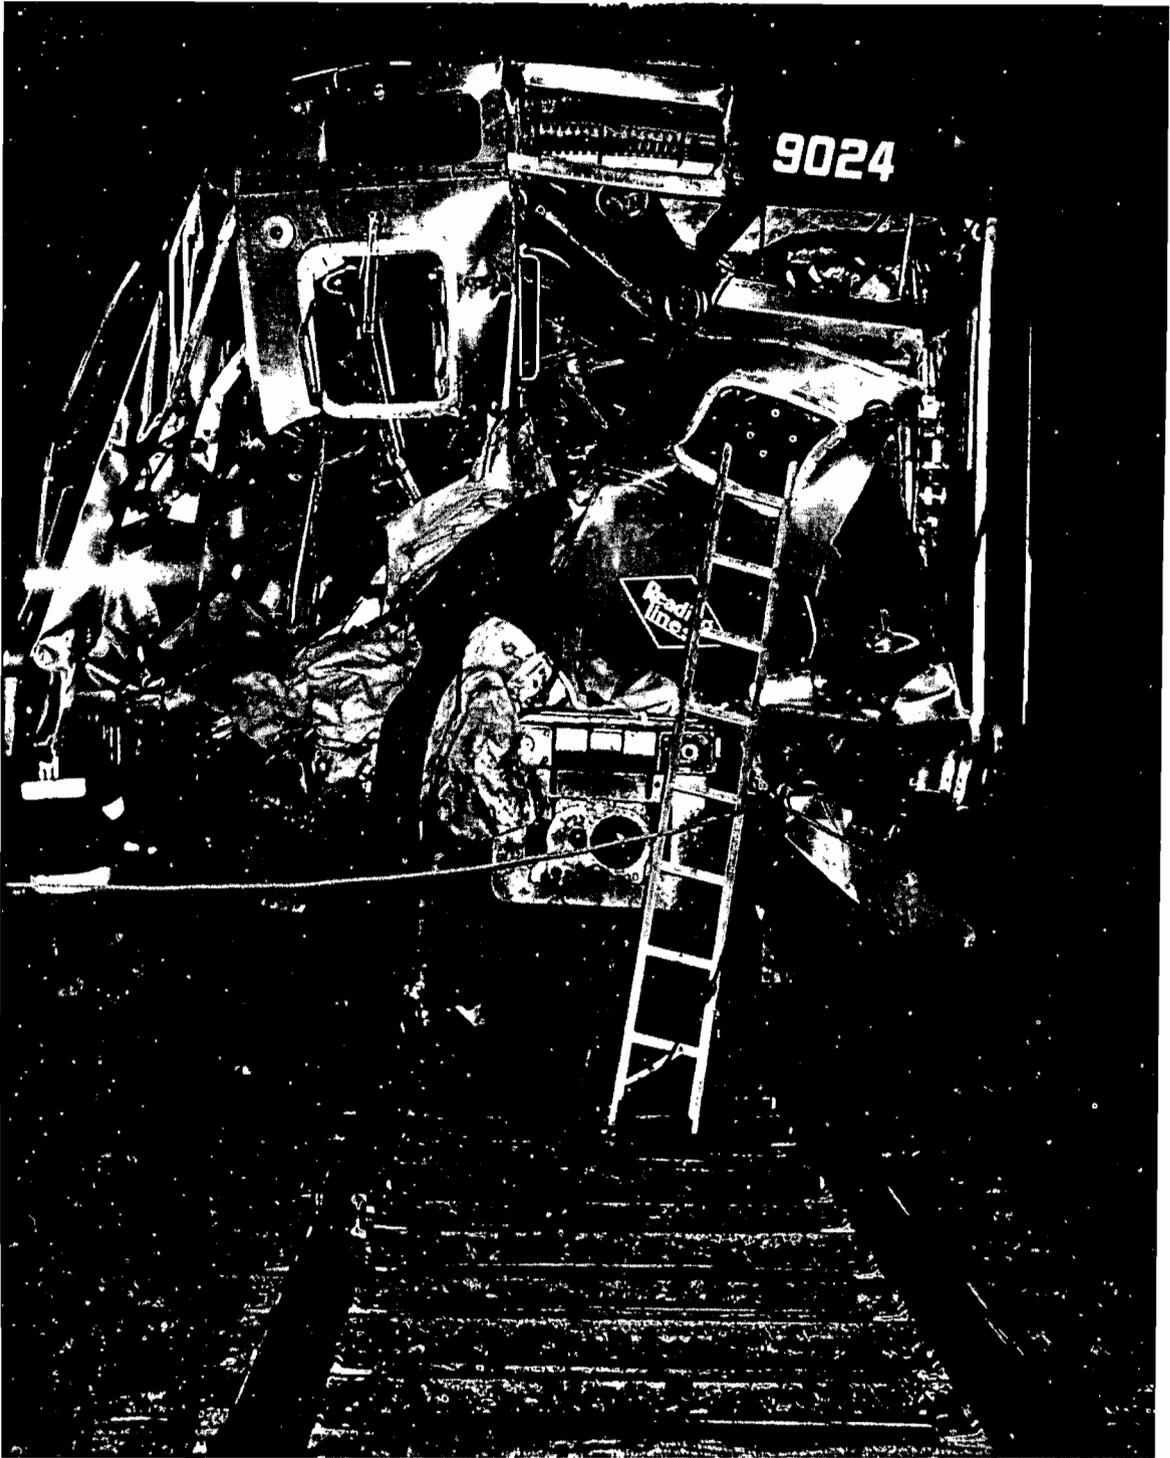
The Train -- The 8-ton coil of steel on the rear of the trailer struck the left front collision post of the lead car 38 inches above the

Figure 6. External view of 9024.

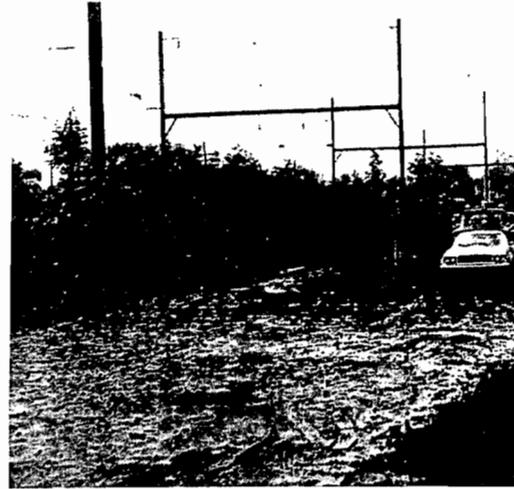
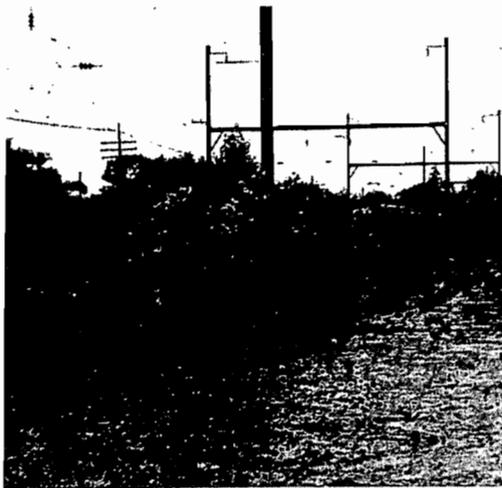
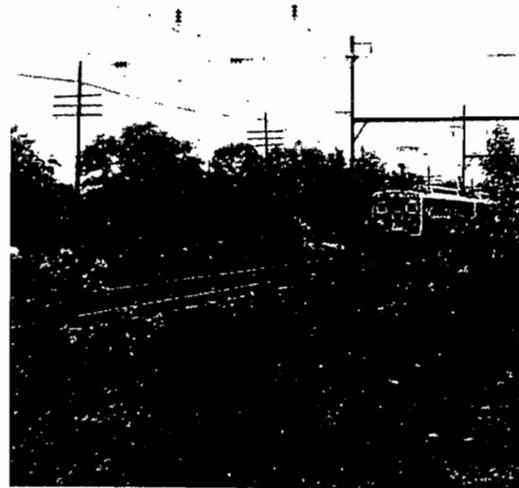
The train and the truck were moved to their preimpact positions. Investigators recorded visibility and sight distances. Photos then were taken at 1-second intervals from the truckdriver's position, assuming a 15-mph approach to the crossing. Photos also were taken at 1-second intervals from the engineer's position, assuming a 60-mph approach of the train. (See Figure 8.)

Figure 8. Driver's view of approaching train at selected intervals.

The driver had used this route frequently. Although he may have had an illusion of good track visibility to the east, the vegetation along the right-of-way intermittently obscured the driver's view until the truck was near the track. The vehicle speeds, the darkness, and the adverse weather could have accounted for the driver's failure to see a train approaching from the east.
