**NATIONAL  
TRANSPORTATION  
SAFETY  
BOARD**

**RAILROAD ACCIDENT REPORT**

**DERAILMENT OF AMTRAK TRAIN ON  
LOUISVILLE AND NASHVILLE RAILROAD**

**REPORT NUMBER: NTSB-RAR-76-6**

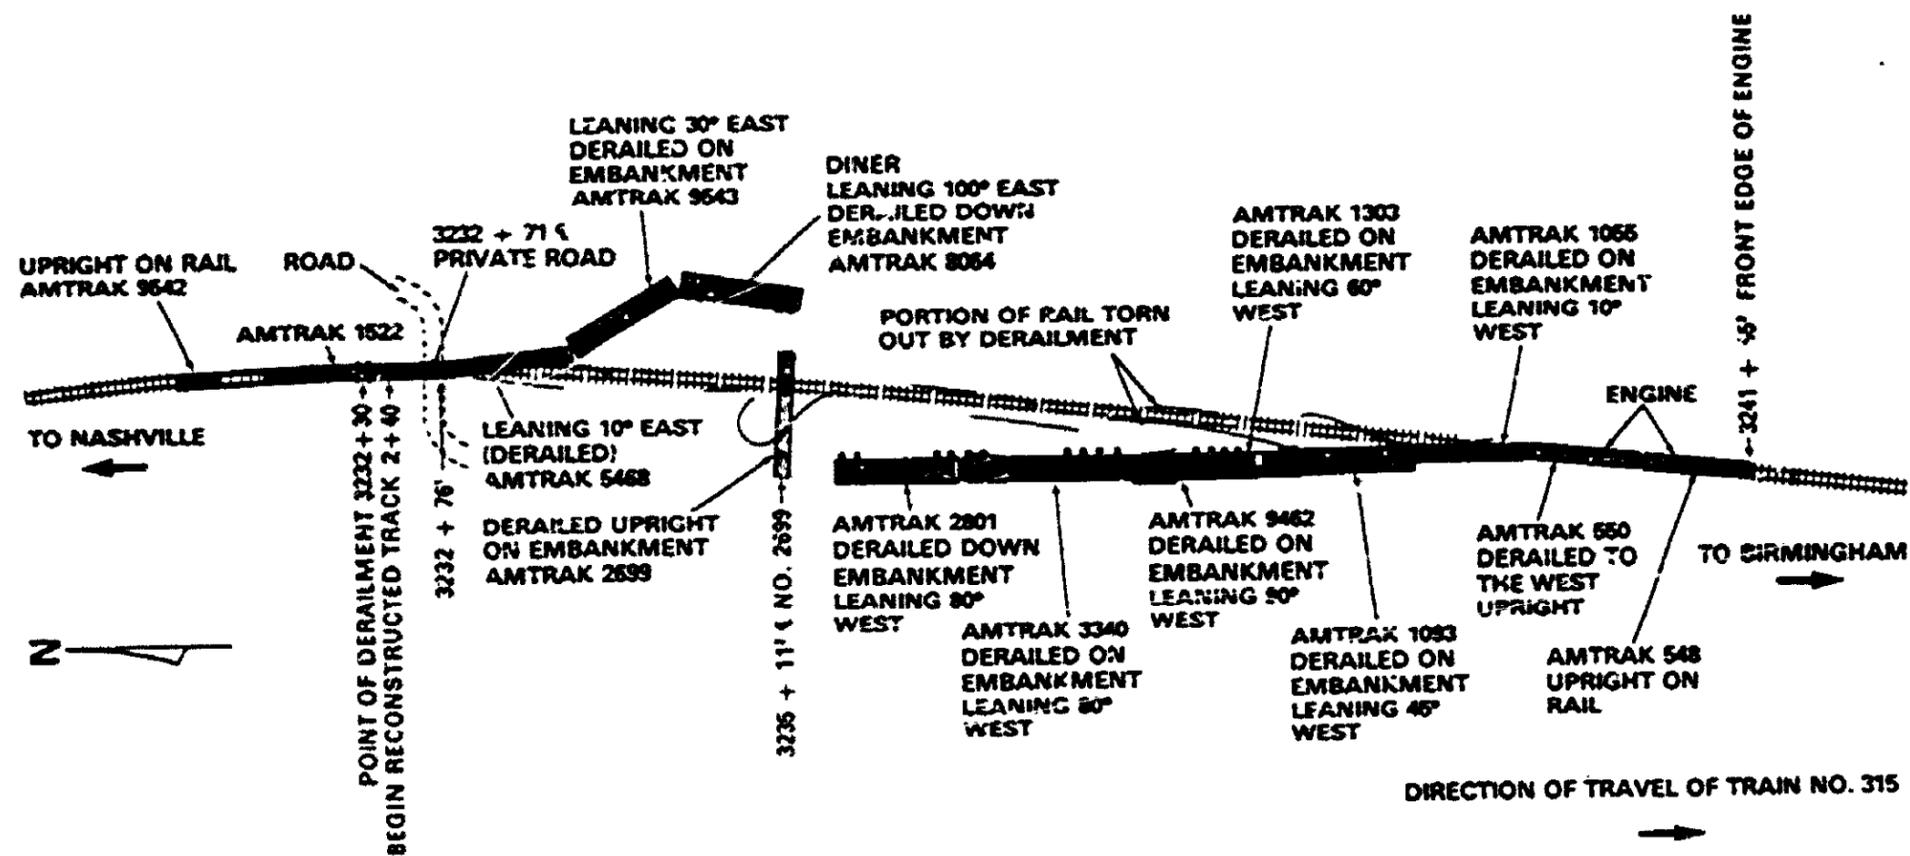
Train 315 derailed on a  $3^{\circ} 8'$  curve to the right at milepost BA 258.1, 258.1 miles from Louisville, Kentucky. (See Figure 3.) The speed limit through the curve is 60 mph for passenger trains. The grade in the vicinity of the accident site descends southward and varies from 0.2 to 0.5 percent. The track extends through a side-hill cut to a tangent fill at the south end of the curve. The fill continues for 540 feet, after which the track enters another cut and a  $3^{\circ} 7'$  curve to the right. The fill is from 35 to 40 feet high at its midpoint.

Figure 3. L & N Railroad Company M. P. B. A. 258.1 Frankewing, Tenn., derailment AMTRAK train No. 315, October 1, 1975, curvature 3° 8' R.

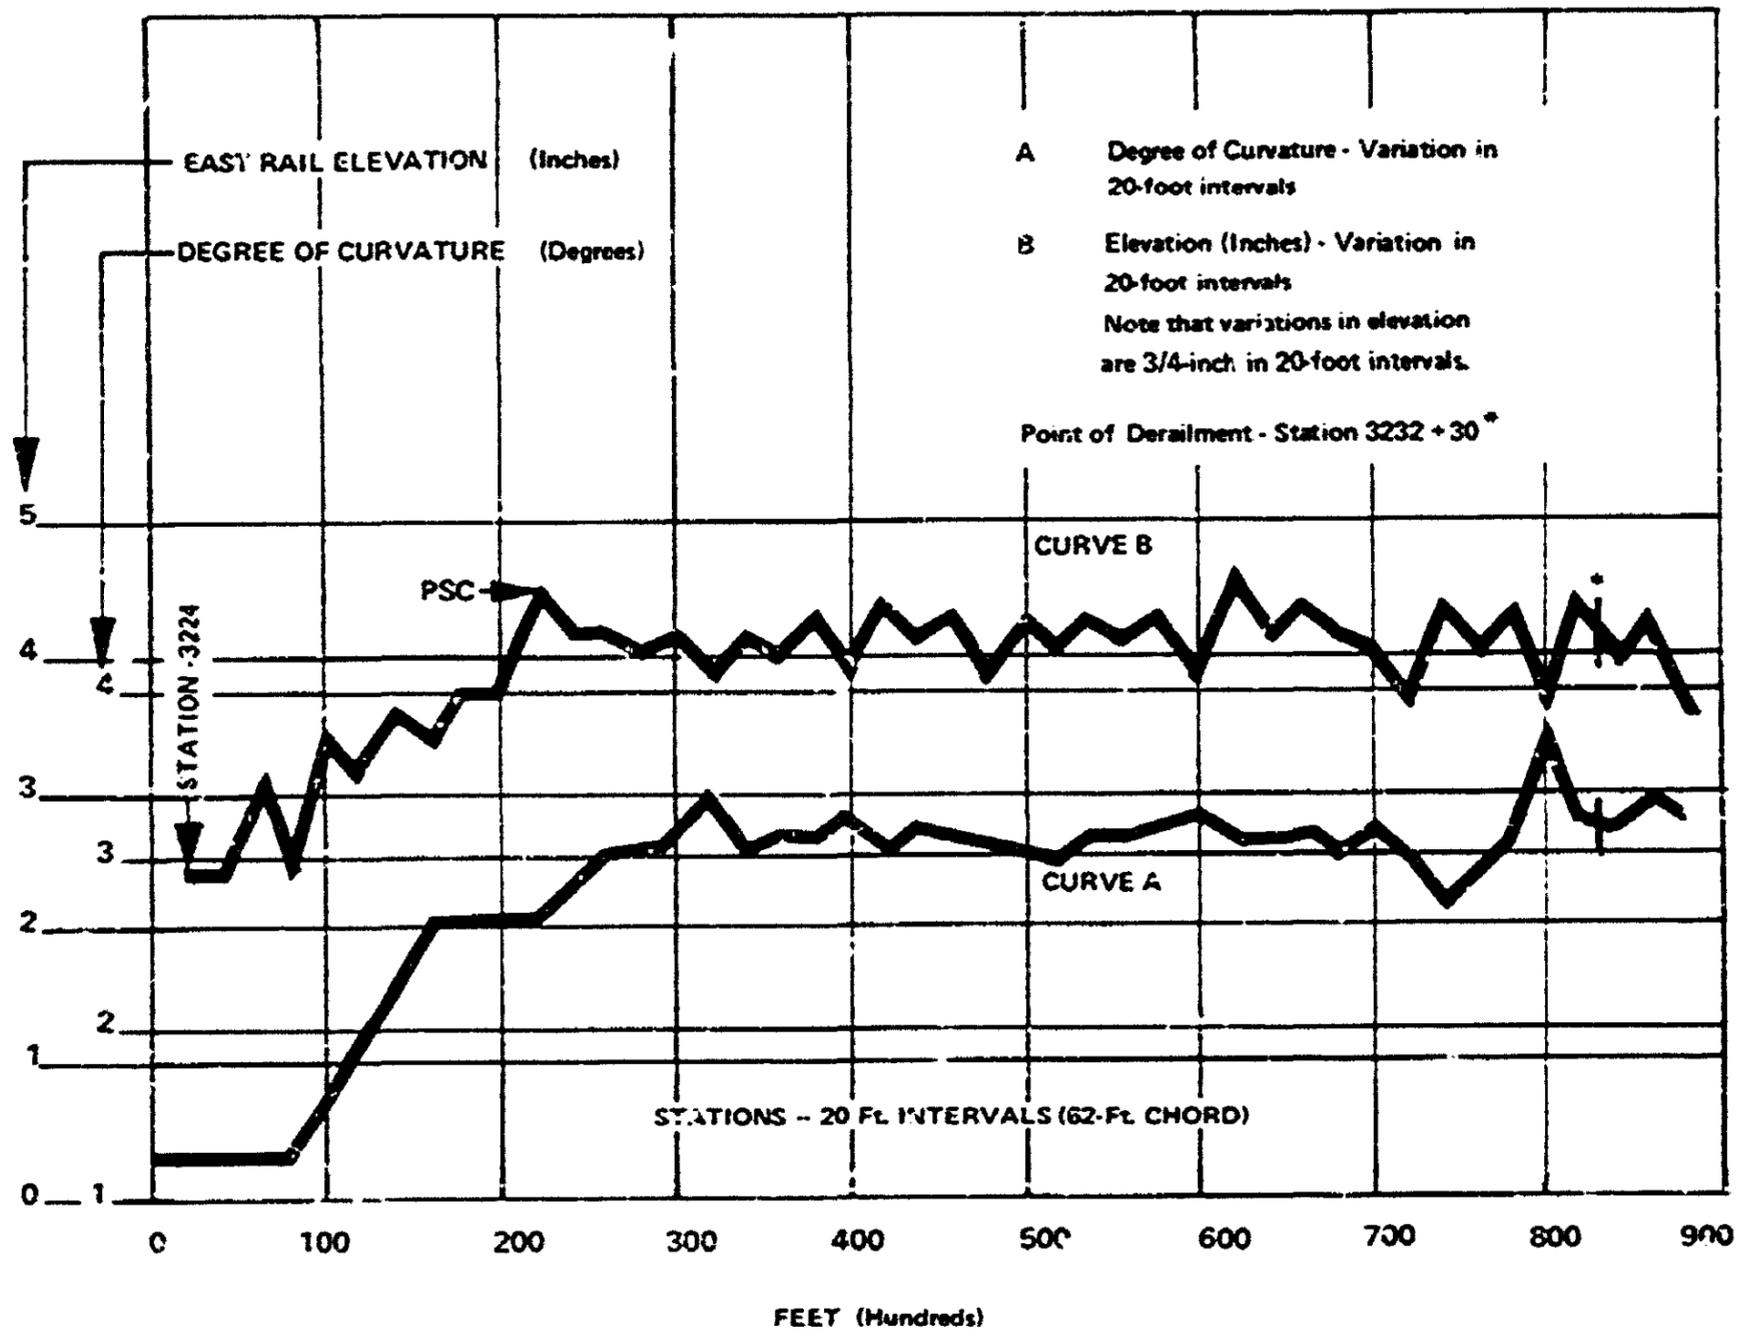
Figure 4. Approach to point of derailment from the north.

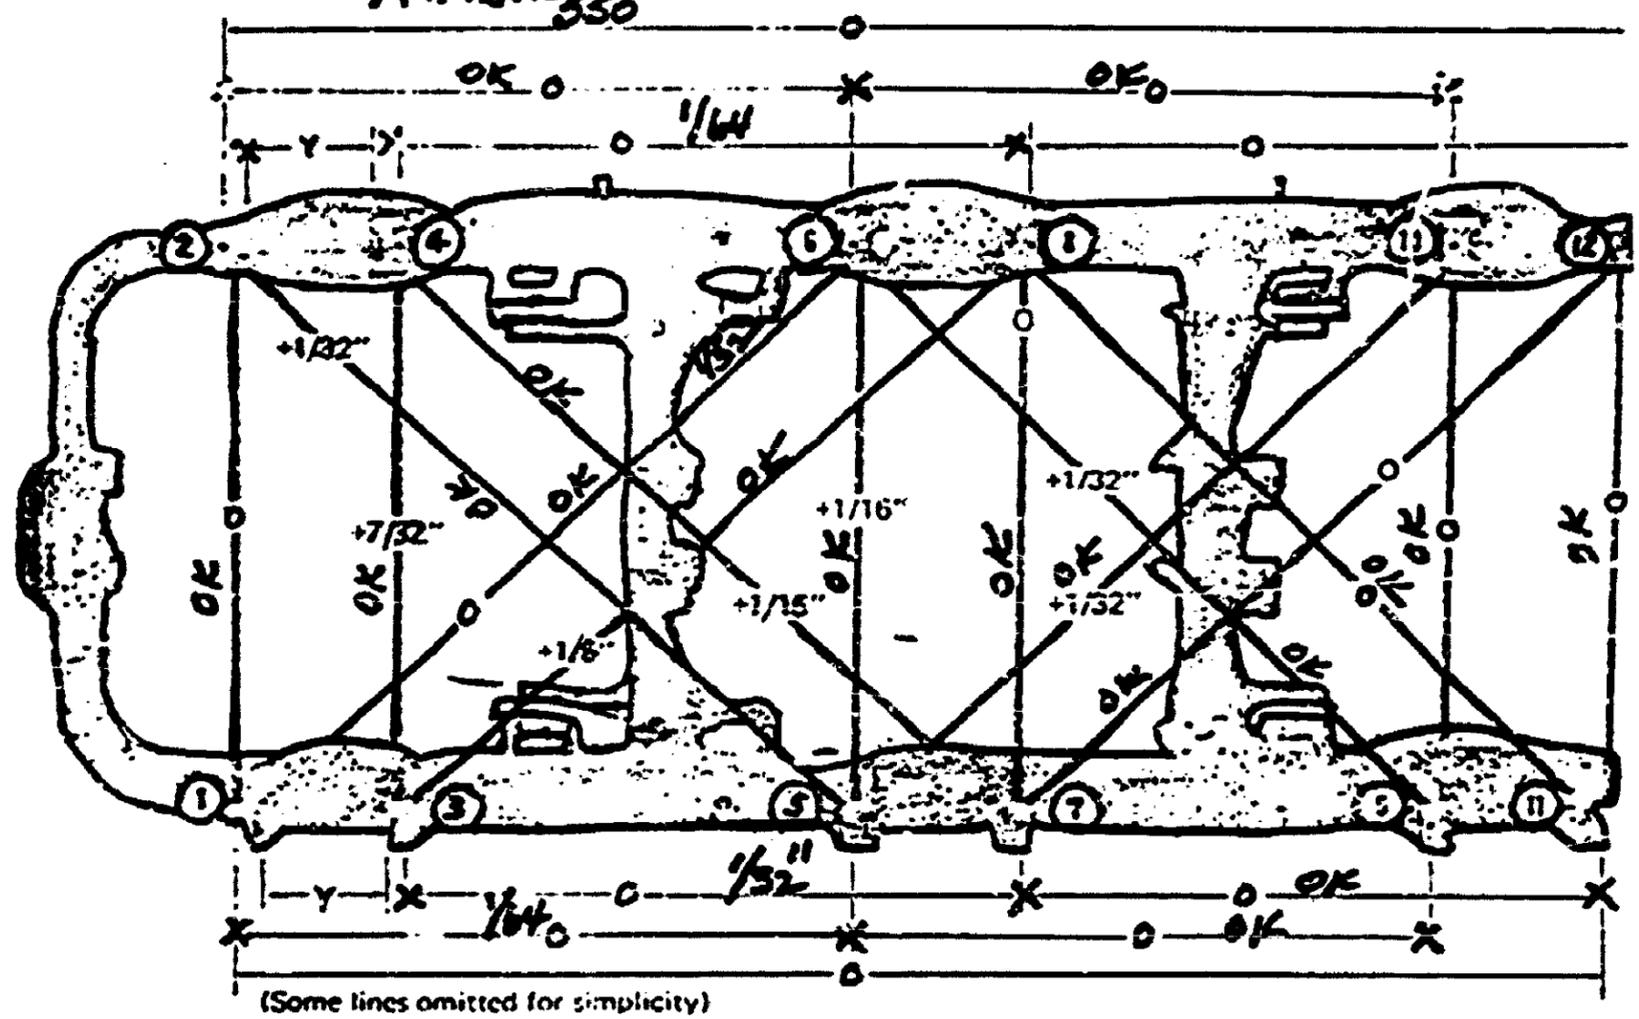
Truck measurements of locomotive 550.

Vertical snubber right side defective.

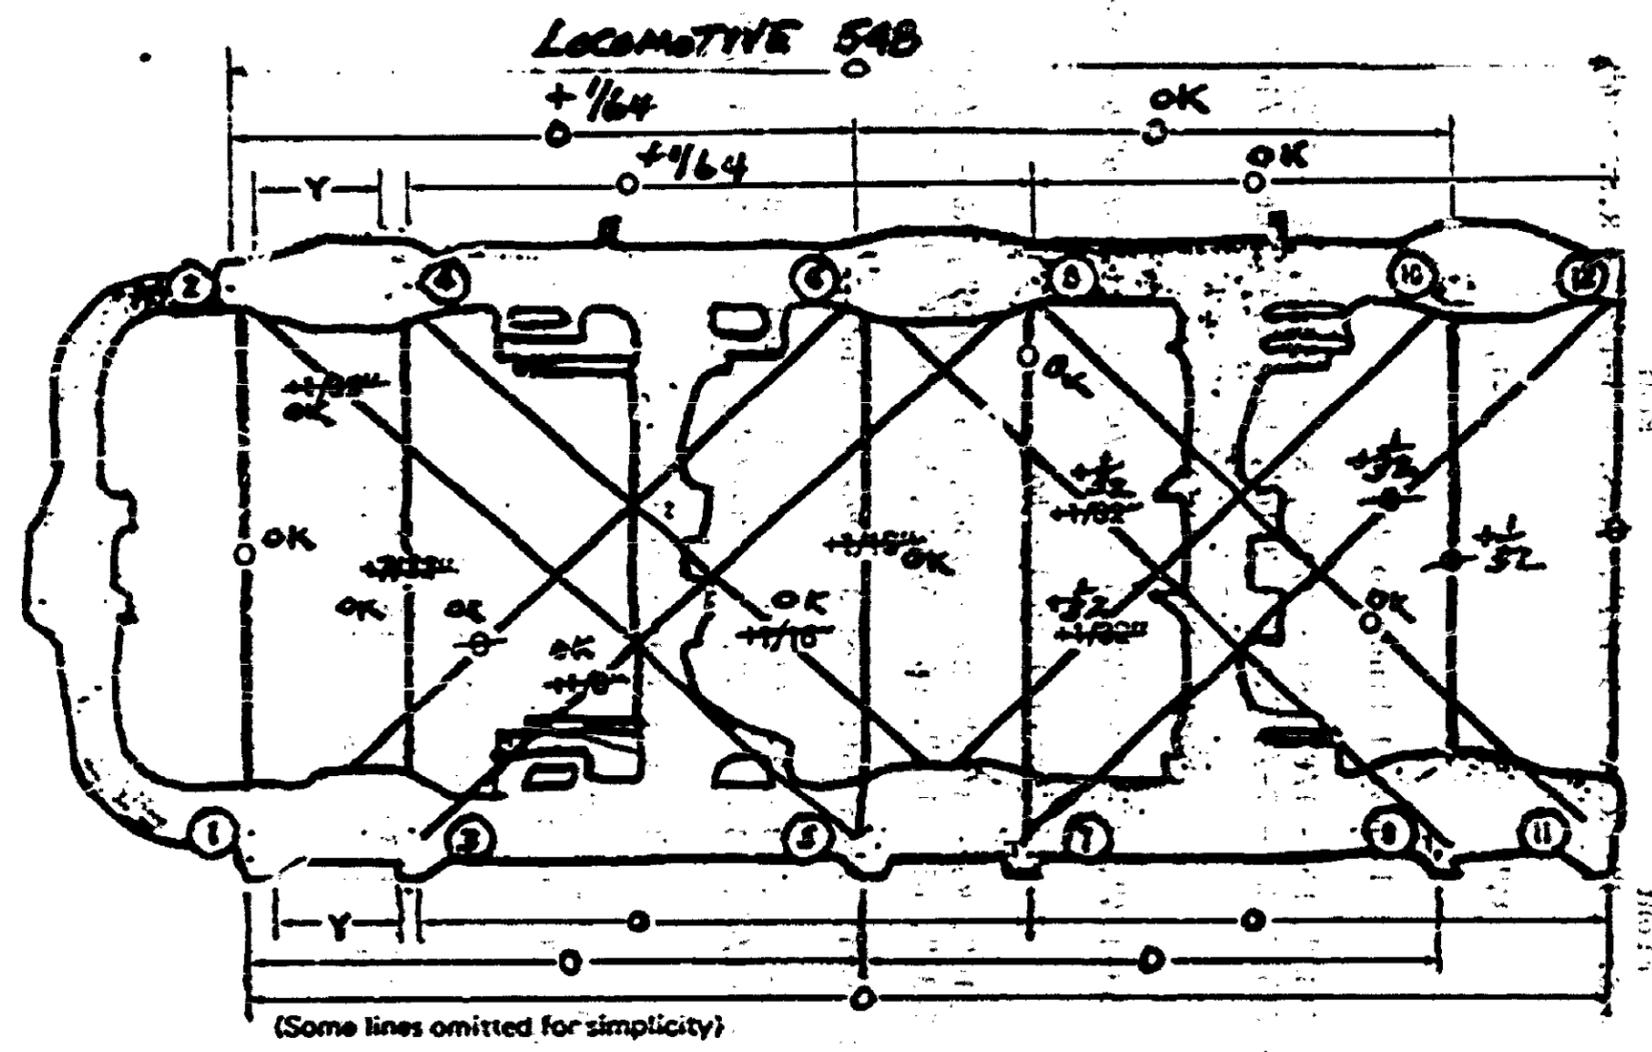
Truck measurements of locomotive 548.
