RAILROAD ACCIDENT REPORT

DERAILMENT OF AMTRAK TRAIN ON
LOUISVILLE AND NASHVILLE RAILROAD

NEW CASTLE, ALABAMA

REPORT NUMBER: NTSB-RAR-77-9

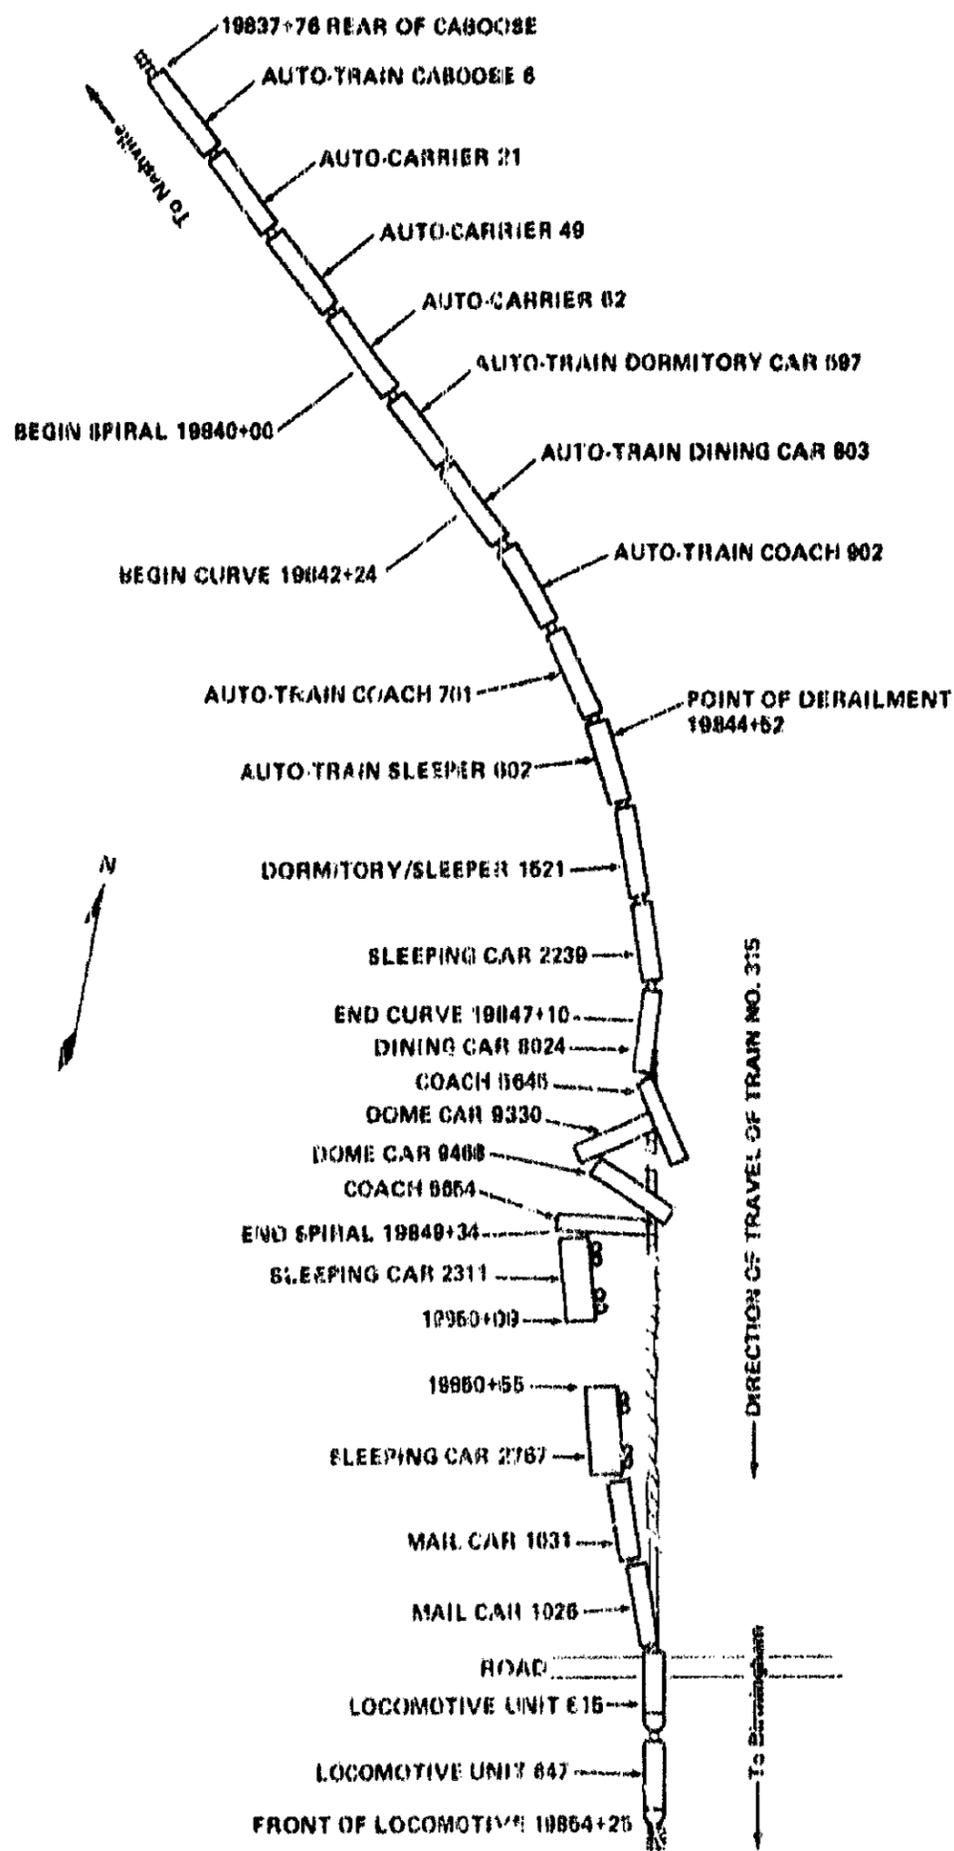
Figure 1. Plan of accident site.

No. 315 derailed as it moved around a 5° curve on an ascending grade of 0.4 percent at New Castle. The curve began 452 feet north of the derailment point and extended southward for 710 feet. The track was laid on a side-hill cut to the point of derailment and then southward on a fill which was 21 feet high at its midpoint. (See figure 1.)

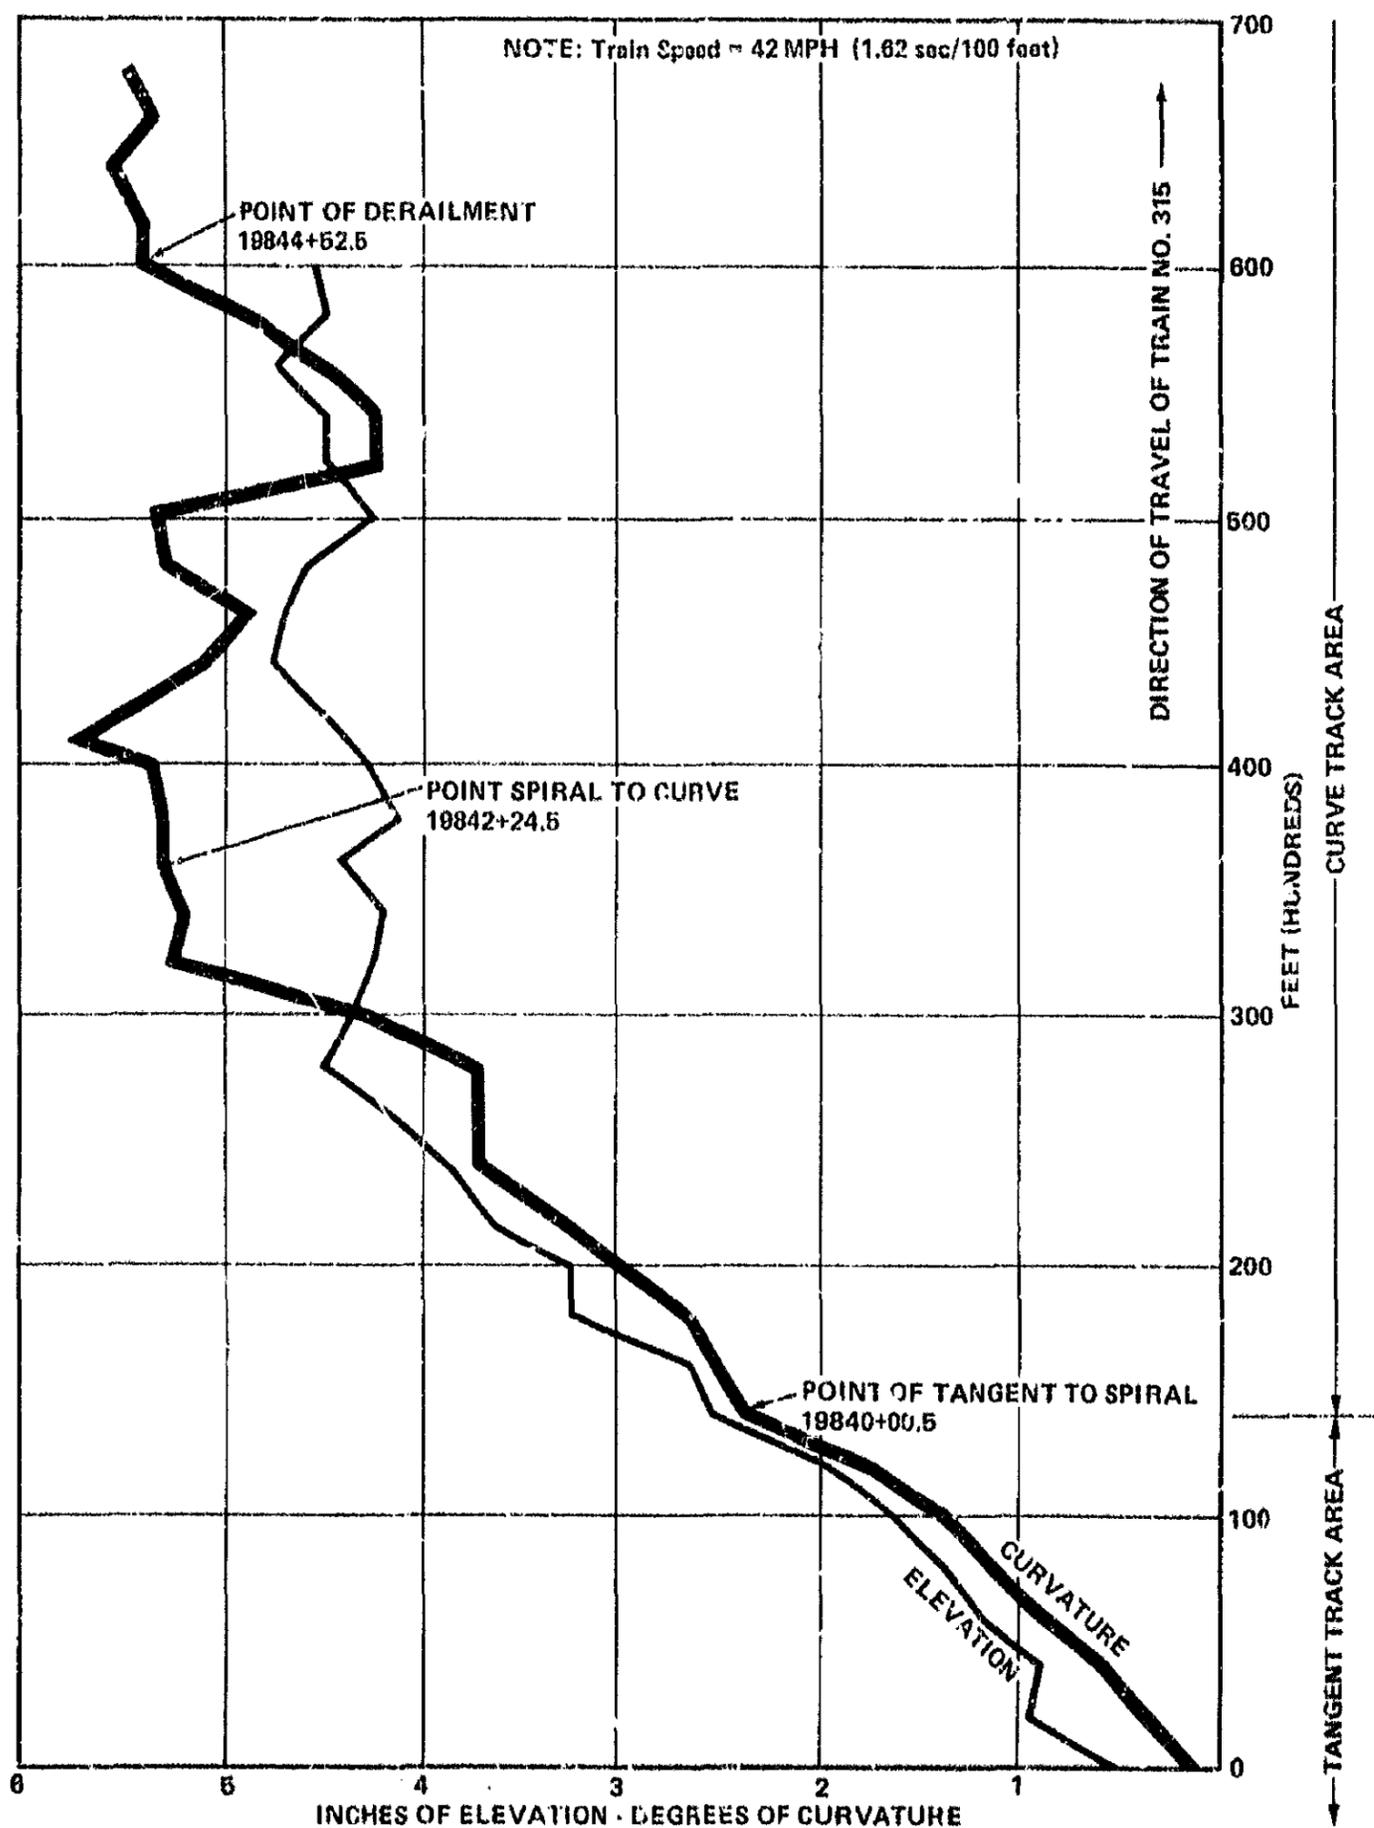
Figure 3. Deviations in curvature and superelevation.

Inspection of the track north of the derailment area revealed irregularities in curvature, gage, and superelevation as follows:

1. Gage varied from standard 56 1/2 inches to 57 7/16 inches.
2. Curvature, when measured by using the midordinate measurement of a 62-foot chord, varied from a minimum of 4°15' to a maximum of 5°56'.
3. Superelevation varied from the designed 4 inches to between 4 and 5 inches.

All of the above deviations were within the requirements for Class 3 track. (See figure 3.) These measurements were taken with the track structure unloaded.

A postaccident examination of the track indicated variations in line, gage, and elevation in the undisturbed track for 600 feet north of the point of derailment. Although the curve deviated from the planned 5° with 4 inches superelevation, these variations did not exceed those allowed by the Federal Track Safety Standards for Class 3 track. From 220 feet north to the point of derailment, track curvature varied from an approximate maximum of 5°45'; to a minimum of 4°15'; the greatest rate of change was within the last 100 feet before the point of derailment. Within this same area, superelevation varied from 4 1/4 inches to 4 3/4 inches, with the greatest rate of change 60 feet in approach to the point of derailment. In examining the relationship of the track's curvature to its elevation immediately prior to the point of derailment, as shown in figure 3, it is evident that the greatest variance occurred in the 200 feet before the derailment point. Many of these changes occurred in a short distance.

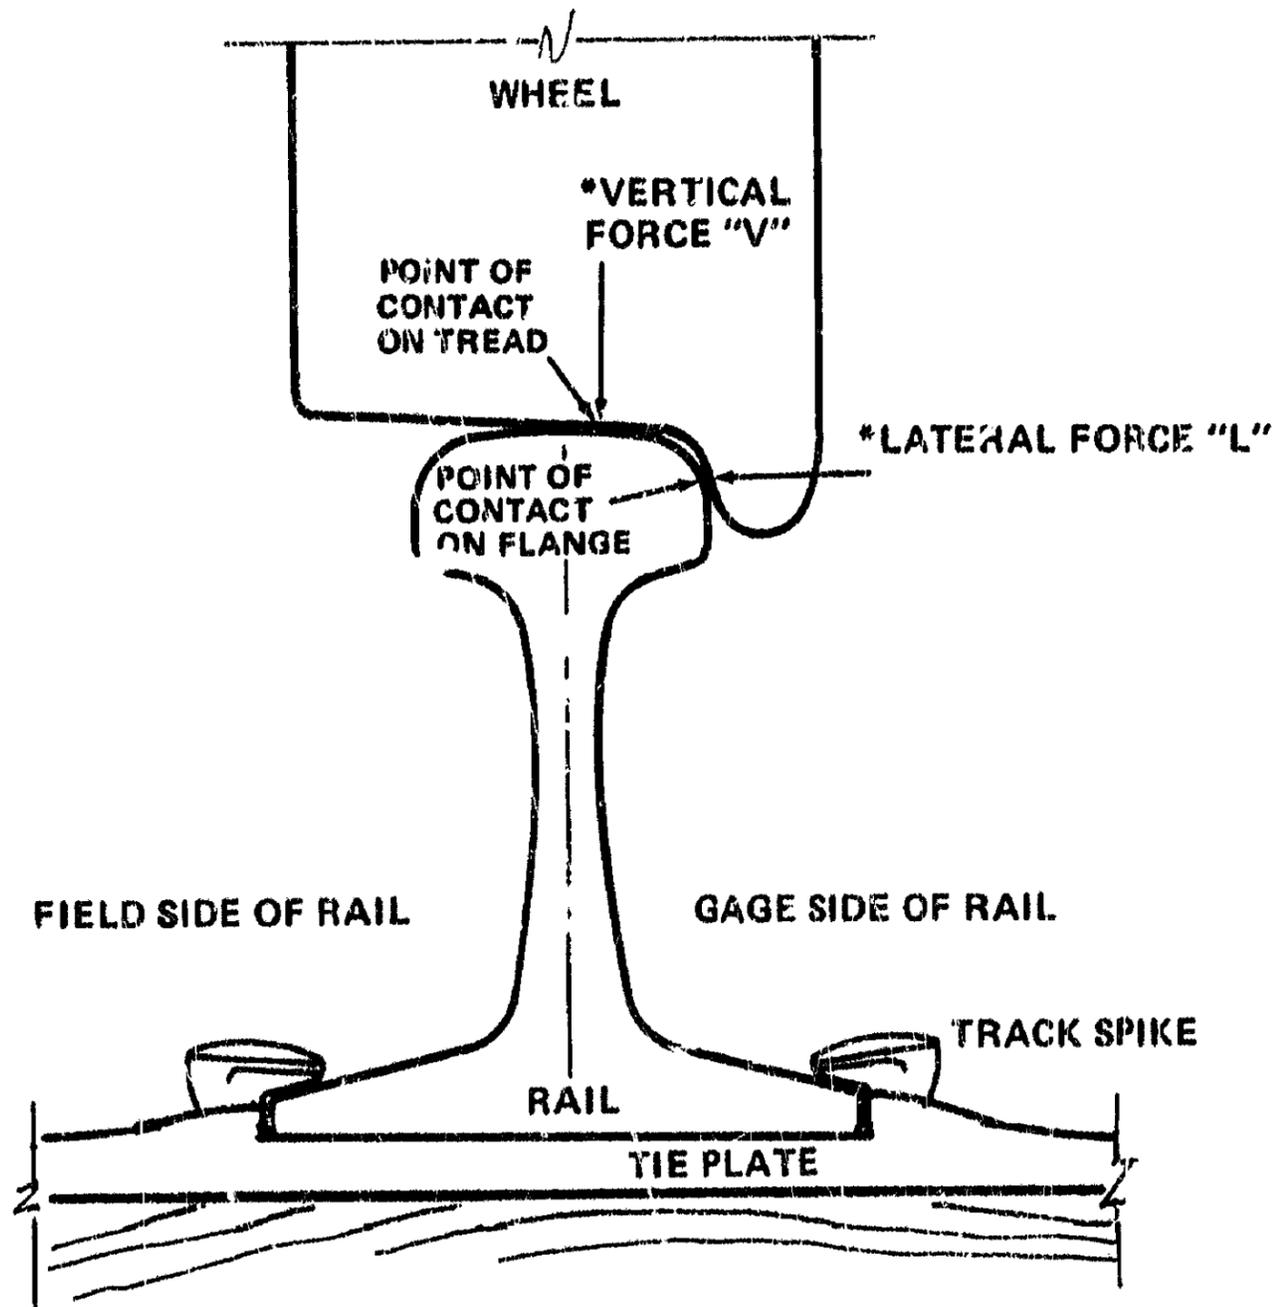
*The lateral to vertical ratio (L/V) is the lateral force pushing outward against the rail compared to the vertical force pushing downward on the top of the rail. The tendency for the rail to tip and/or move laterally, or for the wheel to climb the rail increases as the L/V ratio approaches unity.

Vertical forces due to the weight and movement of the train are transferred through the wheels of the locomotive and cars to the rail and tend to hold the rail in a vertical position on the tie plates, whereas whenever the wheel flanges come in contact with the side of the rail head as the train moves along the track they exert an overturning or tipping lateral force on the rail.
