**NATIONAL
TRANSPORTATION
SAFETY
BOARD**

RAILROAD ACCIDENT REPORT

**REAR END COLLISION OF TWO
CHICAGO TRANSIT AUTHORITY TRAINS**

REPORT NUMBER: NTSB-RAR-77-10

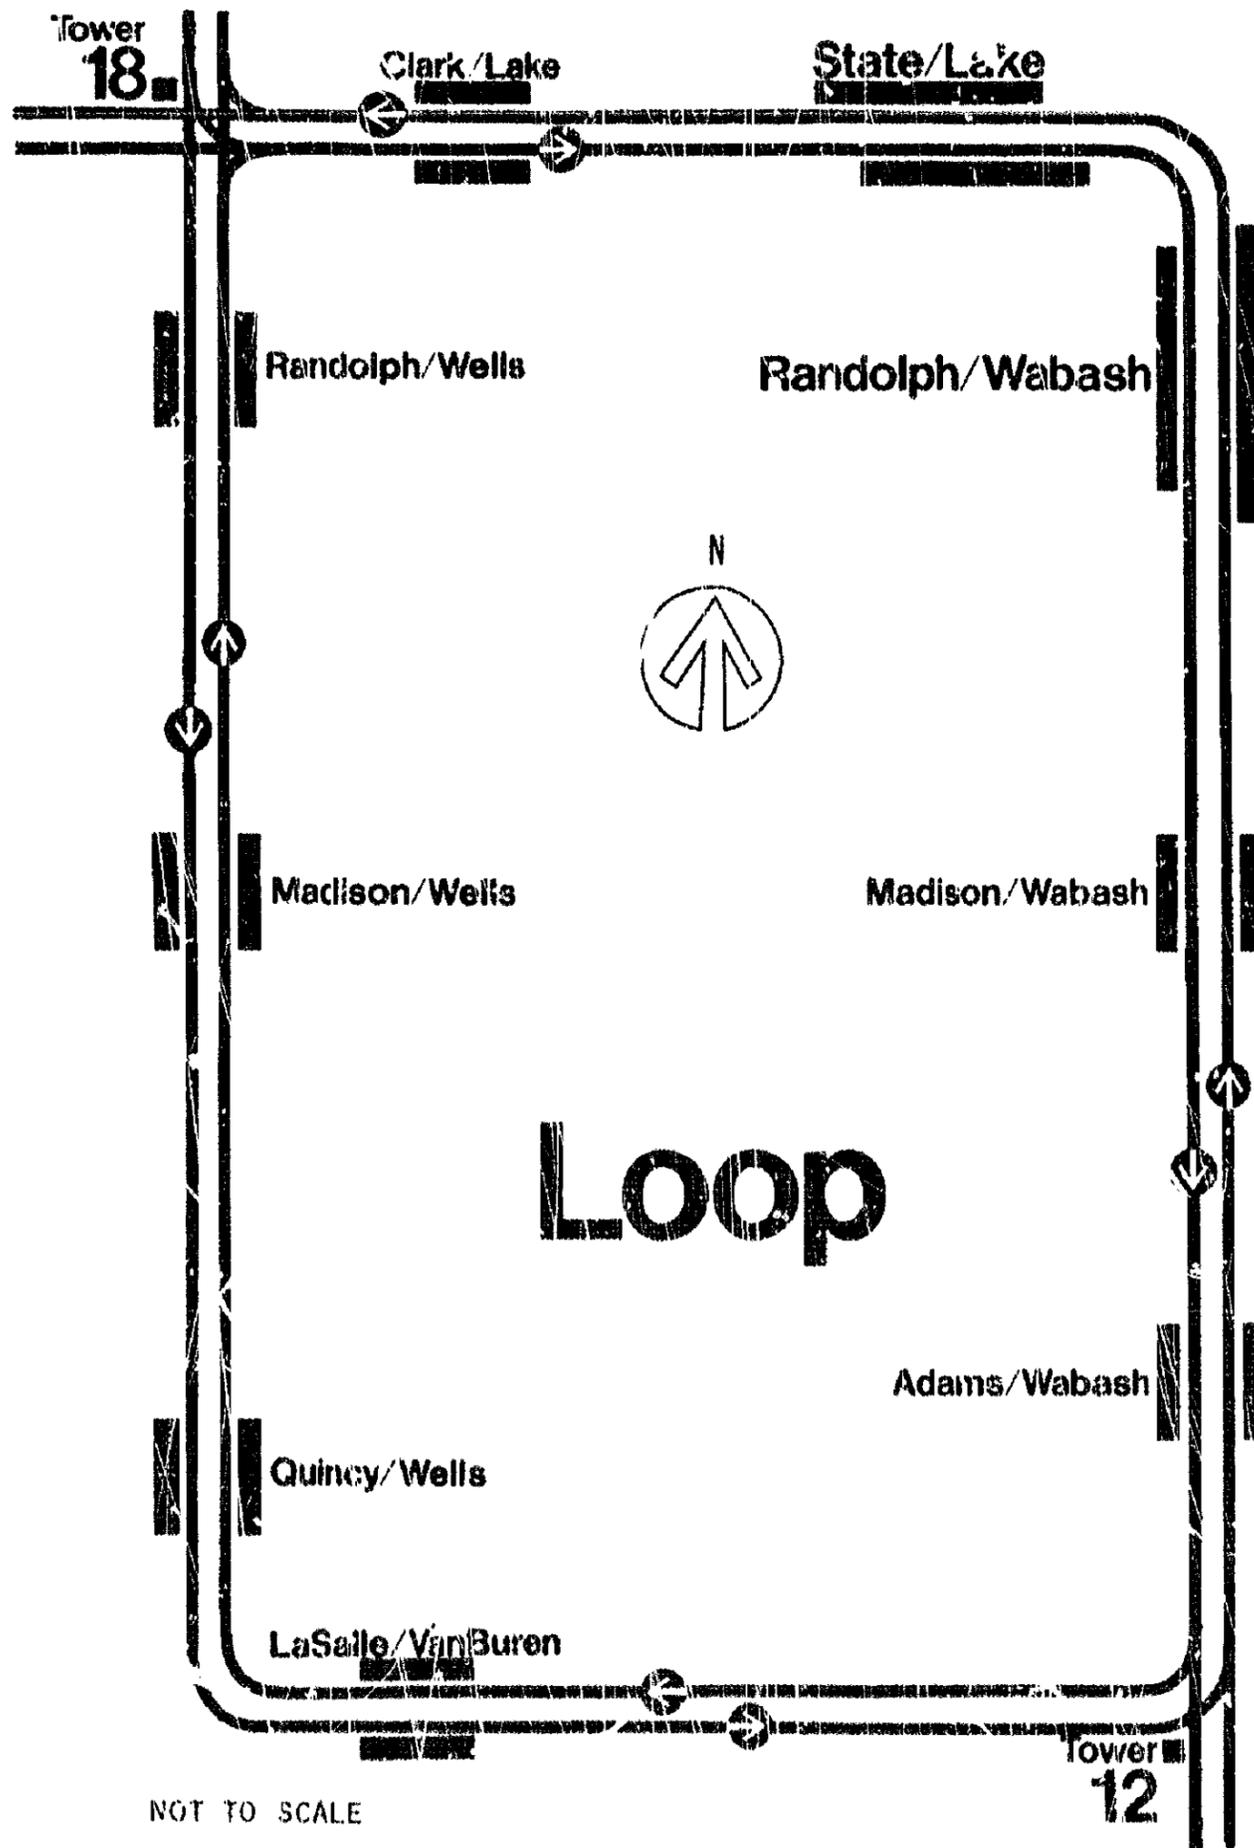
Figure 1. Plan of elevated track structure.

The accident occurred at the northeast corner of the "loop" where the elevated track structure turns west from Wabash Avenue to Lake Street. (See figure 1.)

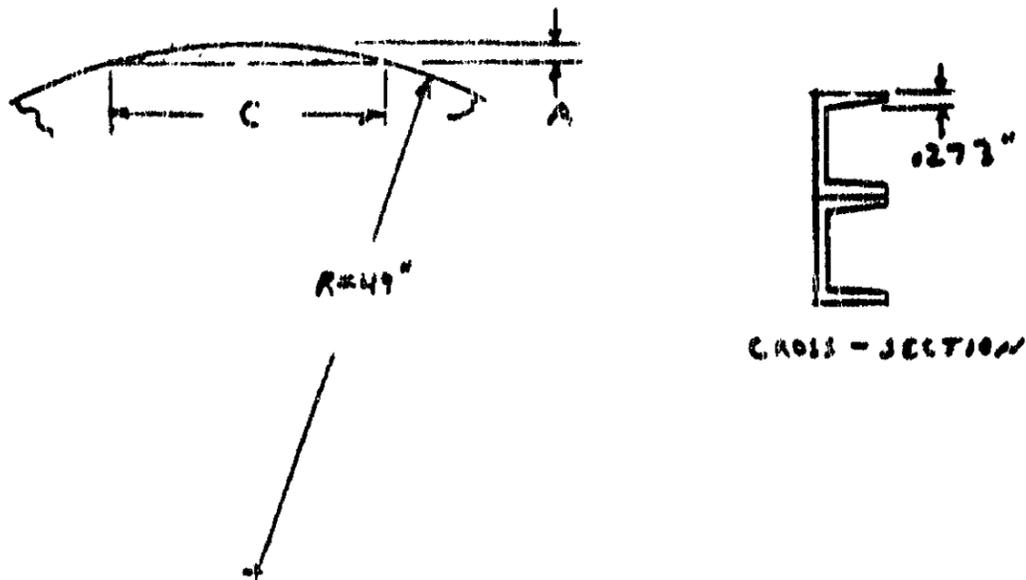
Figure 1. Anticlimber Geometry

Figure 1 is a representation of the anticlimbers.
