RAILROAD ACCIDENT REPORT

LOUISVILLE & NASHVILLE
RAILROAD COMPANY FREIGHT TRAIN
DERAILMENT AND PUNCTURE OF
ANHYDROUS AMMONIA TANK CARS AT
PENSACOLA, FLORIDA
NOVEMBER 9, 1977

REPORT NUMBER: NTSB-RAR-78-4

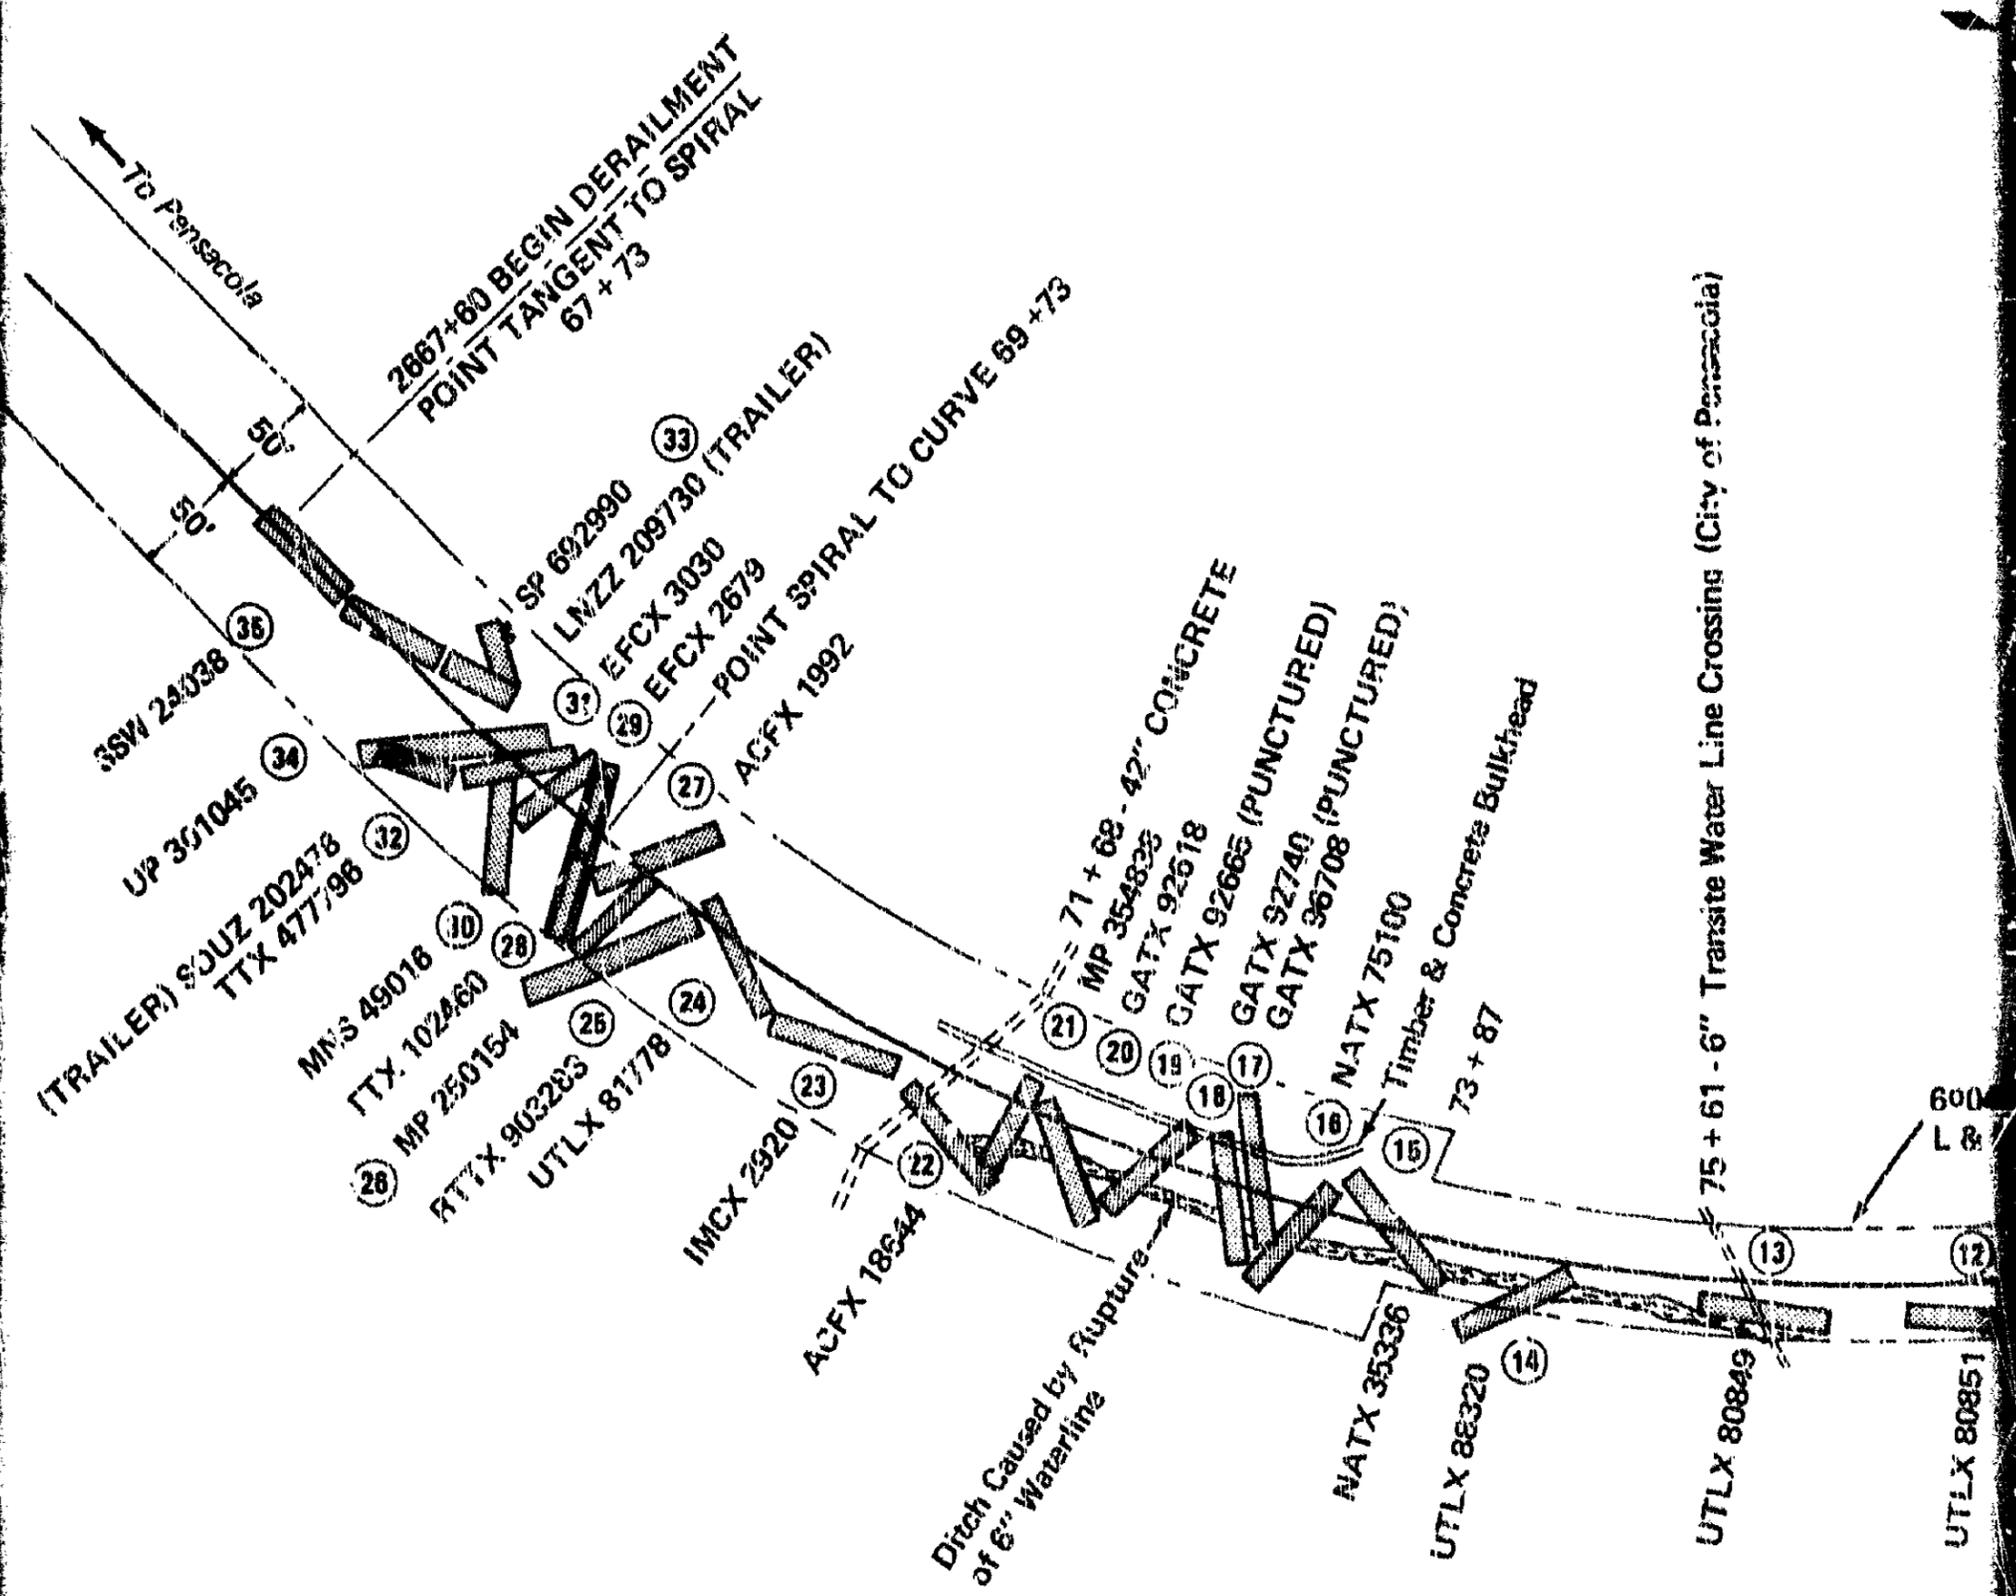
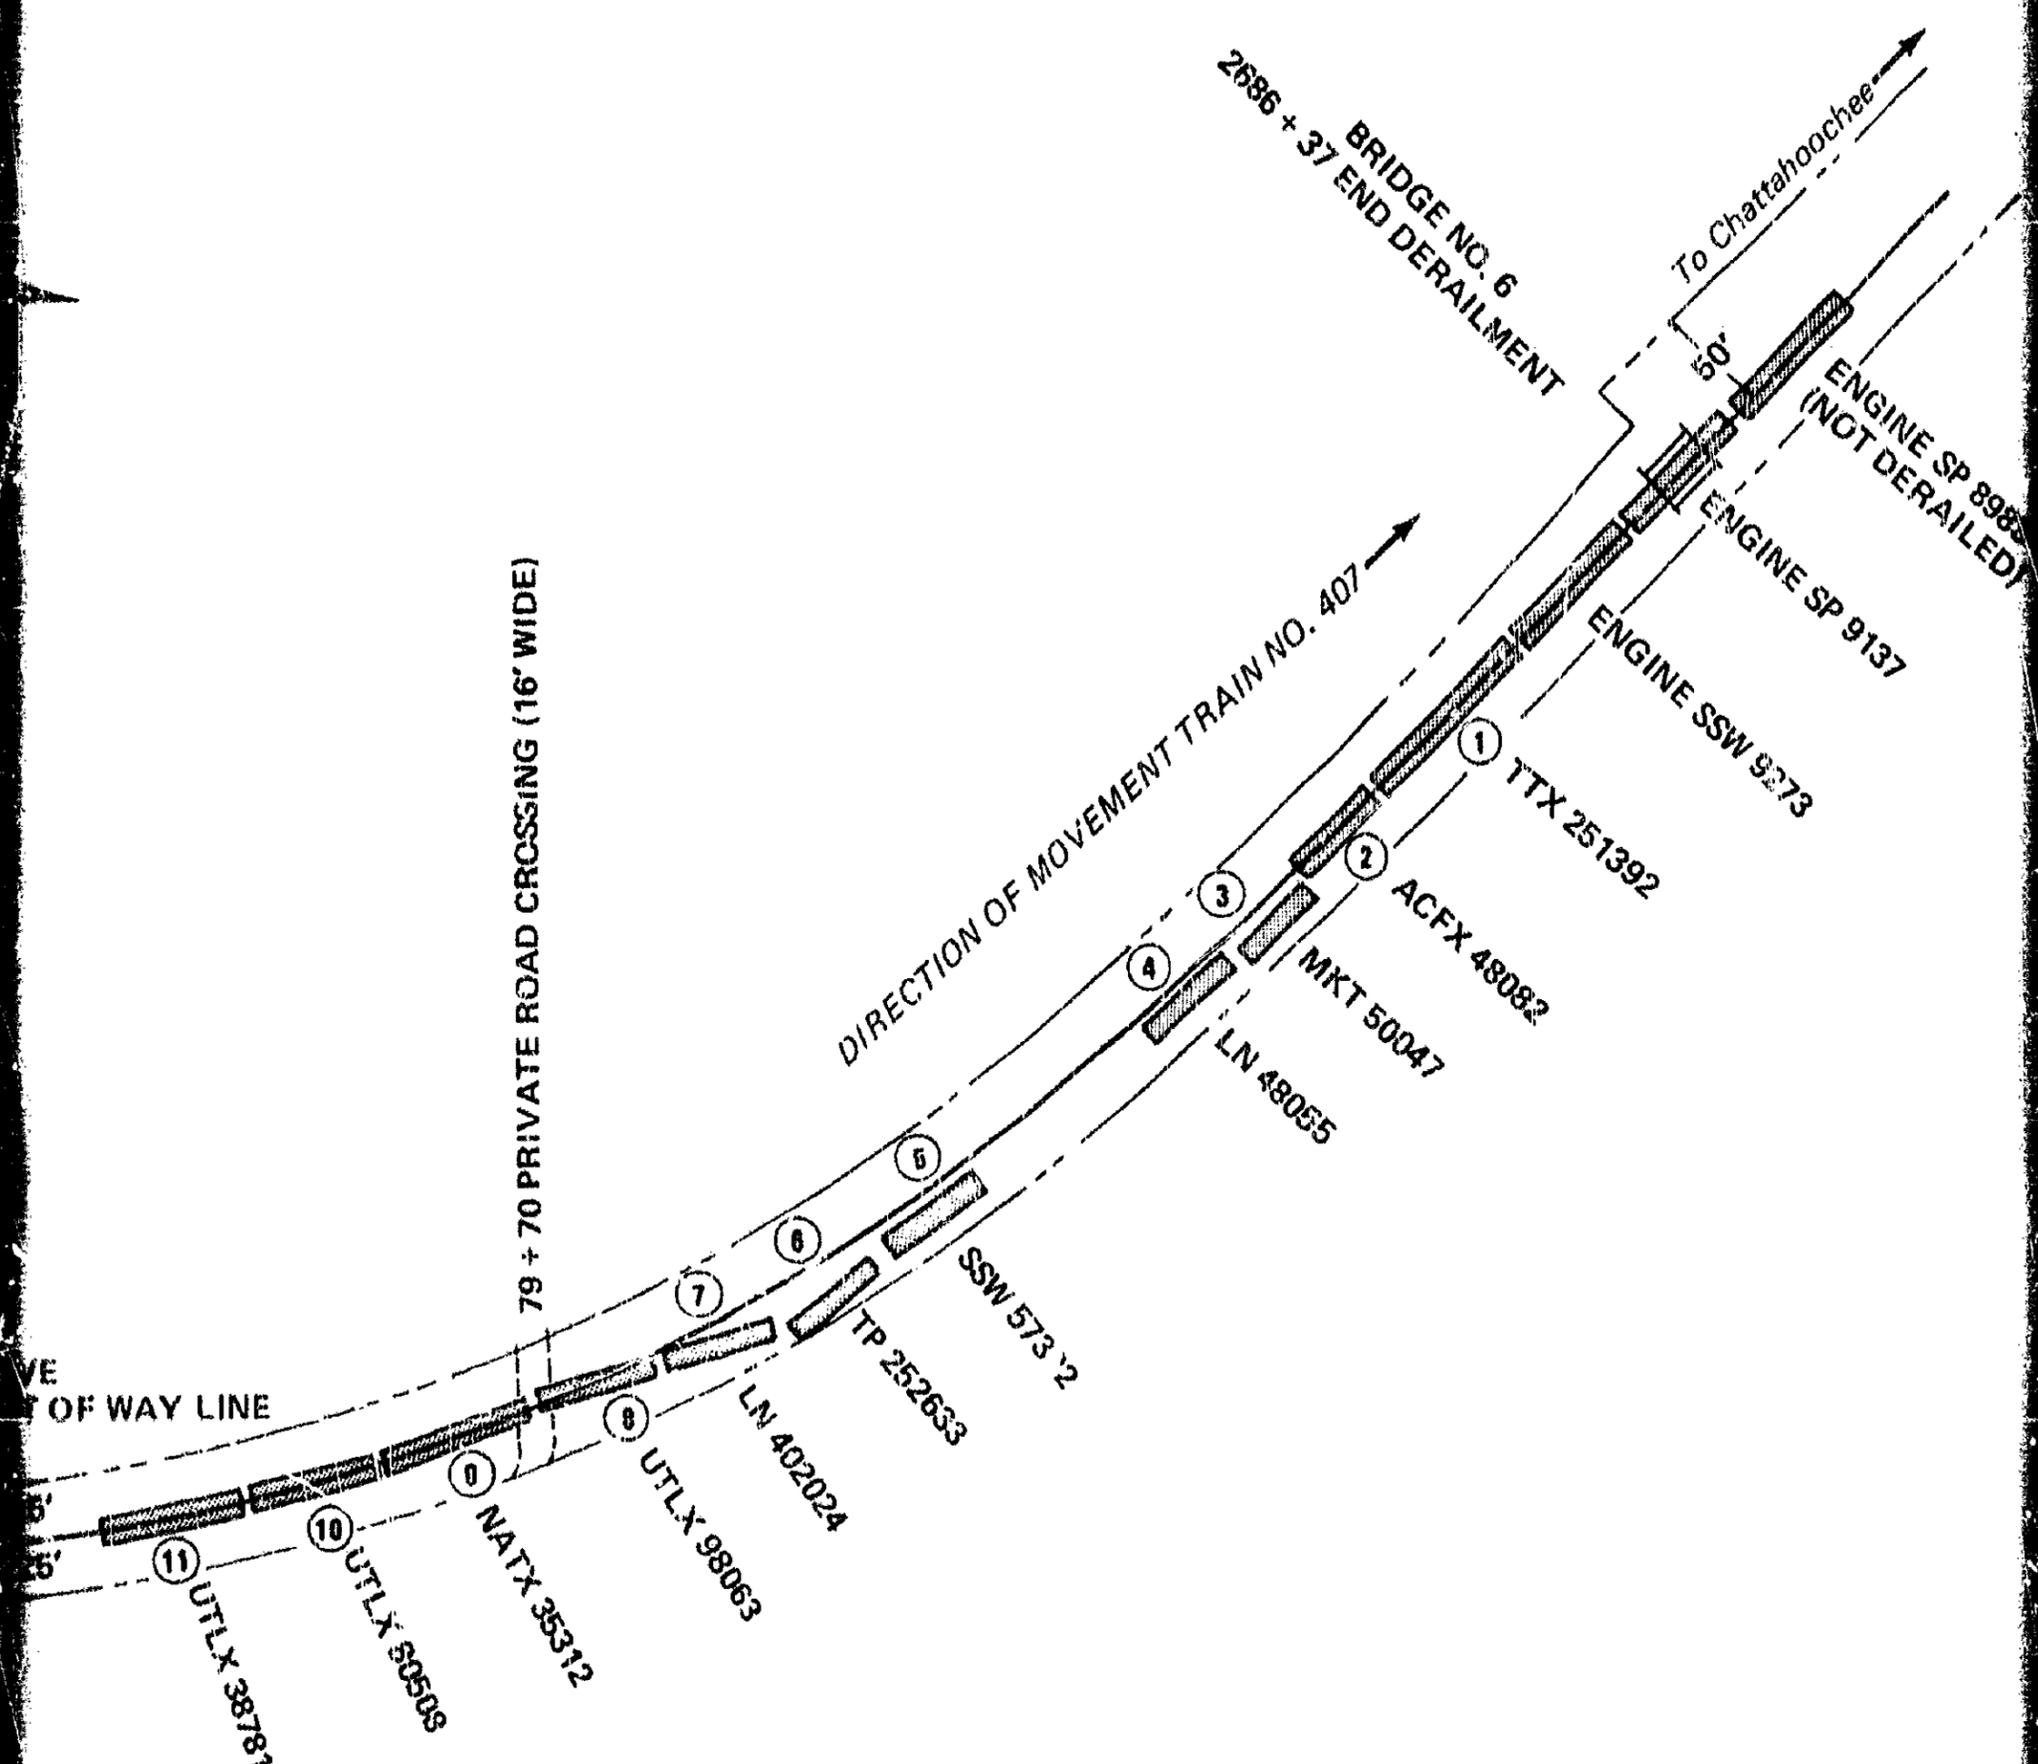
Figure 1. P

The locomotive and cars traveled 800 feet before stopping after the emergency brake application. The conductor and flagman, who were in the caboose at the rear of the train, stated that as the train stopped they noted no slack, jerking, or buff forces in the caboose. The conductor called the engineer on the radio when the train stopped at 6:06 p.m. and was told that the train had derailed. The first two cars, a long flat car loaded with one truck trailer and an empty covered hopper car, remained upright and coupled to the locomotive. The next 11 cars were tipped but remained in line along the following 900 feet of track. The 14th through 35th cars jack-knifed and piled up within the next 700 feet. (See figure 1.)

Accident Site

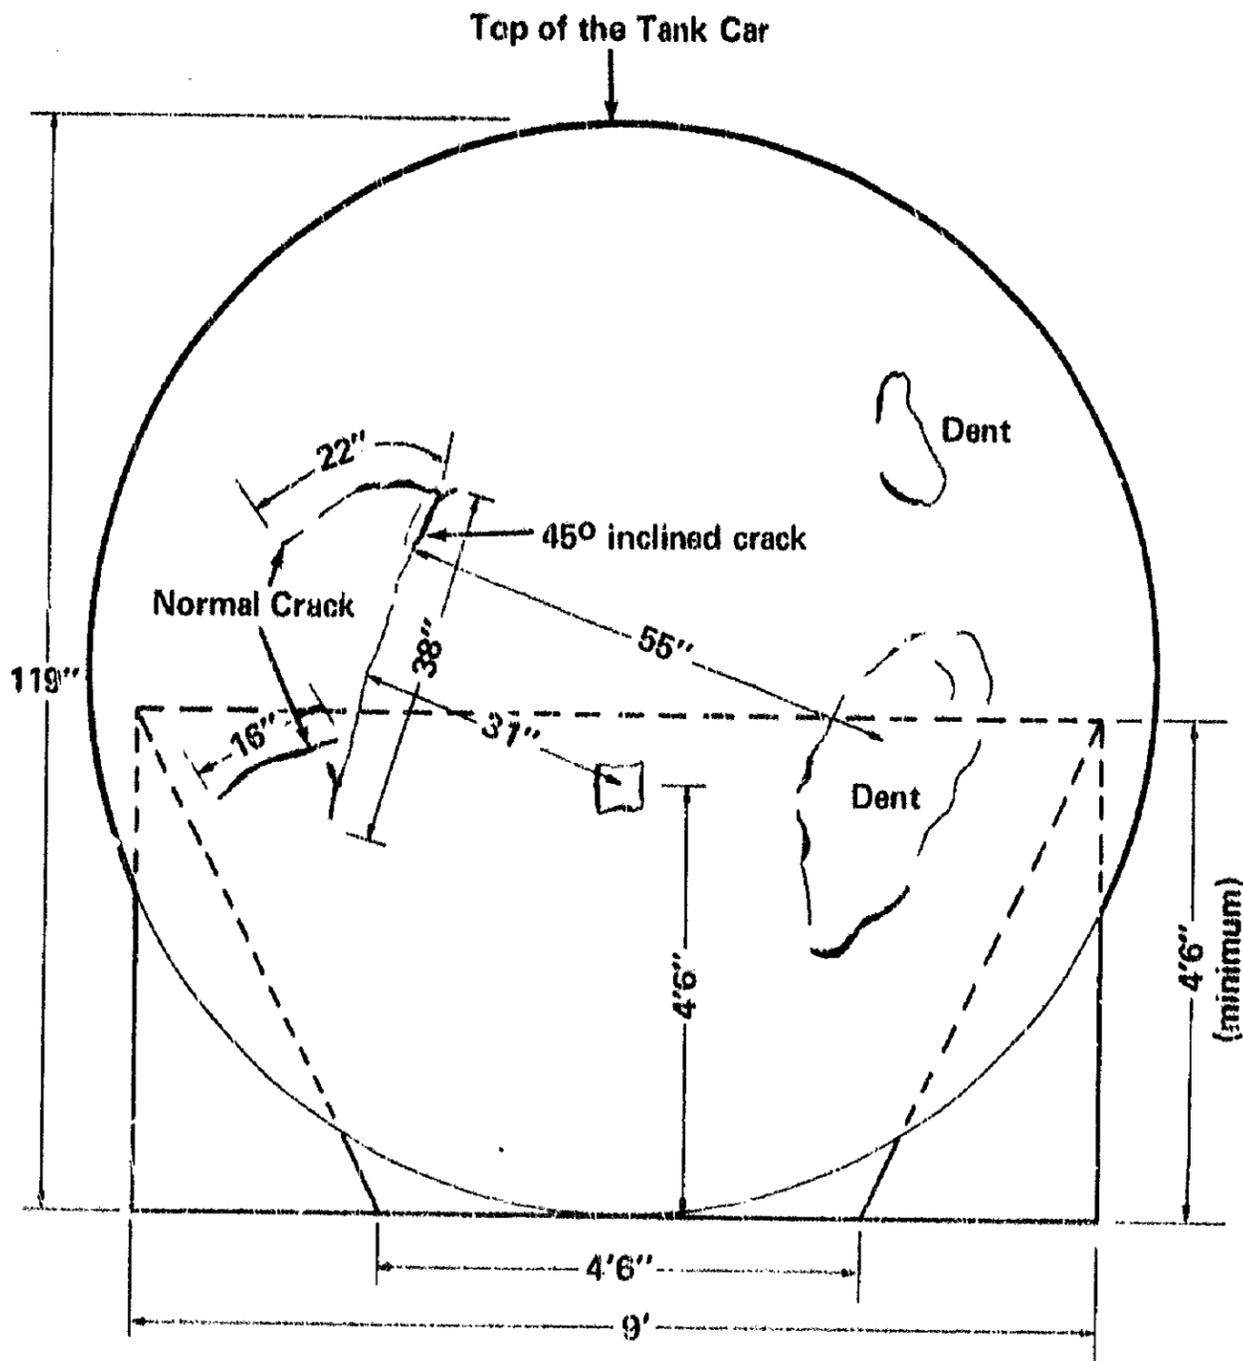
Sixteen of the 17 derailed tank cars contained anhydrous ammonia and were located between the 7th and the 28th cars. The 17th tank car contained solvent and was leaking slightly at a valve. The other derailed cars contained commodities such as feed, lumber, and automobiles. Twelve of the 35 derailed cars were destroyed and the others were heavily damaged. The 18th car was punctured on the right side near the junction of the head and shell of the tank. The puncture consisted of three parallel, 1/4-inch-wide, vertical cracks, about 6 inches apart, and located near the 4-o'clock position from the top of the tank. One 19-inch-long crack was adjacent to the weld of the head and shell. The other two cracks were 19 inches and 9 inches long respectively. The puncture of the 19th car was a 3-inch-wide by 38-inch-long tear in the leading tank head. It was located near the 10 o'clock position from the top and about 31 inches to the left of the vertical centerline. (See figure 2.)

The dashed lines show (approximately) the region which must be covered by the head shield being phased under current FRA regulations.

Figure 2. Tank car GATX 92665 head damage.

11. If the punctured tank cars had been equipped with head shields and T&B shelf couplers the punctures may have been averted and the severity of the accident reduced.
12. The local public safety personnel reacted promptly and effectively to the anhydrous ammonia emergency because of their development of an emergency plan and prior accident experiences.
13. Current DOT hazardous material guidelines for handling an emergency lack adequate information on how to determine the potential danger zone of exposure to the released hazardous materials.

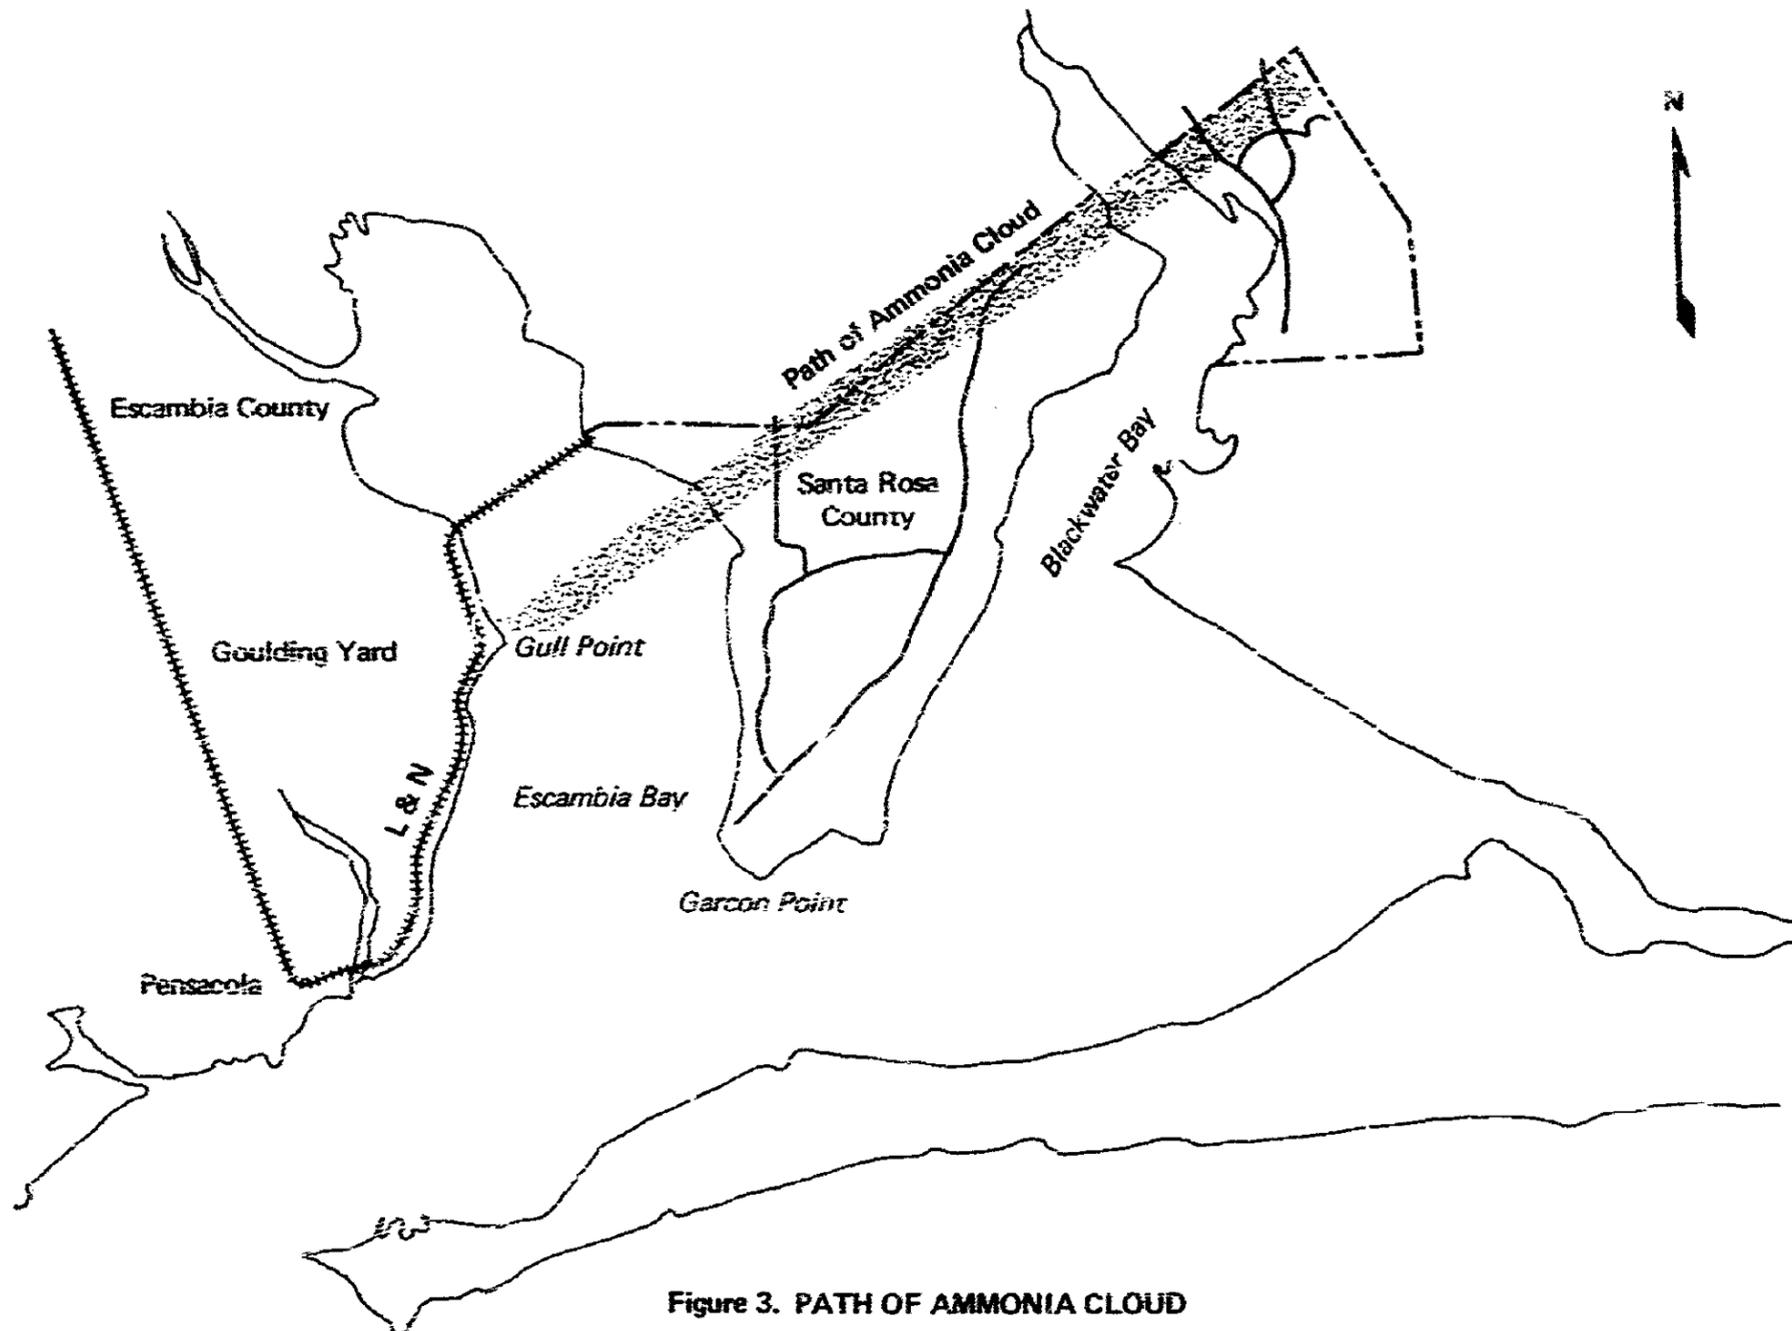
Figure 3. PATH OF AMMONIA CLOUD

The developing heavy dense ammonia fog deposited ammonium hydroxide particulates on exposed surfaces as the wind carried this fog over Escambia Bay. This cloud migrated as a single puff of fine ammonium hydroxide droplets with the prevailing wind speed across the bay, reaching landfall 4 miles eastward in Santa Rosa County, a sparsely populated area. The ammonium hydroxide in this cloud enabled the airport radar to track the migration across the bay; otherwise, ammonia could not have been observed on the radar screen. Within 60 minutes the cloud of ammonium hydroxide traveled 4 miles over the bay and 5 miles over land in Santa Rosa County, before dissipating. The wind direction kept the number of injuries low; an eastern wind would have blown the lethal cloud through a heavily populated urban area of Pensacola.
