# **NATIONAL TRANSPORTATION SAFETY BOARD**

## **RAILROAD ACCIDENT REPORT**

**COLLISION OF  
PORT AUTHORITY OF ALLEGHENY COUNTY  
TROLLEY CAR NO. 1790 AND BUS NO. 2413  
PITTSBURGH, PENNSYLVANIA  
FEBRUARY 10, 1978**

**REPORT NUMBER: NTSB-RAR-78-5**

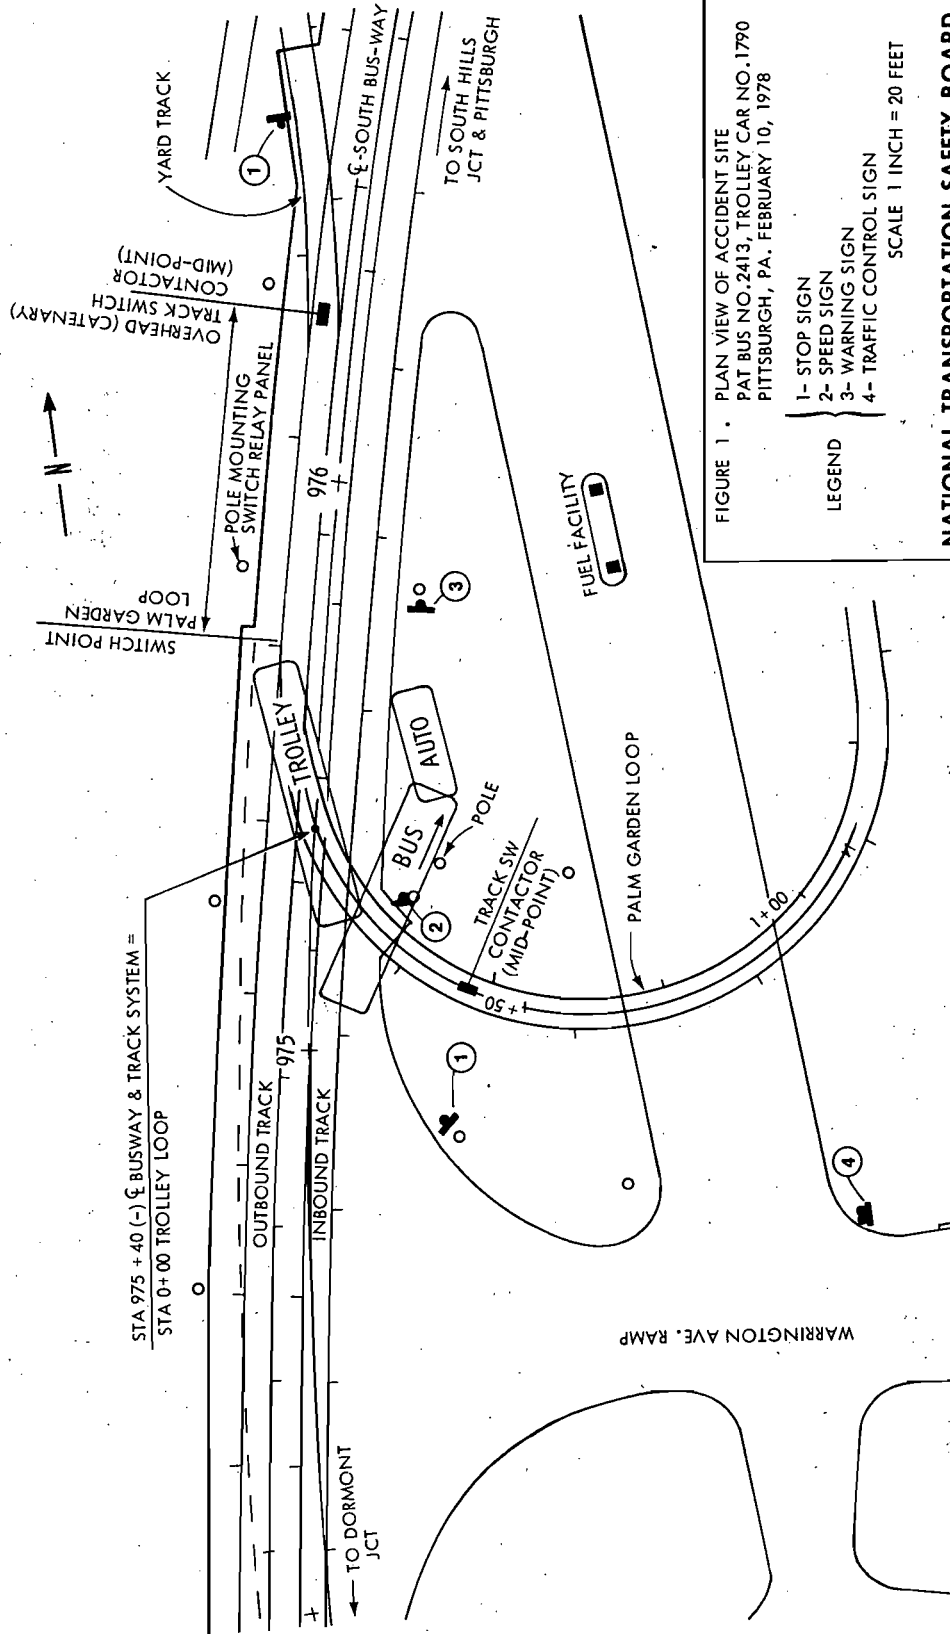
FIGURE 1. PLAN VIEW OF ACCIDENT SITE  
PAT BUS NO.2413, TROLLEY CAR NO.1790  
PITTSBURGH, PA. FEBRUARY 10, 1978

There are two main tracks which run north and south through the accident area. The west track is the "outbound" track and the east track is the "inbound" track. The two tracks are embedded in concrete, thus permitting the surface to be used as a roadway. The roadway is on a 3-percent descending grade outbound. The roadway curvature varies to a maximum of 5° to the left outbound through the Palm Garden Loop switch area. There are no pertinent sight impediments near the switch. (See figure 1.)

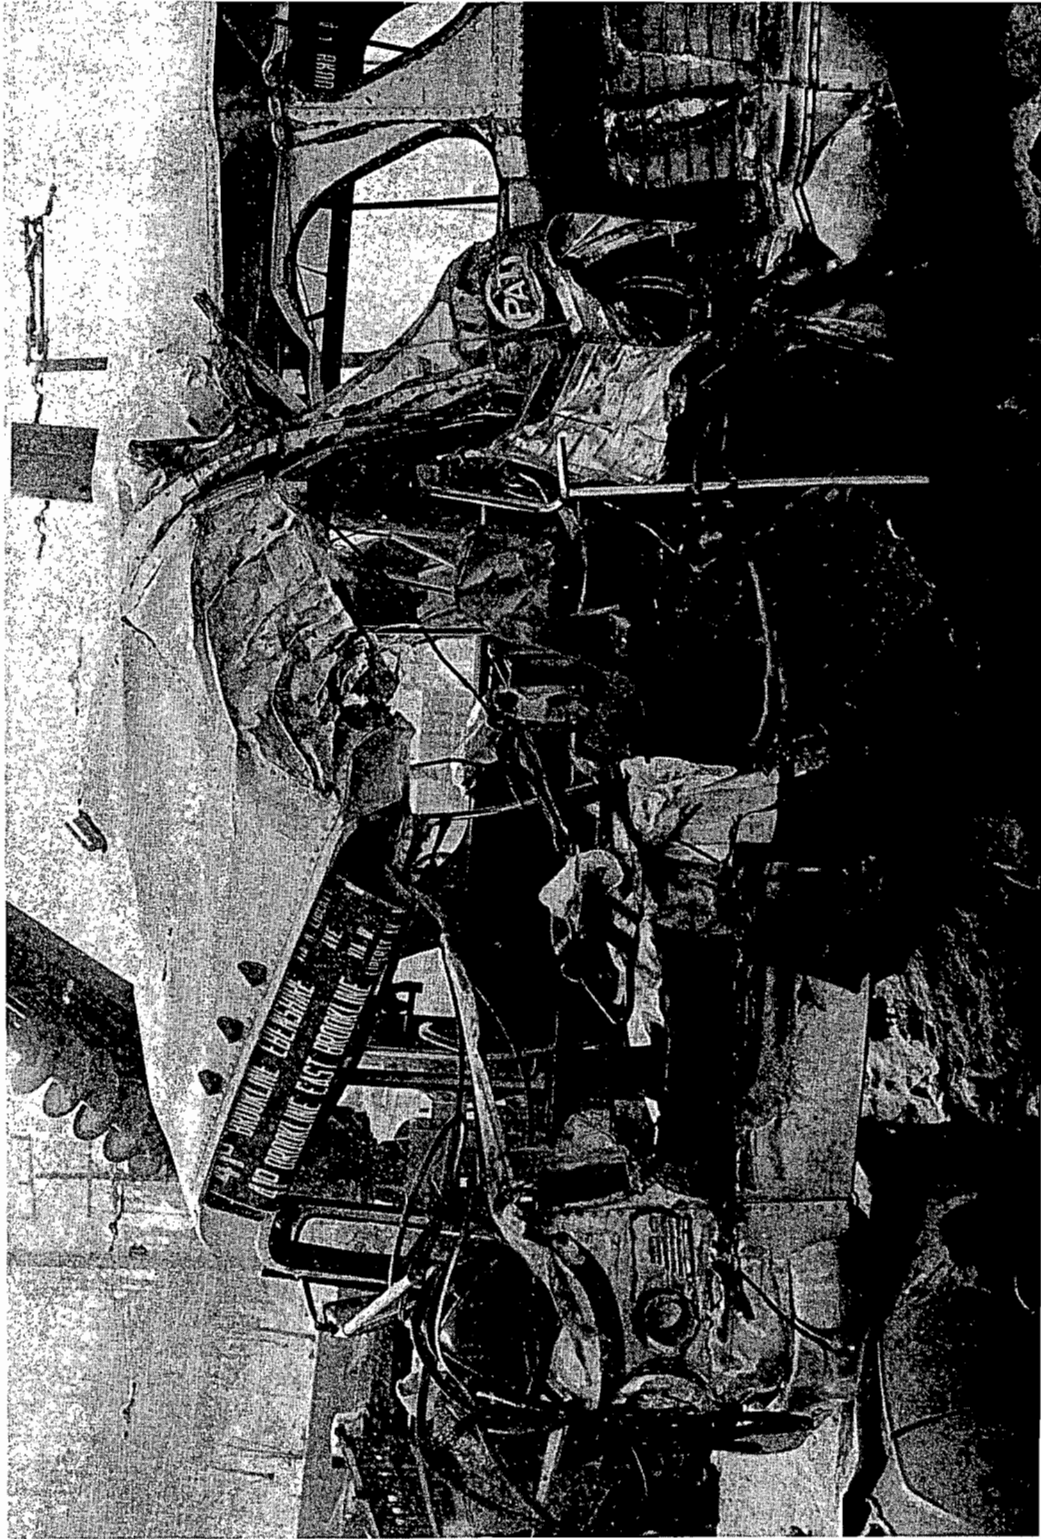
Figure 2. PAT bus No. 2413.

The trolley car struck the bus on the left front corner. The upper section of the bus was displaced rearward approximately 5 feet and downward 3 feet. The roof structure above the windshield frame was displaced to the left 2 feet, and the windshield was missing. The trolley car penetrated into the bus about 3 feet at the deepest point. Major deformation was evident along the left side for almost 15 feet. (See figure 2.)

The trolley car struck and penetrated the left side of the bus with virtually no penetration resistance, and because of the relative motion of the two vehicles, the penetration was effectively extended along the side. This action caused the greatest amount of energy to be absorbed in the immediate area occupied by the driver and the three passengers who were killed. The driver was not using his seatbelt, but even so it would not have prevented his injuries nor would seatbelts have helped the passengers. All of the fatalities received their injuries because of the impact crushing of their occupiable space. The deforming metal and left front axle/wheel assembly absorbed much of the kinetic energy and thus reduced the potential for injury to passengers outside of the "crush zone." If the impact had been head-on, or if the left front side had been more resistant to crushing, more of the impact energy would have been transmitted through the bus body and there may have been more injuries.

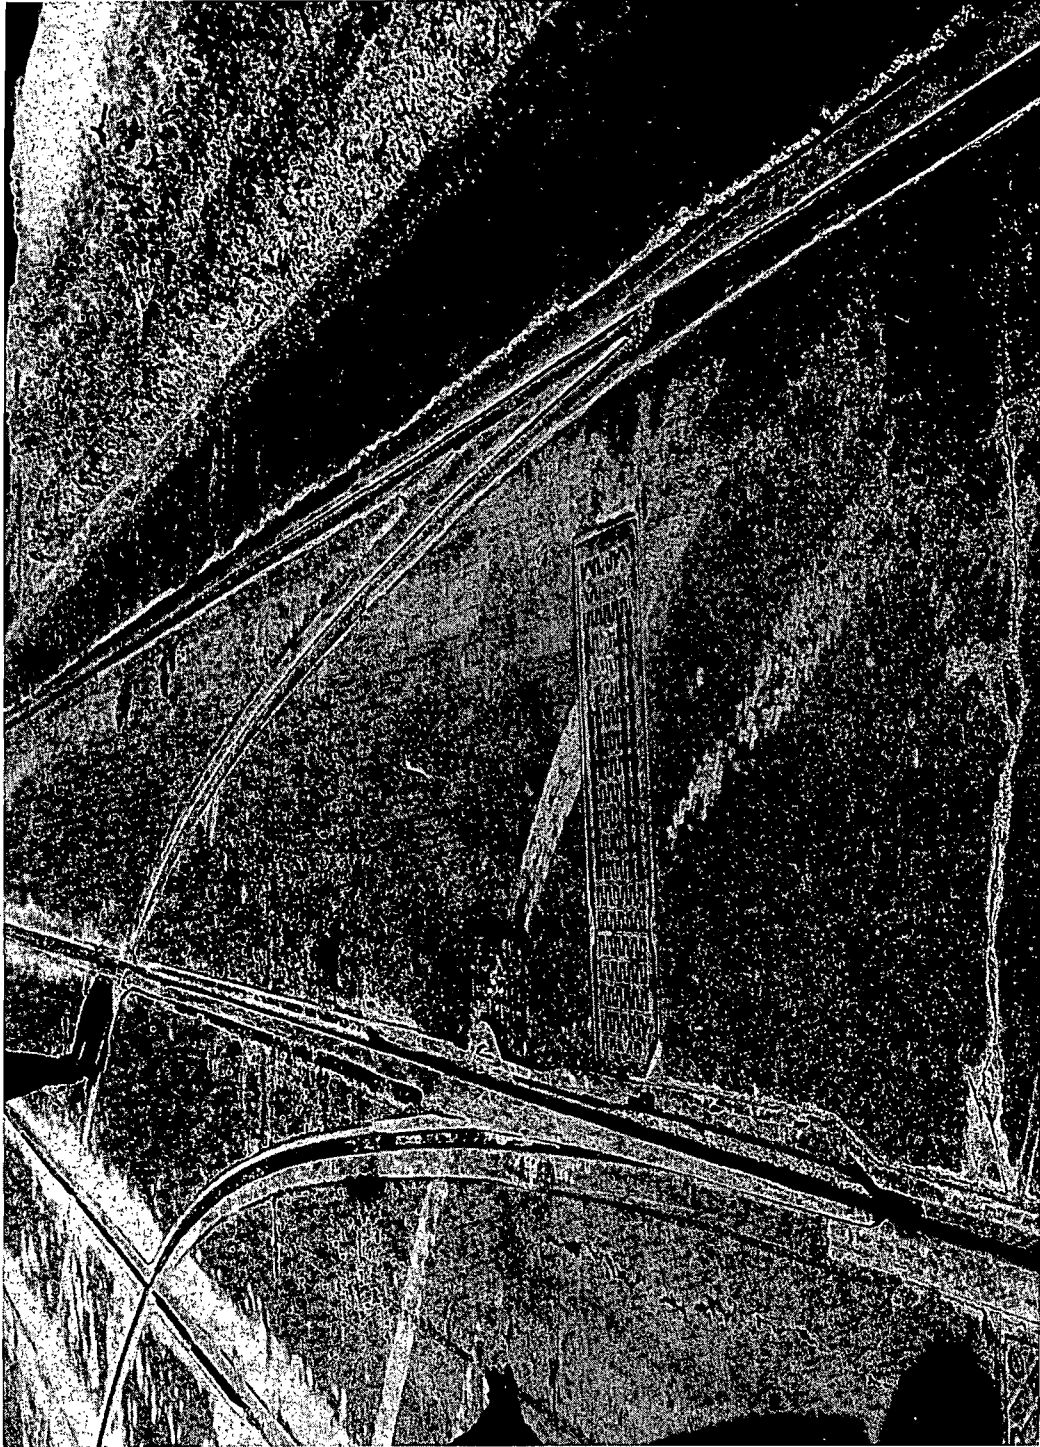
Figures 3. Track switch.

The switch has one movable point which is operated by the electro-magnetic switch machine. (See figure 3.) The switch machine consists of two coils which, when separately energized, lines the route for either a straight movement or for the curve. There is no positive locking device, and the switch is held in either position by spring pressure. Power to energize and operate the switch machine and the relay panel is obtained from the 600-volt d.c. catenary.

The left front wheel contour and flange were found to be in good condition with no marks to indicate that the wheel "picked" <sup>3/</sup> the switch. The switch point had no marks to indicate it had been picked. The switch point fitted the stock rail, and it did not roll or raise when a car moved over it.

On February 14, 1978, the track switch for the Palm Garden Loop was made to operate semi-automatically. An operator entering the Palm Garden Loop now has to stop his car and position the switch for the curve manually. It will then restore for a straight move automatically after a trolley car passes a closure contactor in the loop catenary. Specific instructions are given for operating a trolley car over an electric switch. (See appendix B.)

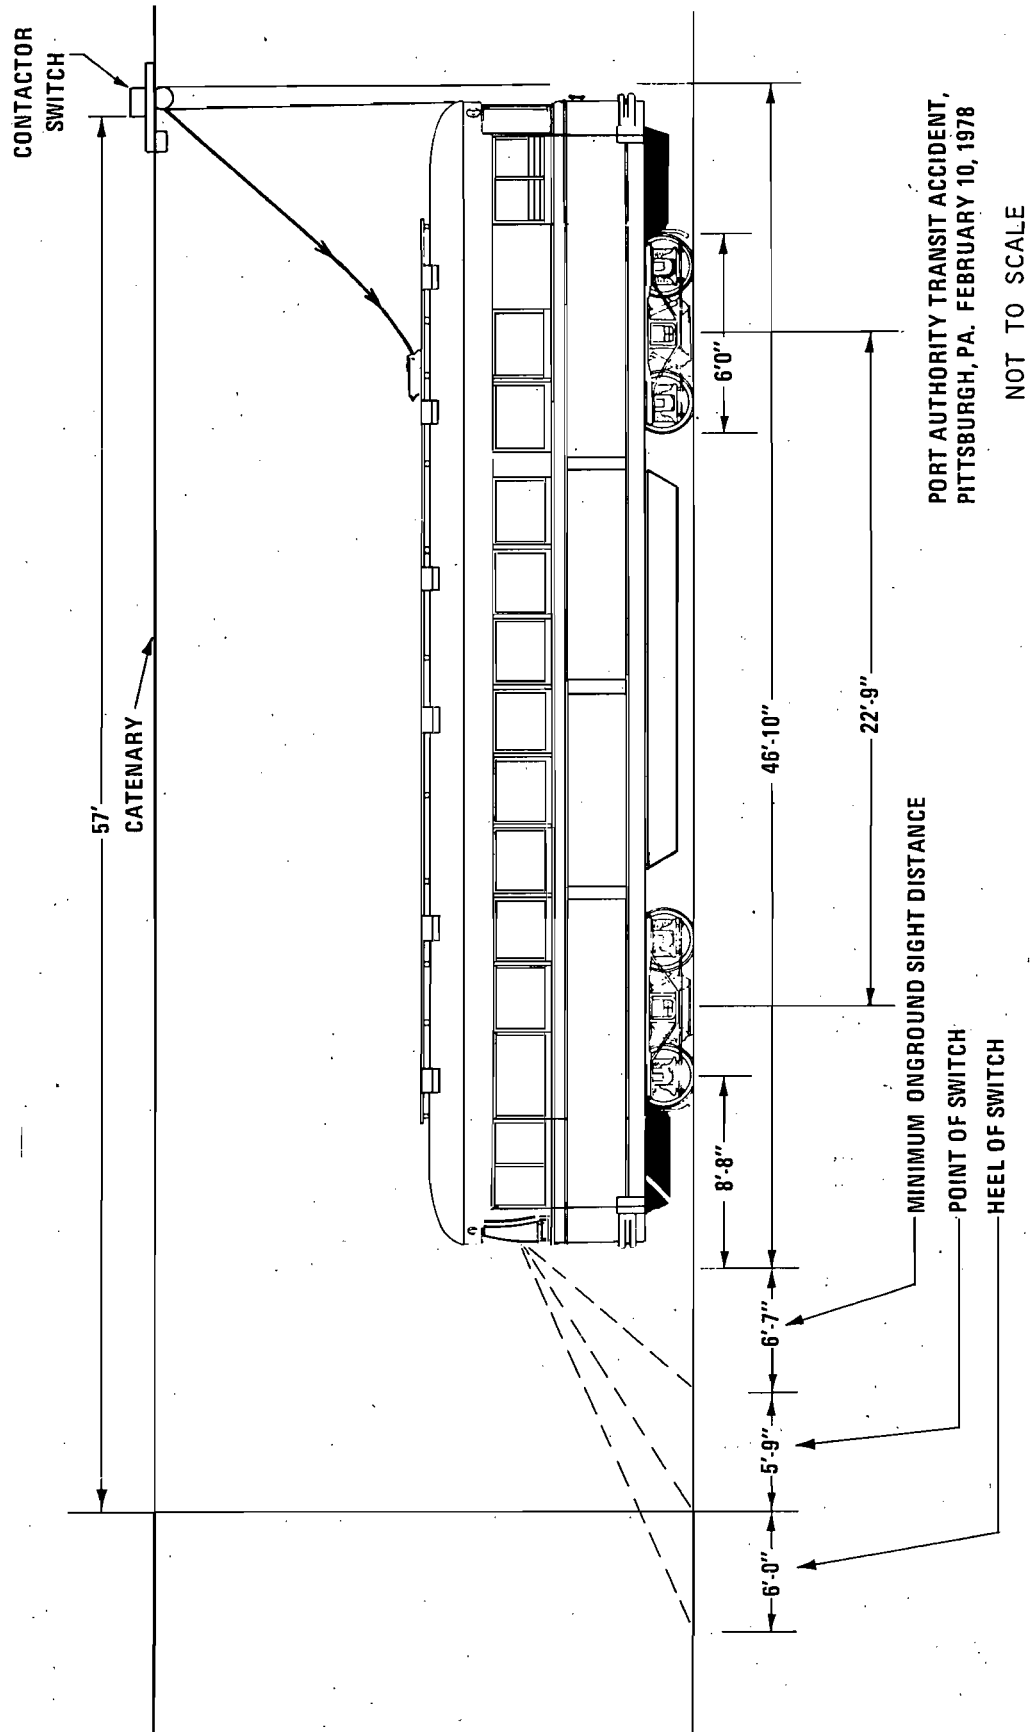
Figure 4. Trolley car dimensions and some average sight distances for a typical operator.

The contactor is located 57 feet from the switch point so that an operator will have time to stop his car if the switch does not respond properly. The closest the operator can see the ground ahead is 6 to 8 feet because of the car overhang. When the trolley pole is just engaging the contactor, the point of the switch is 12 feet from the front of the car, which gives the operator about 4 to 6 feet ground view of the switch point. After the trolley pole clears the contactor, the operator's ground view of the switch point would still be 2 to 4 feet. The front of the car would be about 10 feet from the switch point, and this distance, if extended to the heel of the switch, would be about 16 feet. (See figure 4.) Movement of the switch point can be observed throughout its 6-foot length.

Trolley operators do not have positive identifying markings to let them know when the trolley pole is on the contactor. Through experience, they listen for a "thump" that is transmitted through the car as the pole leaves the contactor. This is their only indication of the trolley pole's location relative to the contactor, other than using an estimated distance from the front of the car to the switch point.

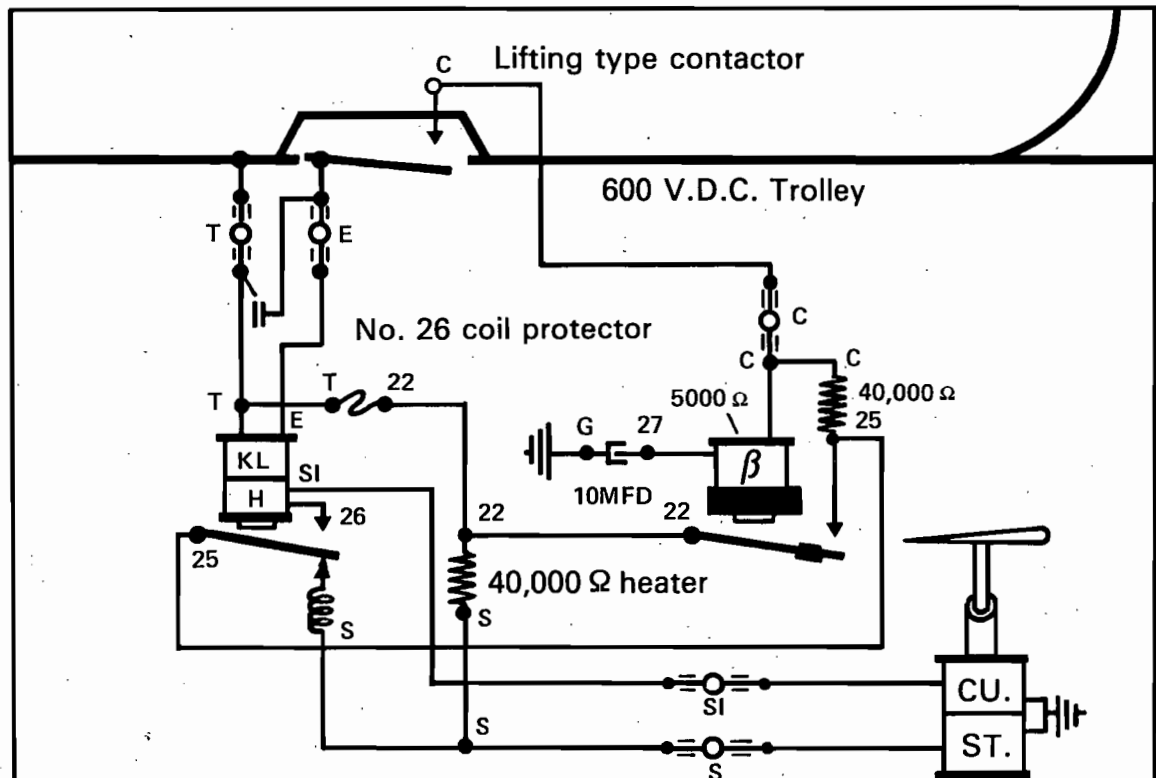
SWITCH RELAY CIRCUIT

The relay panel consists of two relays, identified as "KL" and "B," and miscellaneous components. The position of relay "KL" determines whether the switch point will be positioned for the curve or straight track. The "KL" relay operates on 60 amperes d.c. current or more. The "B" relay has to operate for the switch to assume either position. (See appendix A.)

The relay panel is the "heart" of the switch operation. The reported switch failures occurred with two different relay panels in service. Both failures reportedly occurred after the car's trolley pole had passed clear of the contactor. All operations of the switch were proper when the control relays were operated manually. Tests were made with several different cars, including car No. 1790, in an attempt to produce an undesirable response and none occurred. In summary, no failure of the switch was observed during tests, the switch operated properly from February 10 to February 14 without a failure, and the performance history of this switch circuit lends credence to its reliability.
