## **RAILROAD ACCIDENT REPORT**

**DERAILMENT OF AMTRAK TRAIN NO. 8,  
THE EMPIRE BUILDER,  
ON BURLINGTON NORTHERN TRACK  
LOHMAN, MONTANA  
MARCH 28, 1979**

**NTSB-RAR-79-7**

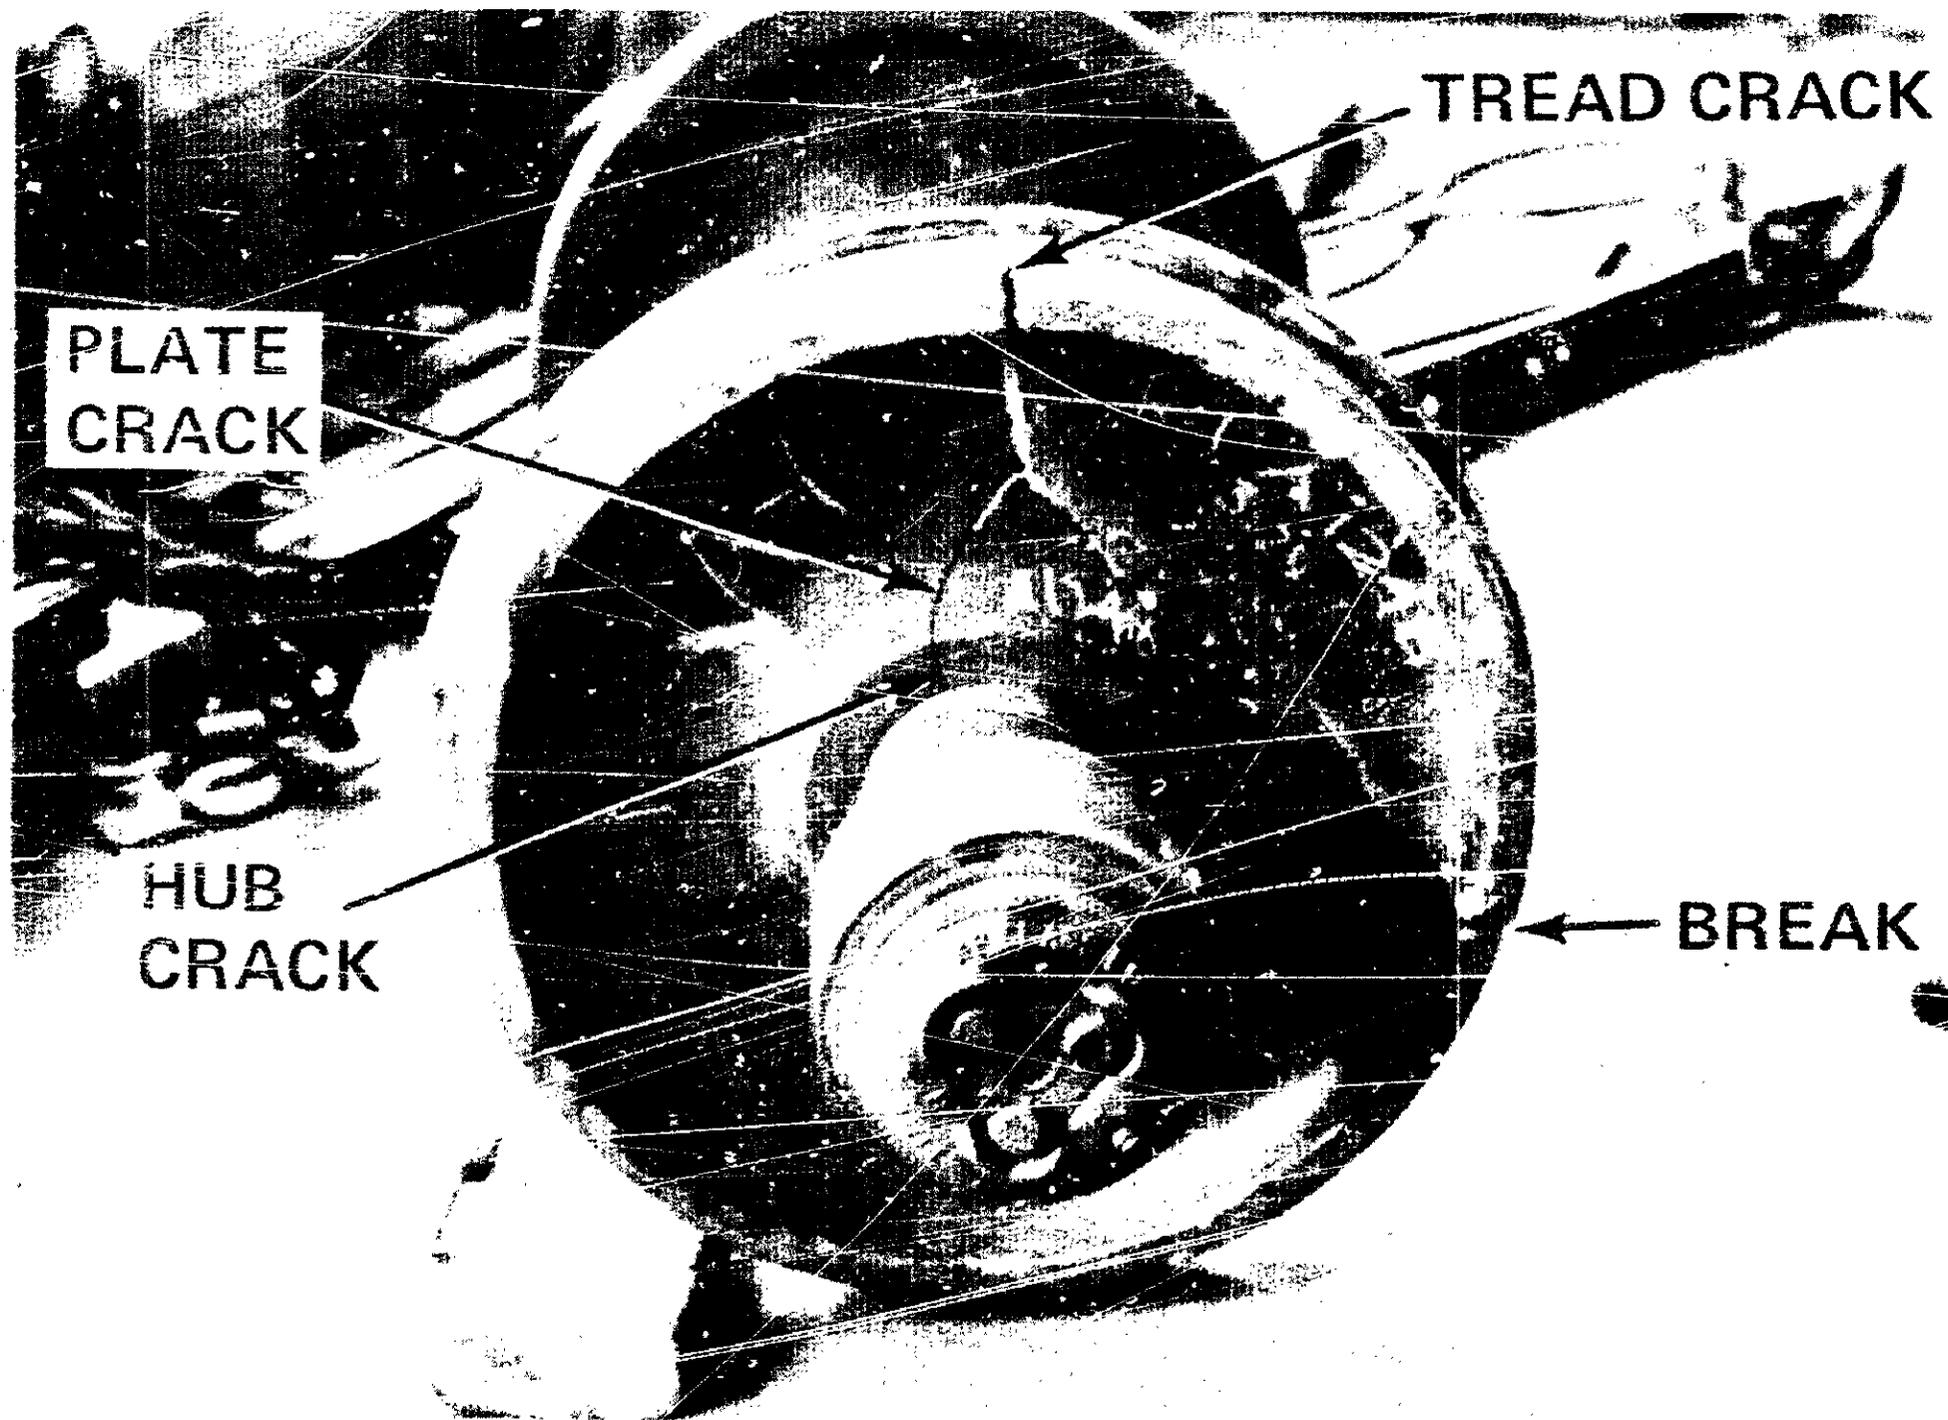
PLATE  
CRACK

TREAD CRACK

HUB  
CRACK

← BREAK

Figure 1. Failed wheel showing crack and break.

The R-1 wheel had a radial break extending from the rim, through the plate, and into the hub. The break line for the broken wheel section was nearly horizontal through the plate. The broken piece of wheel was found 267.5 feet east of the switch, 34.5 feet south of the track's centerline. There was also a 7-inch flat spot on the tread and the flange. There were no batter marks at the rim breaks, and the axle seat showed only slight scoring from the wheel's turning on it.

The broken wheel was sent to the BN's Como laboratory at St. Paul, Minnesota for a metallurgical analysis. The visual examination disclosed a circumferential heat band in the tread adjacent to the flange. Several thermal cracks were evident in the heat band. (See figure 3.) When a section was examined, it was found that a fracture originated in a thermal crack in the tread and then propagated about 3/8 inch into the tread before it finally ruptured. (See figure 4.) The crack then progressed through the plate and hub, which allowed the wheel to move on the axle seat.

The results of the metallurgical tests of the failed wheel corroborate the overheating effect caused by prolonged exposure to the sticking brakes. They also verified that the overheating caused thermal cracks to develop from which the break was initiated. Once the wheel was internally stressed, some externally applied force or forces in the tread overstressed it and the fracture progressed to the hub. The wheel failure was the result of improper use.

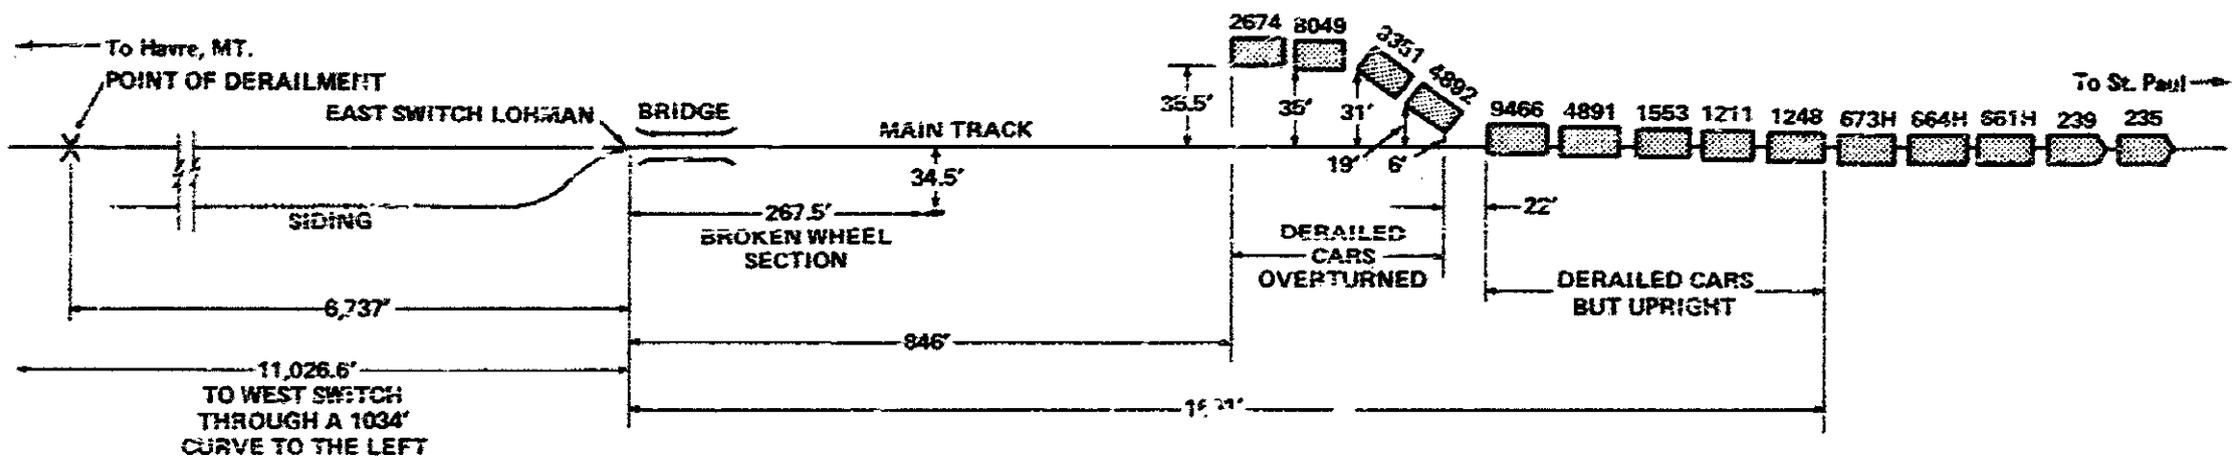
The locomotive and three heater cars were not derailed. The west end of the fourth and the east end of the fifth cars were derailed. The next three cars were derailed but remained upright on the track structure. The coupler between the eighth and ninth cars broke, and the last four cars overturned on their left sides. They stopped approximately parallel to the track on the north slope of the fill upon which the track was built. The locomotive stopped about 1,925 feet east of the east siding switch. (See figure 2.)

Figure 2. Plan view of the derailment.

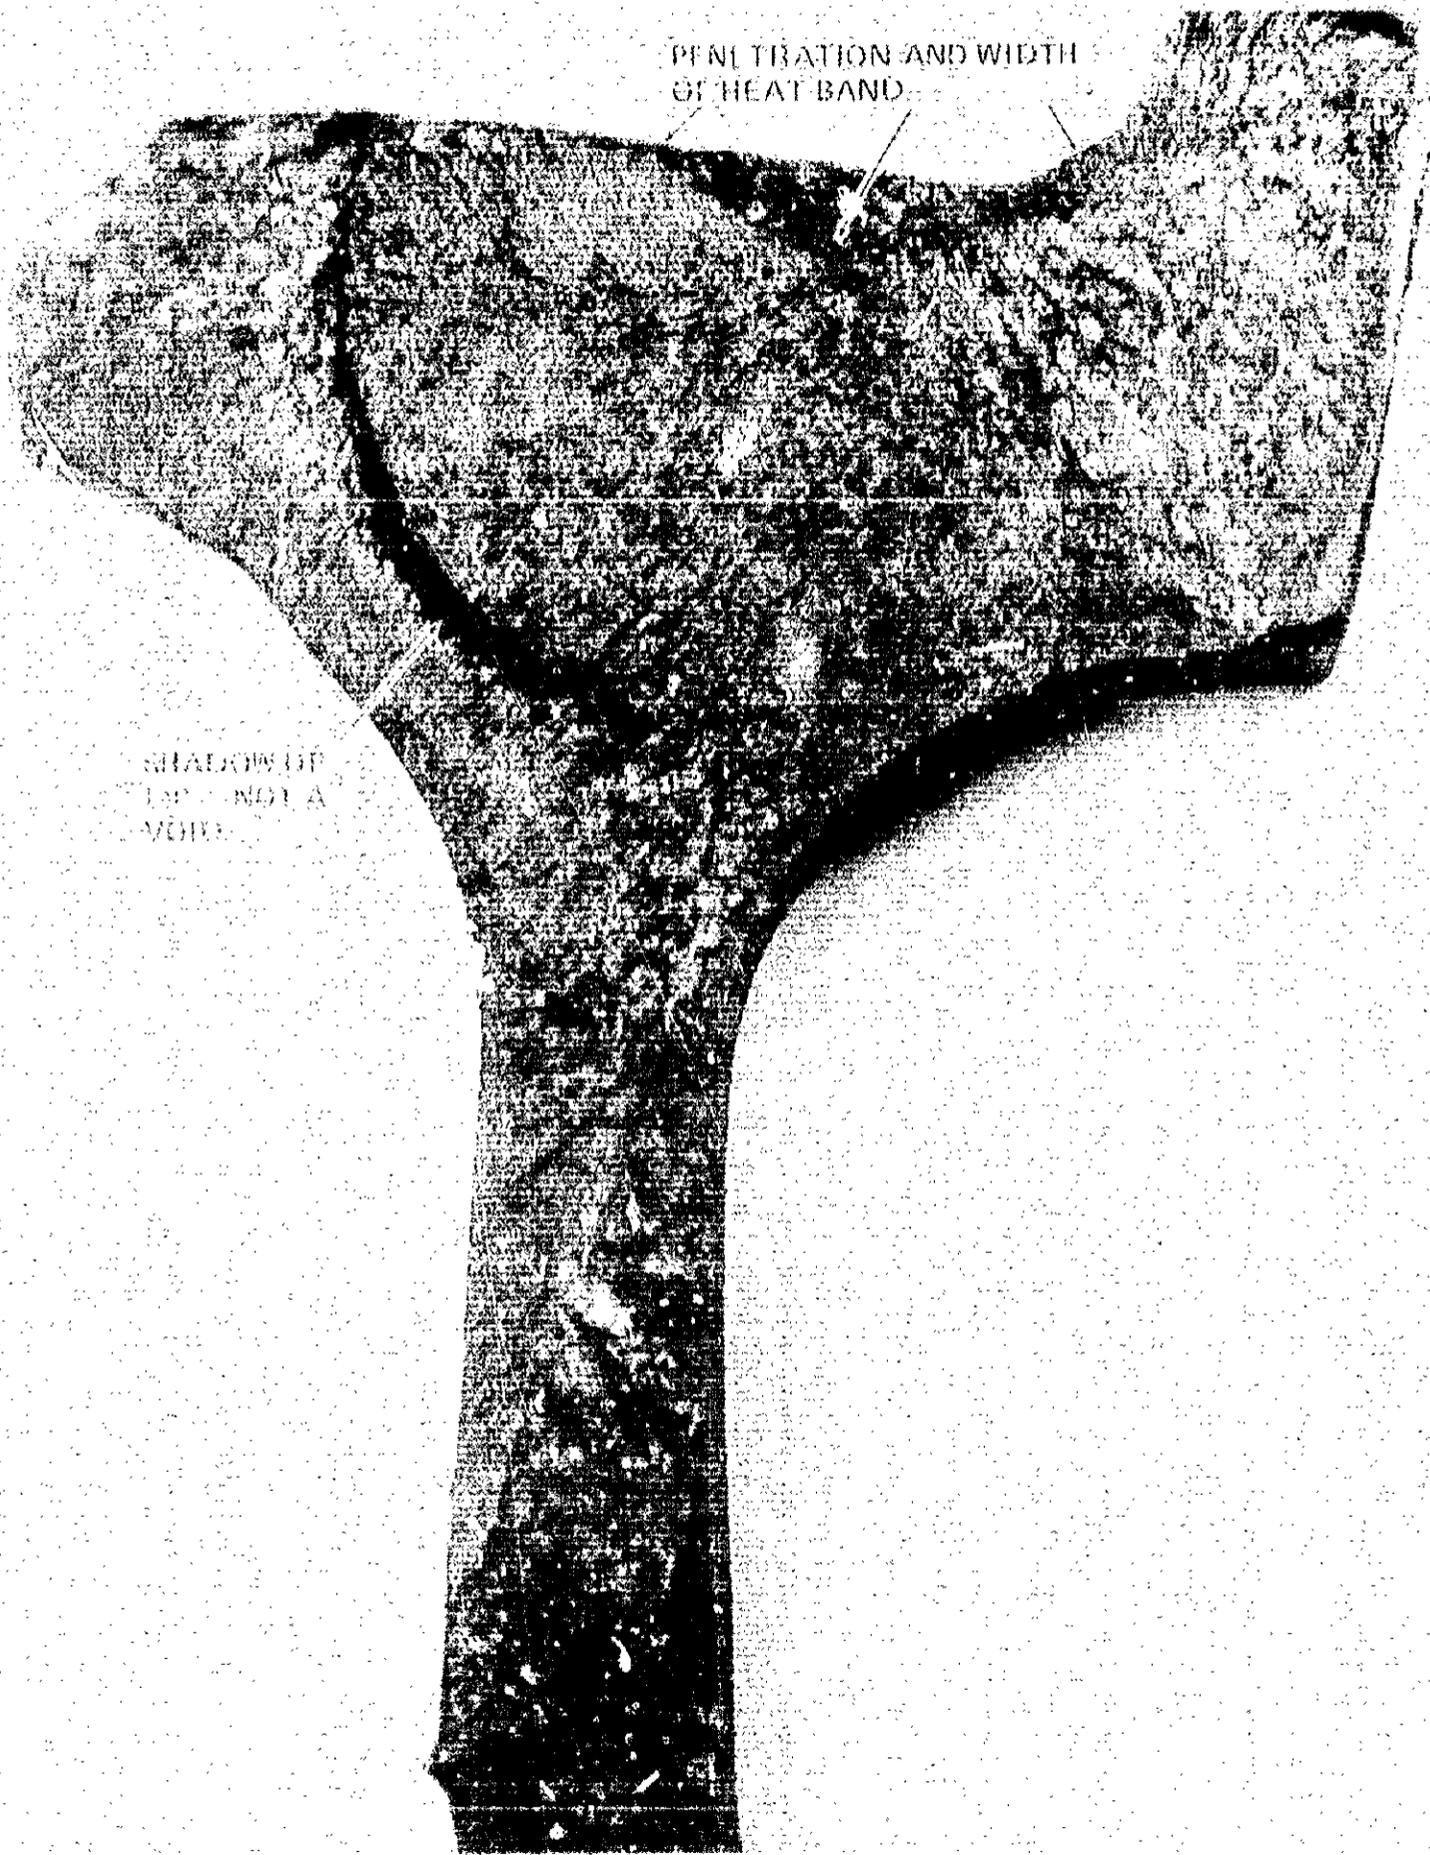
Figure 4. Section of failed wire at the break.
