NATIONAL TRANSPORTATION SAFETY BOARD

RAILROAD ACCIDENT REPORT

REAR-END COLLISION OF TWO
UNION PACIFIC FREIGHT TRAINS
RAMSEY, WYOMING
MARCH 29, 1979

NTSB-RAR-79-9

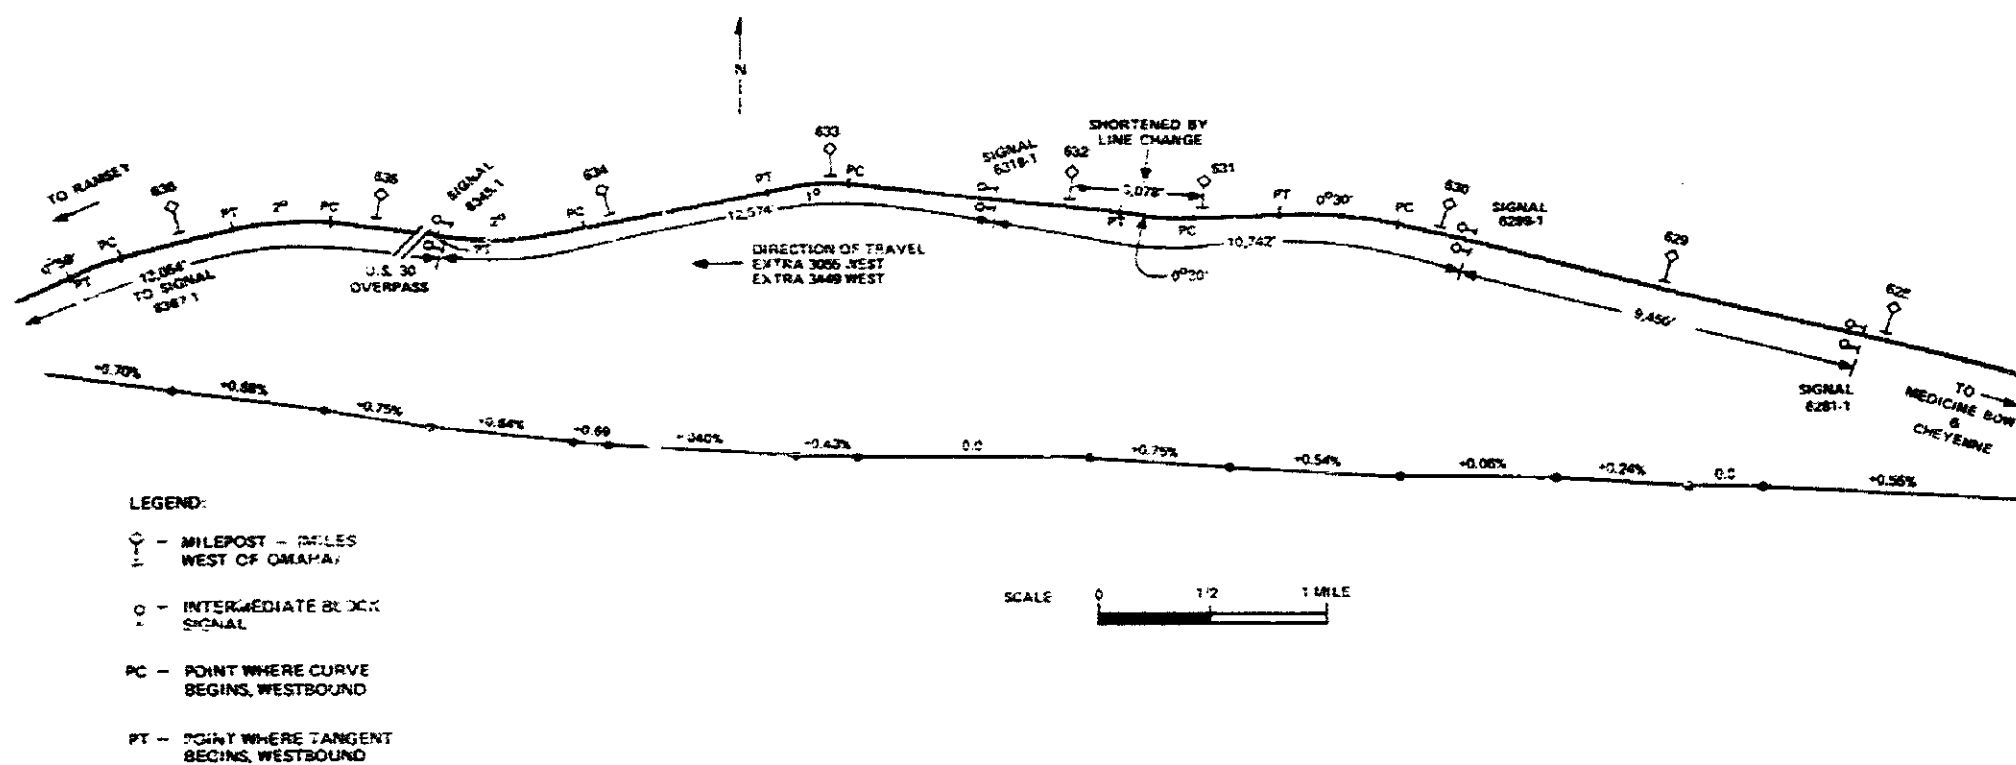
Figure 1. Diagram and profile of approach to accident location from signal 6281-1 to section shown in Figure 2.

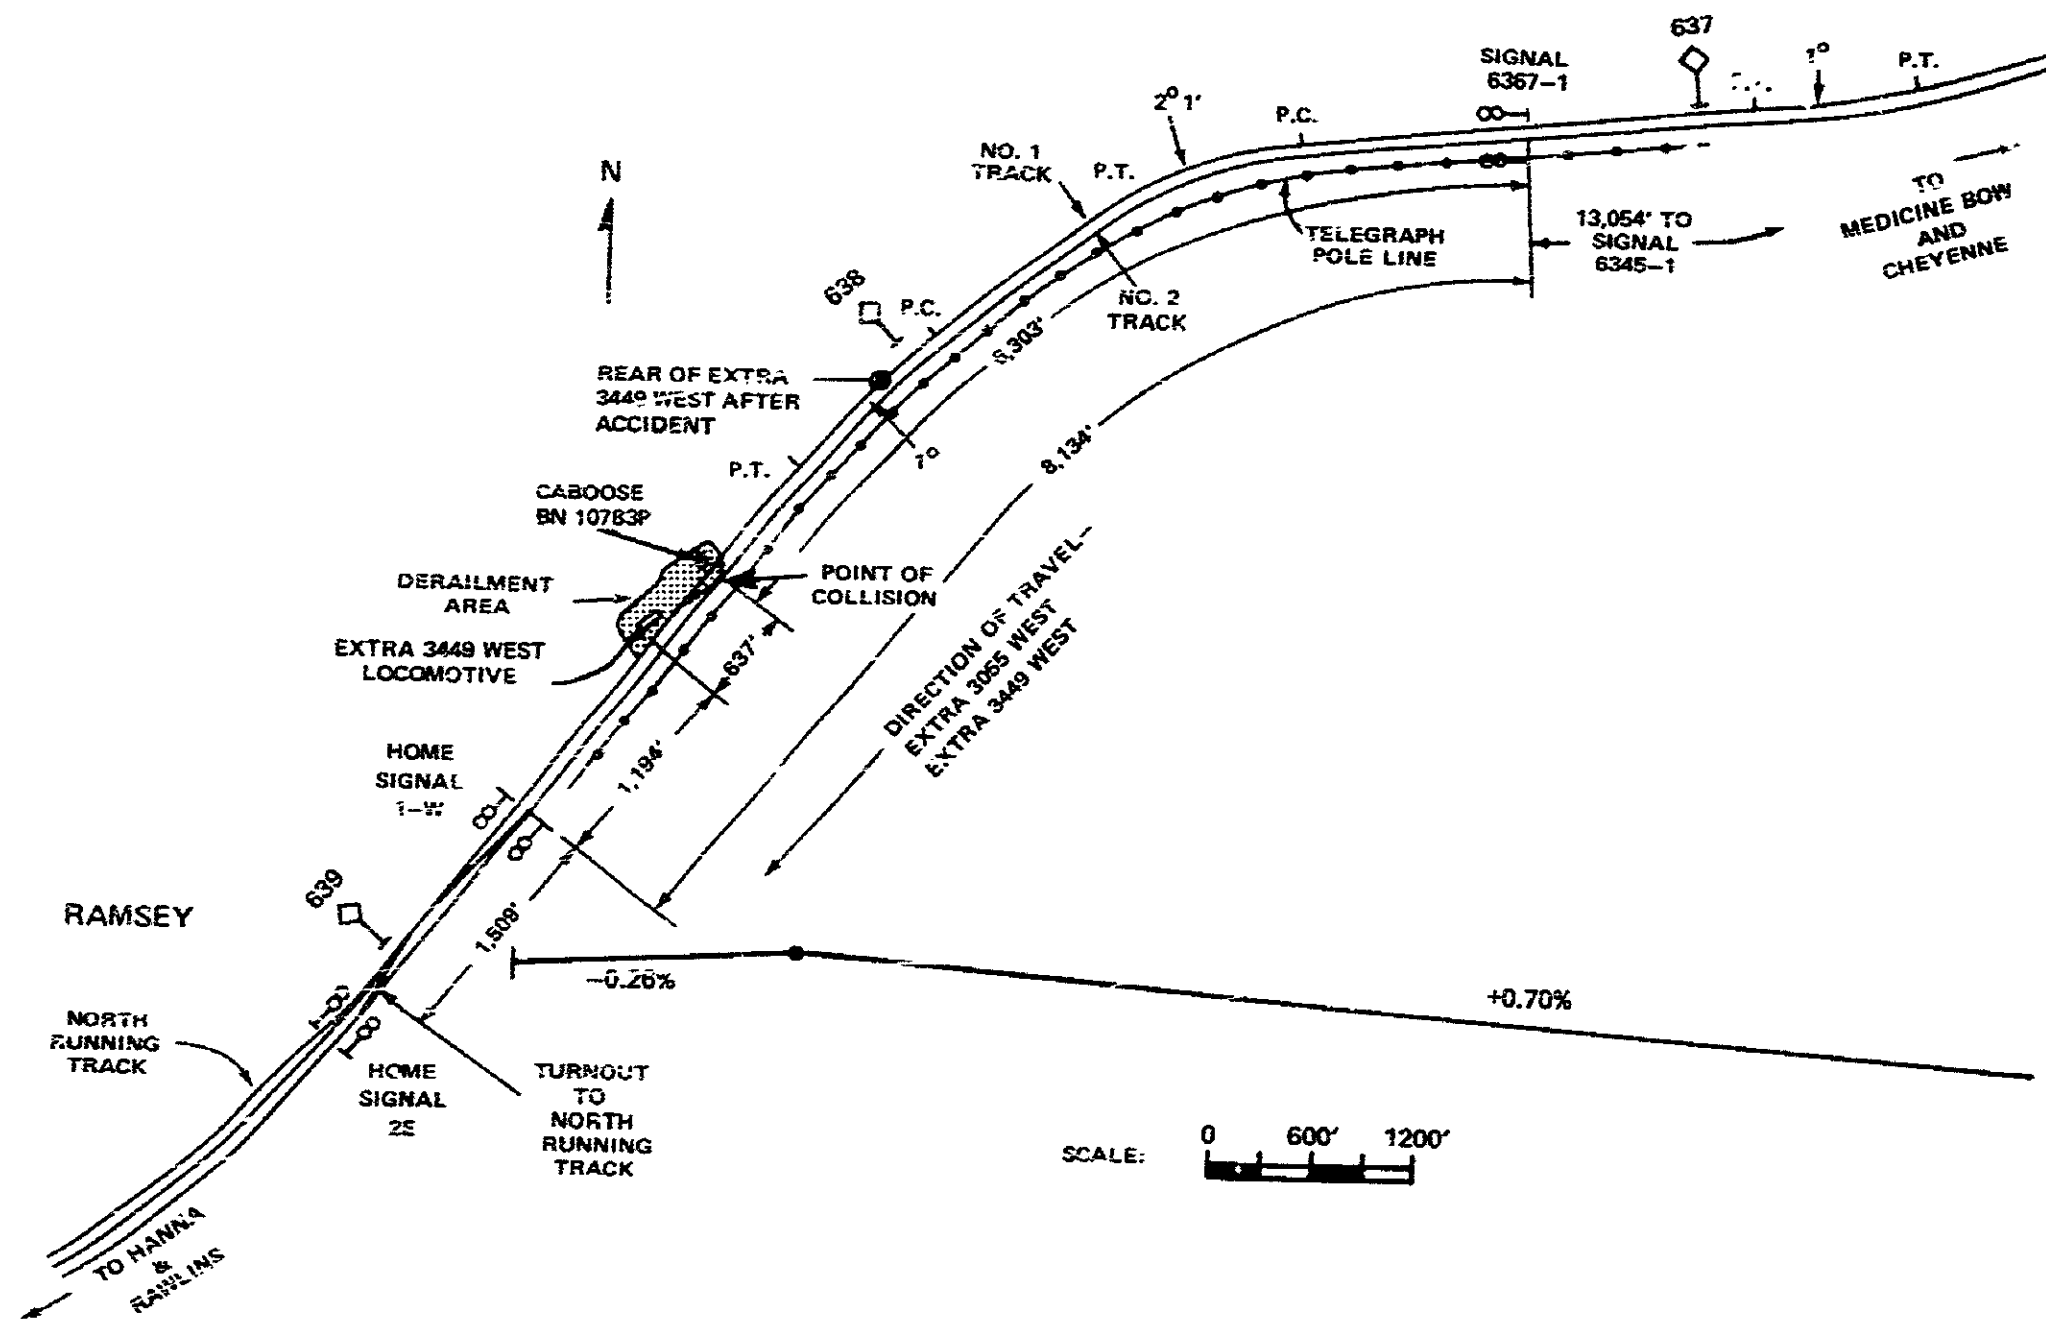
Signal 6299-1, the third signal west of Medicine Bow, can be seen from a westbound train as soon as the train passes the preceding signal more than 9,400 feet to the east. Due to track curvature and terrain, the last three intermediate signals approaching Ramsey -- 6319-1, 6345-1, and 6367-1 -- are first continuously visible to a westbound train at distances of about 3,300, 2,300, and 2,500 feet, respectively. The point of collision could first be seen from a westbound train 2,300 feet to the east. Beyond that point, a pole line south of the main track partially obscured the location. Beginning at signal 6367-1, a westbound train on the No. 1 track moves through a tangent for 1,512 feet, followed by a 2-degree, left-hand curve for 1,174 feet, a tangent of 1,289 feet, and a 1-degree, left-hand curve for 1,597 feet. The remaining 731 feet to the point of collision is tangent. Over the entire distance the grade ascends at the rate of 0.70 percent except for the last 300 feet which is 0.26 percent descending westbound. (See figure 2.)

Figure 2. Diagram and profile of accident location and approach from signal 6367-1.

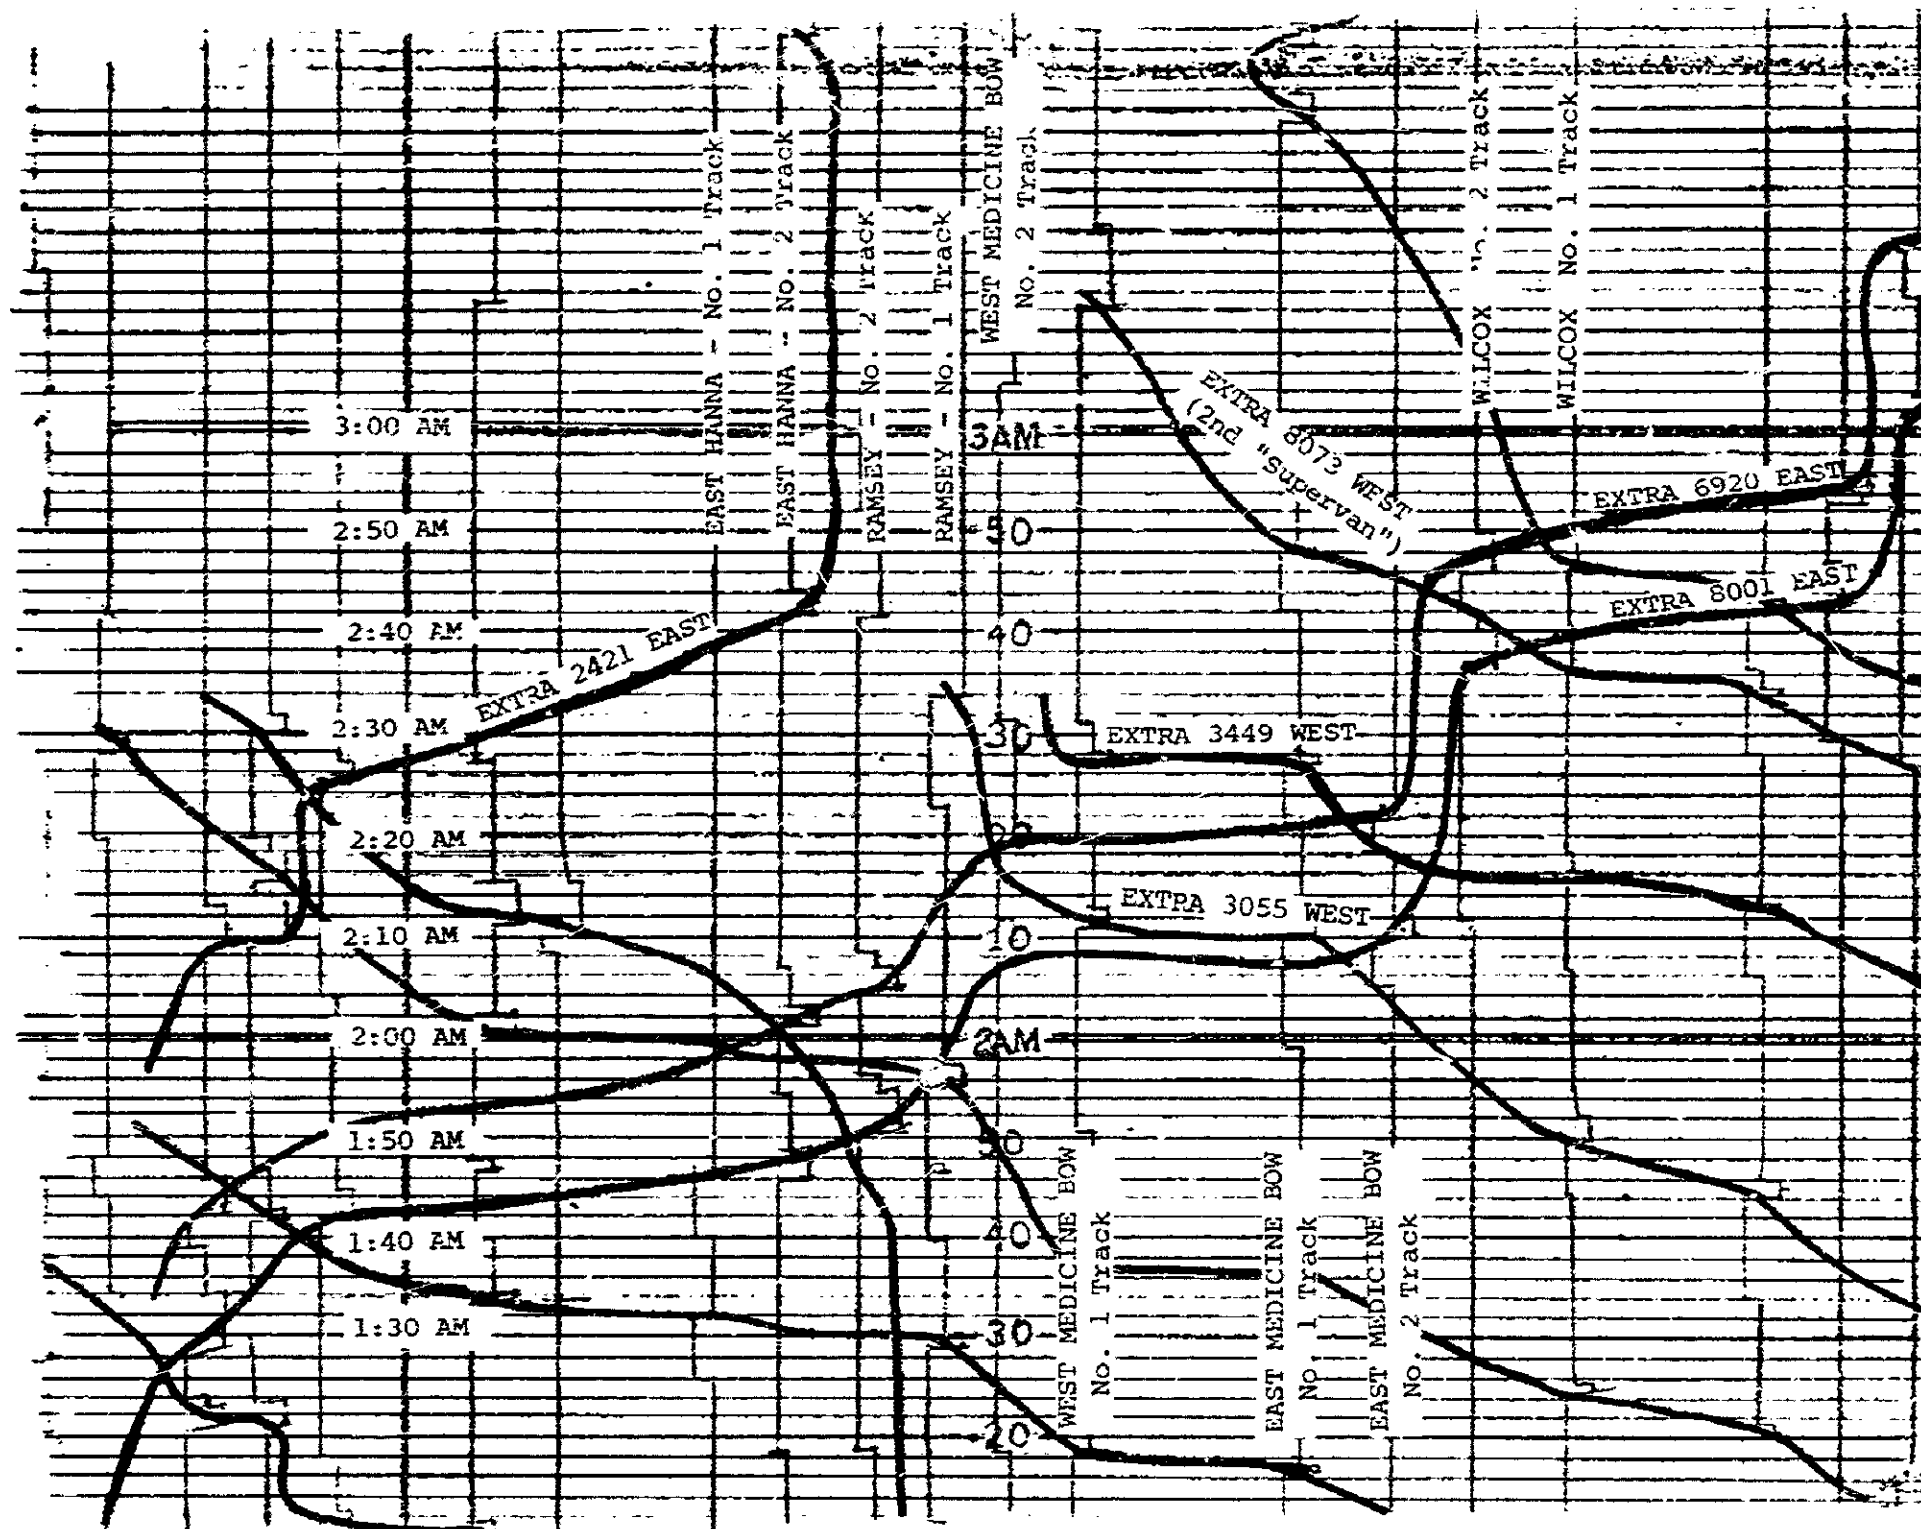
Figure 3. Centralized Traffic Control recording graph for Ramsey-Medicine Bow area from 1:30 a.m. to 3:00 a.m., March 29, 1979. Times, locations, and identification of trains have been superimposed on a copy of the original graph.

The recording graph from the dispatcher's CTC machine was inspected and the various passing times for both westbound trains and the last two eastbound trains they passed generally conformed with the times stated by crewmembers of Extra 3055 West and the eastbound trains. The accuracy of the graph was also confirmed by the passing times of the eastbound trains registered by the operator at Hanna, and by analysis of the speed recorder tapes removed from the lead units of Extra 3055 West and Extra 3449 West. (See appendix C.)
