RAILROAD ACCIDENT REPORT

DERAILMENT OF
UNION PACIFIC RAILROAD
FREIGHT TRAIN
GRANITE, WYOMING
JULY 31, 1979

NTSB-RAR-79-12

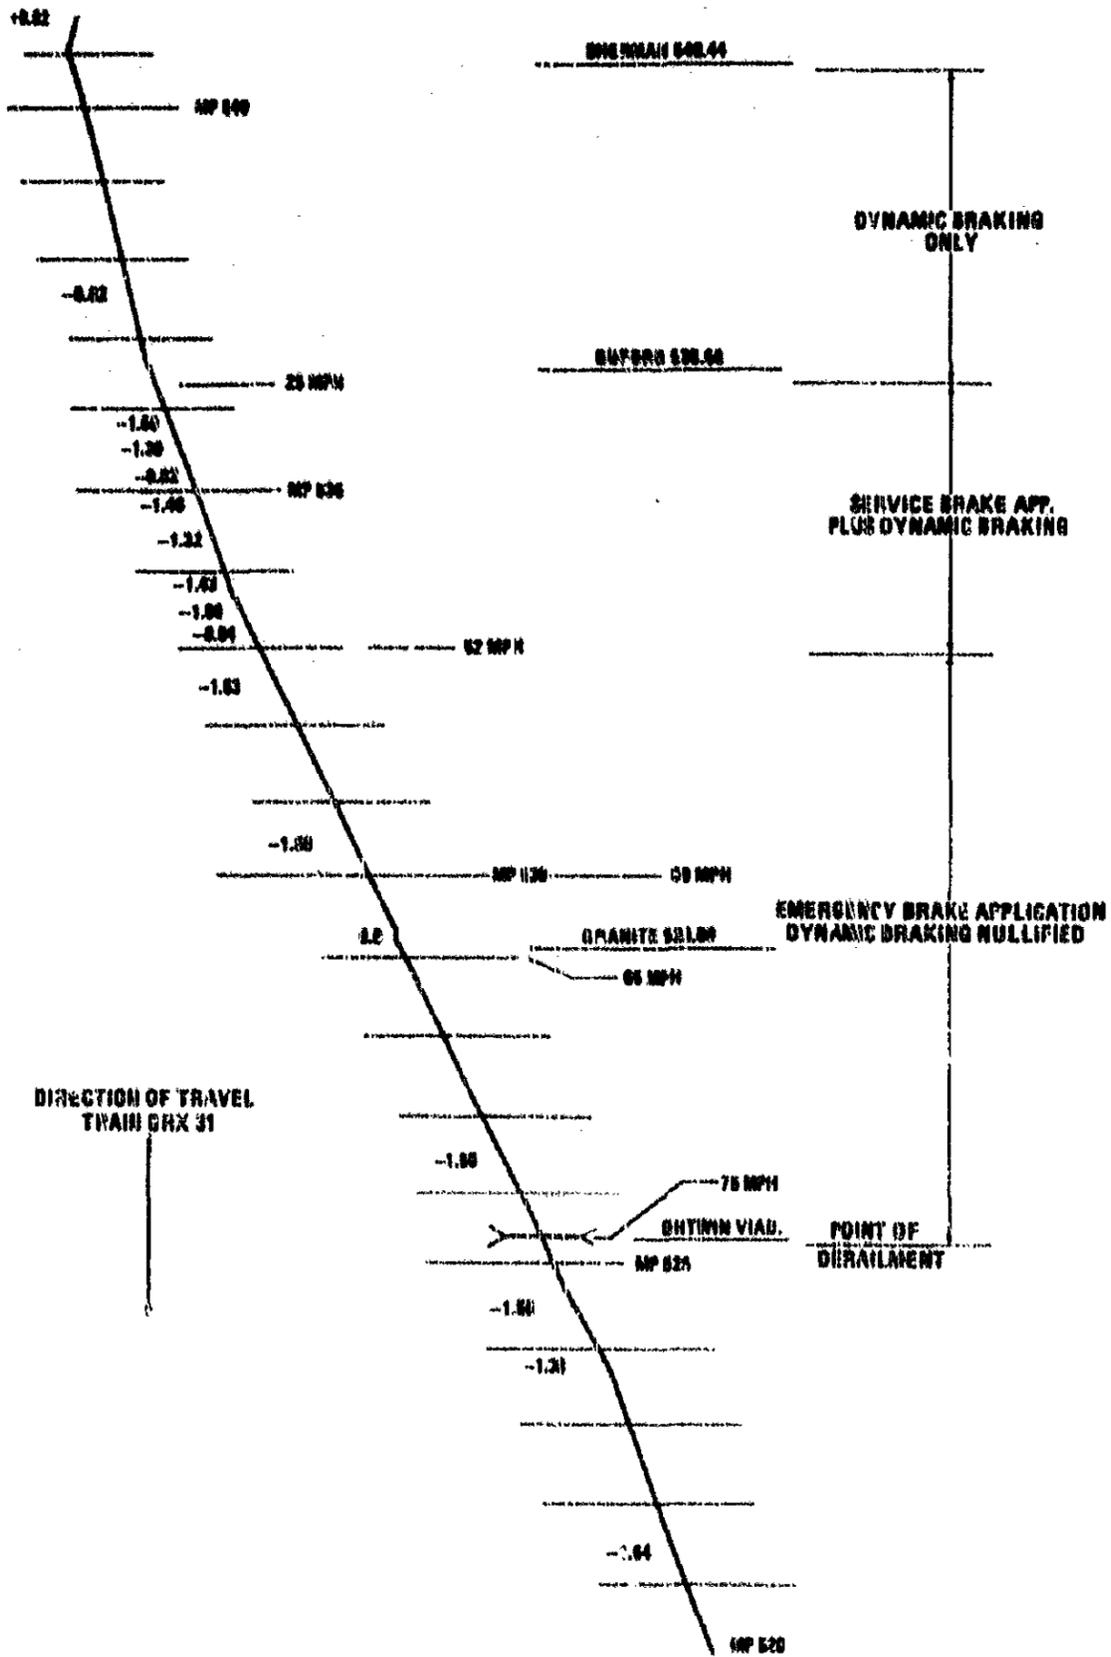
Figure 1. Profile of track between mileposts 540.44 and 520 showing speeds obtained and location of brake application.

To reproduce the dynamics of the train as it descended the grade, 16 tests were conducted on a Train Dynamic Analyzer. (See appendix C.) Tests 1 through 12 failed to produce a profile similar to that described by the engineer. In test No. 13, the analyzer was programmed for the brakes to be applied on only the three locomotive units and the first six cars of the train, as described by the yard train crew at Granite. The movement of the train was then programmed as described by the engineer. This test produced a profile that most nearly duplicated the operation of the train as described by the engineer and indicated by the speed tape.

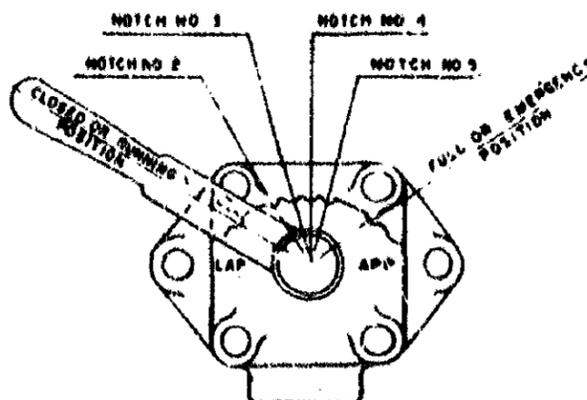
Figure 3. A-1 caboose valve.

Caboose Valve - An air valve connected to the brake pipe for the purpose of applying the brakes from the rear of a train should it become necessary for the crewmen at the rear to bring the train to a stop.
