## RAILROAD ACCIDENT REPORT

REAR END COLLISION OF SOUTHERN PACIFIC  
TRANSPORTATION COMPANY FREIGHT TRAINS  
02-HOLAT-21 AND 01-BSMFK-20  
THOUSAND PALMS, CALIFORNIA  
JULY 24, 1979

NYSB-RAR-80-1

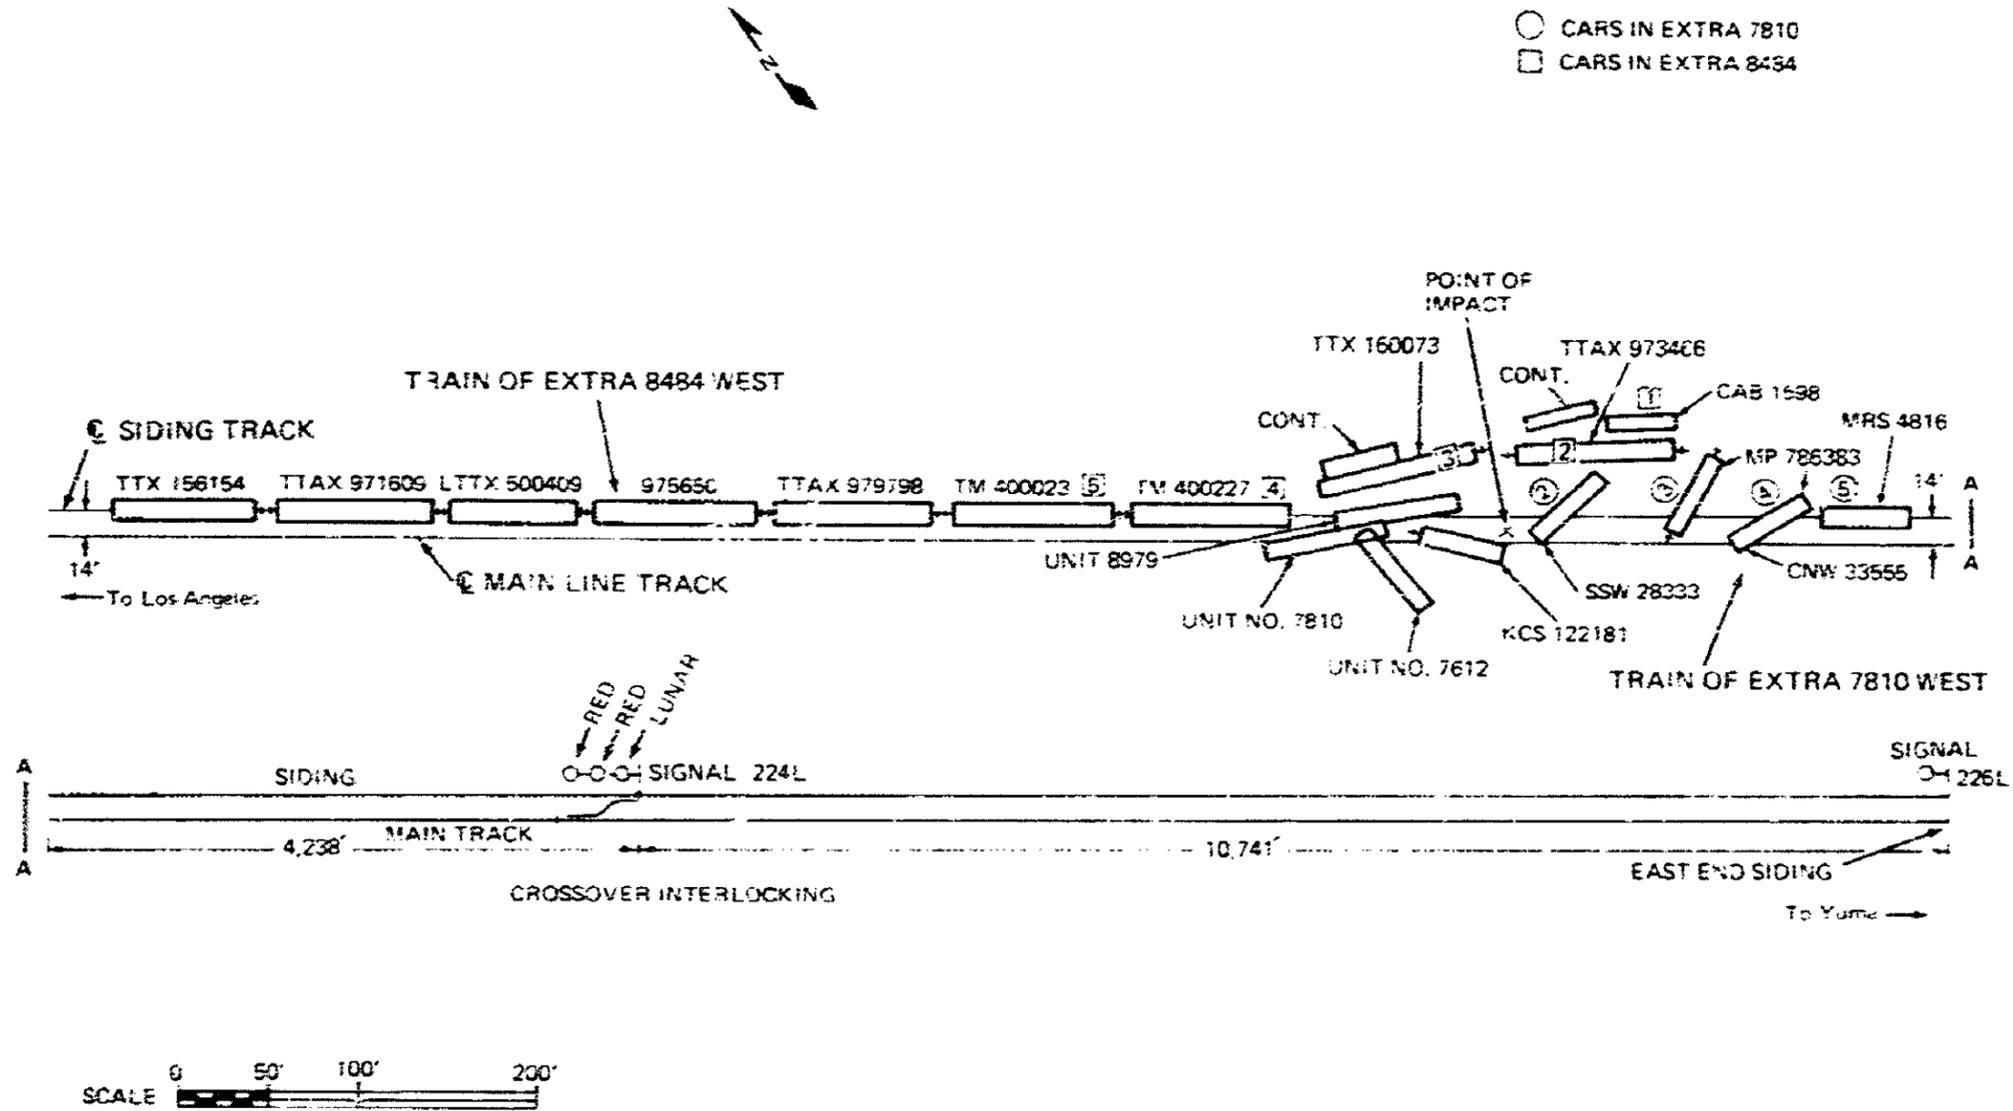
Figure 1. Thousand Palms derailment.

West of the crossover interlocking, the head brakeman remembered seeing the door open on the caboose of Extra 8484. He did not see any persons and he did not remember seeing a red marker light. He was not sure whether or not he operated the emergency brake valve on the fireman's side, but he thought he did. He did not call the aspect of signal 224L at the crossover interlocking to the engineer, but he recalled the engineer telling him that the train ahead was moving out and "we will follow it down to the west end." He said he did not question this logic. Shortly thereafter, about 4:03 a.m., while moving at approximately 20 mph, Extra 7810 West struck the rear of Extra 8484 West about 4,238 feet west of the crossover interlocking signal. (See figure 1.)

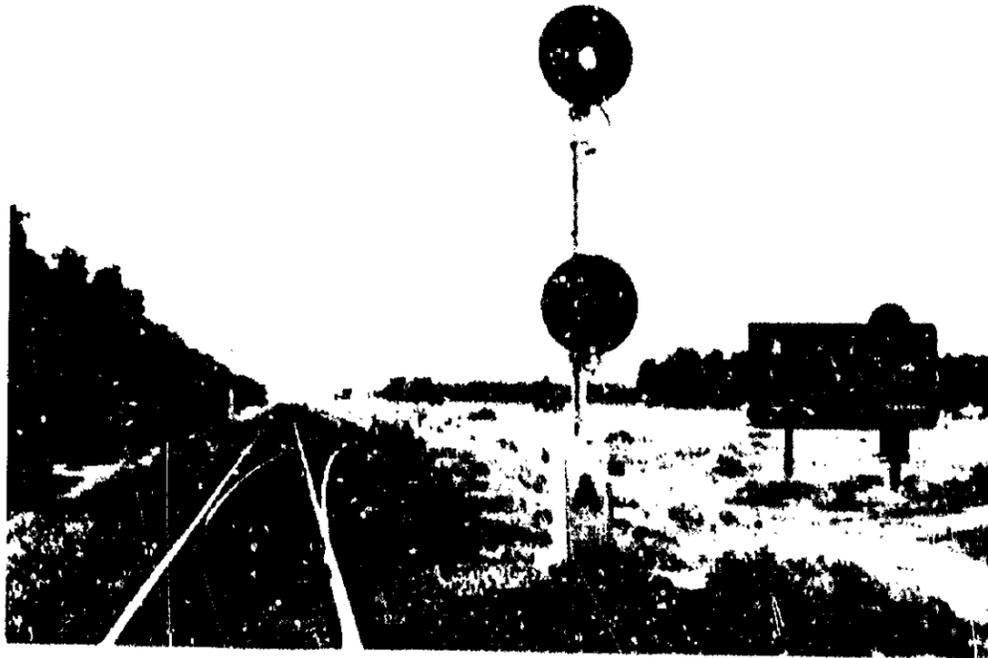
Figure 3. Signal 226L east entrance to Thousand Palms siding and view west.

The head brakeman of Extra 7810 West said that he remembered a red over yellow signal aspect at the east entrance to the siding at Thousand Palms, which permitted the train to proceed at a restricted speed, but that he did not call it to the engineer as required by operating rule 34. He did not recall the signal aspect displayed by the crossover interlocking home signal, signal 224L, at the midway point of the siding, but he said that he saw a flashing white light at that point. He did not take any action in either instance.

The track at Thousand Palms is tangent with a grade averaging about 1.13 percent ascending westward from Myoma and continuing westward. A siding 21,620 ft in length parallels the main track on the north. A crossover connecting the siding with the main track is located 10,471 ft from the east end of the siding. (See figures 3 and 4.)

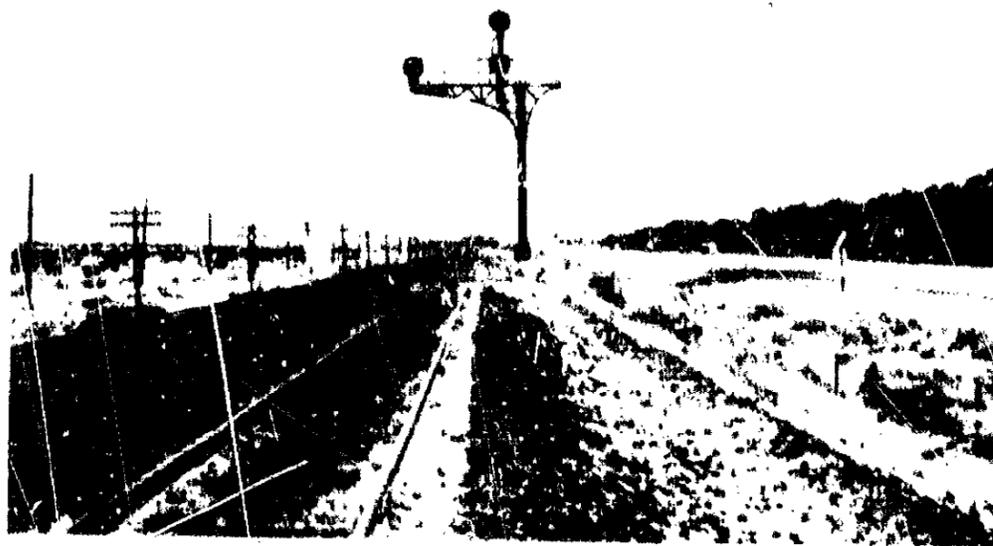
Figure 4. Signal 224I, at crossover interlocking and Thousand Palms siding and view west.

5. Signal 224L displayed a stop aspect when Extra 7810 West passed.
6. Extra 7810 West passed the stop aspect of the signal at the crossover interlocking without stopping.
