# NATIONAL TRANSPORTATION SAFETY BOARD

## RAILROAD ACCIDENT REPORT

REAR END COLLISION OF  
CONSOLIDATED RAIL CORPORATION  
FREIGHT TRAINS ALPG-2 AND APJ-2  
NEAR ROYERSFORD, PENNSYLVANIA  
OCTOBER 1, 1979

NTSB-RAR-80-2

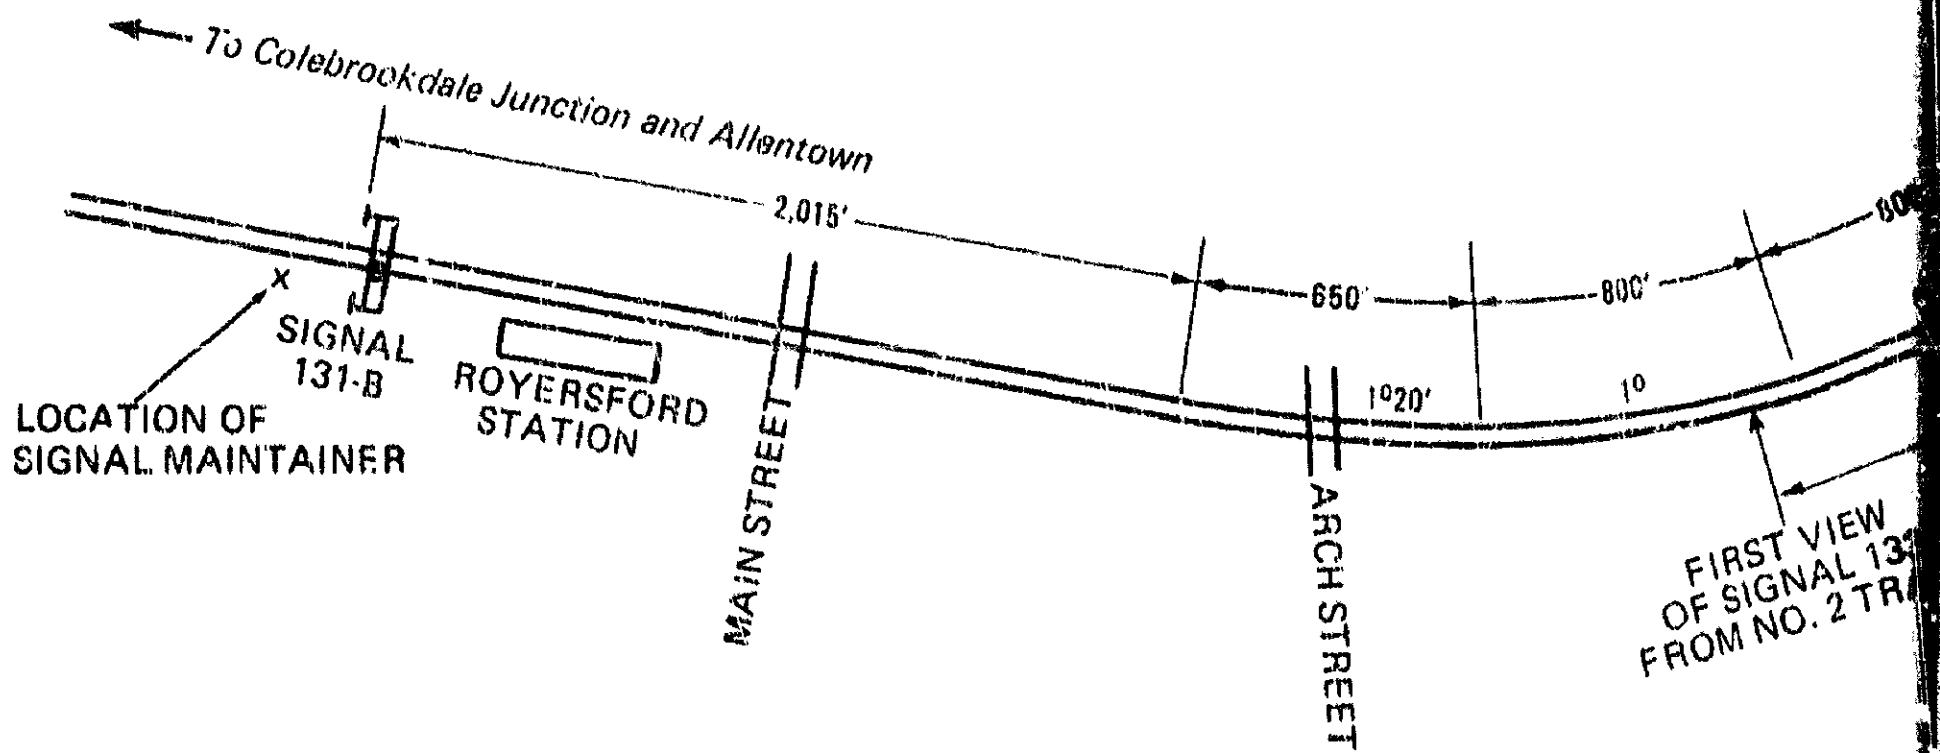
**Figure 2. Diagram of accident location**

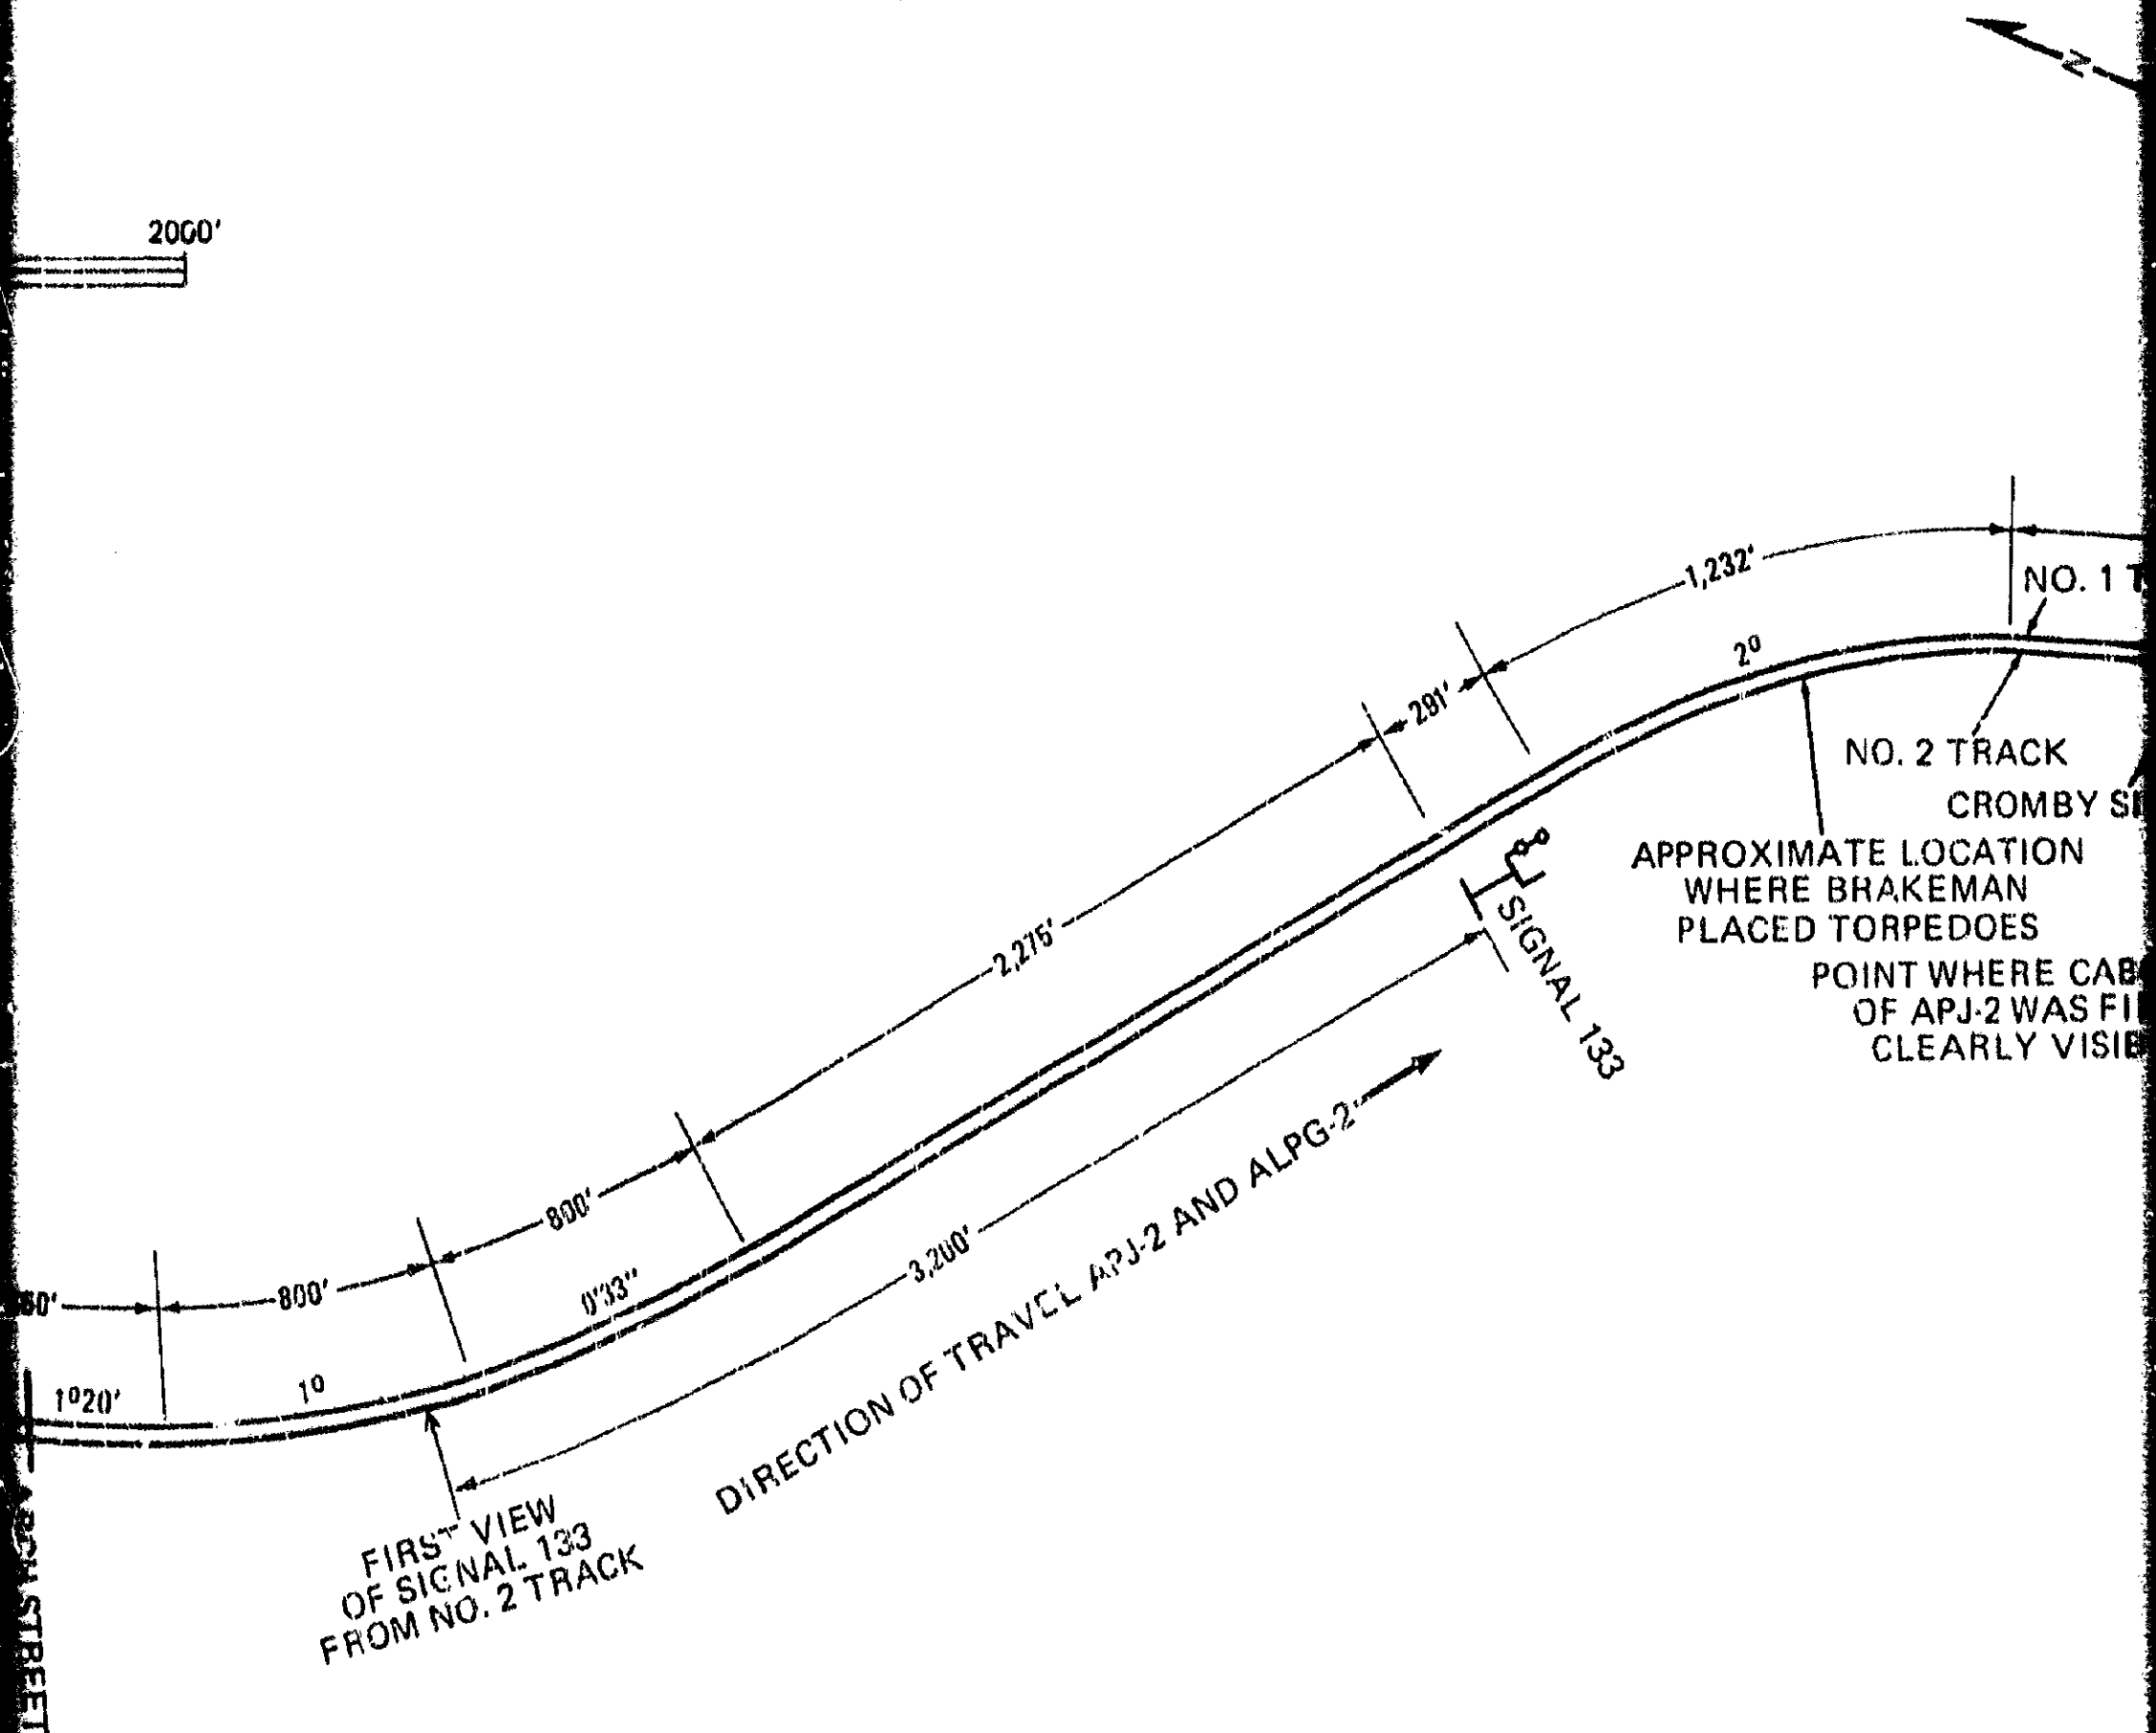
**of accident location and approach from signal 131-B**
