# NATIONAL TRANSPORTATION SAFETY BOARD

## RAILROAD ACCIDENT REPORT

HEAD-END COLLISION OF  
AMTRAK TRAIN NO. 392 AND  
ICG TRAIN NO. 51  
HARVEY, ILLINOIS  
OCTOBER 12, 1979

NTSB-RAH-80-3

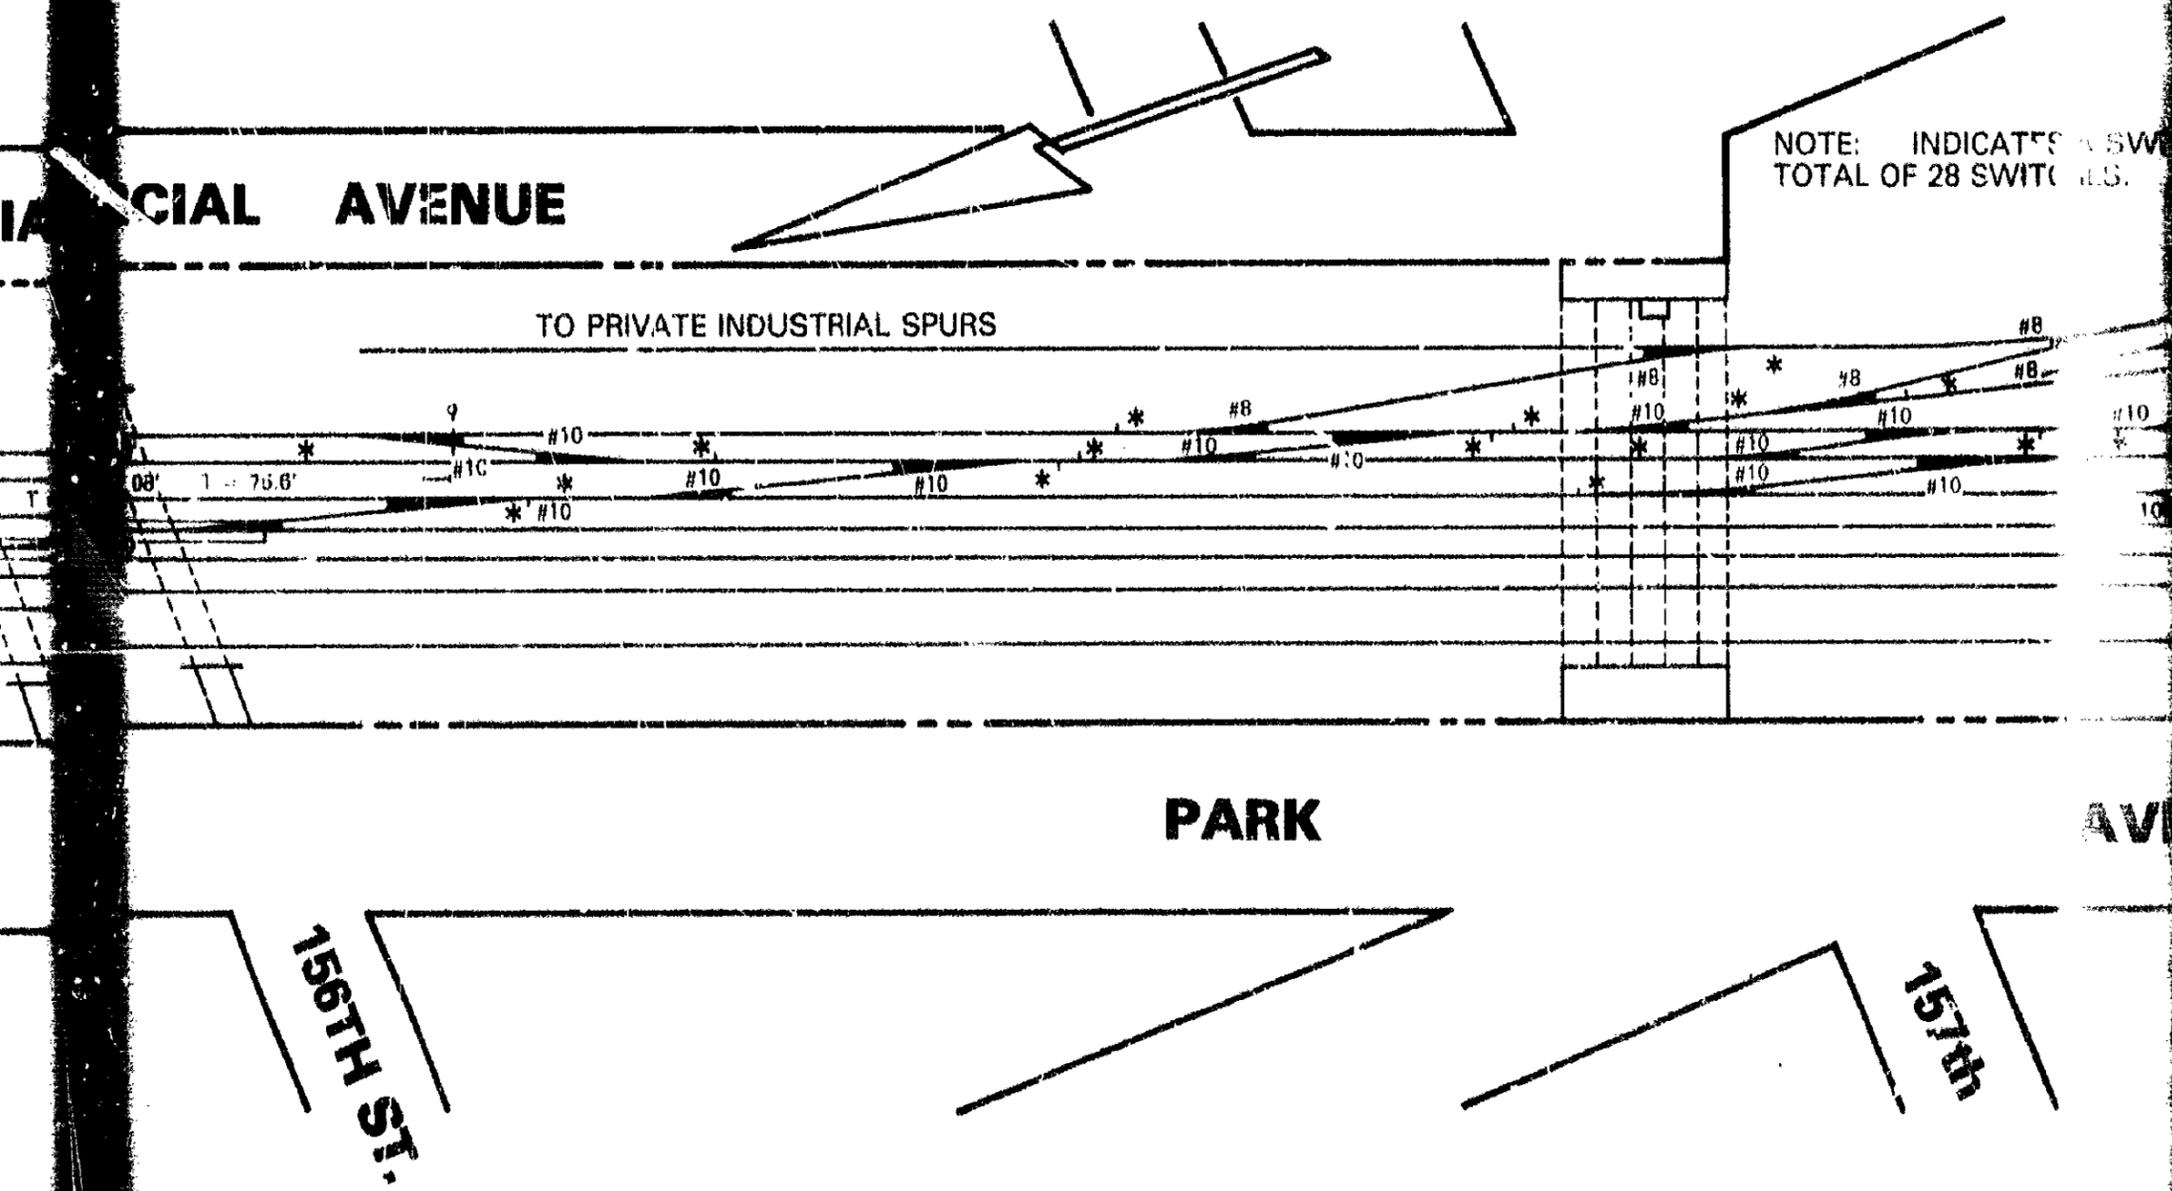
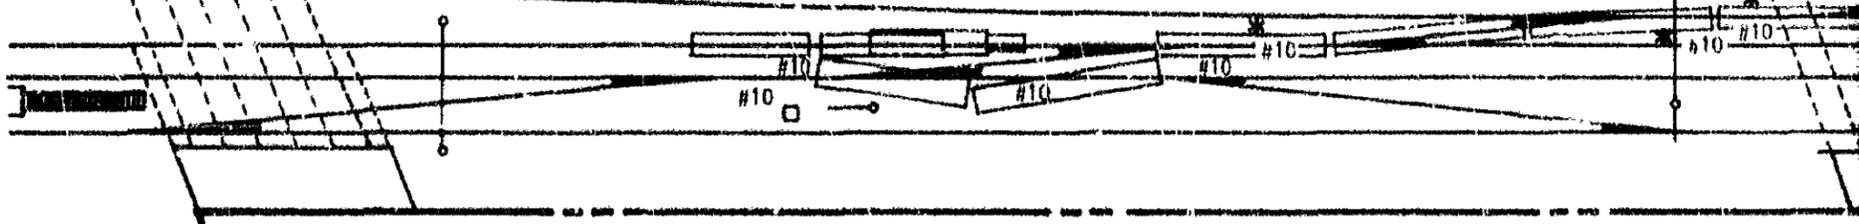
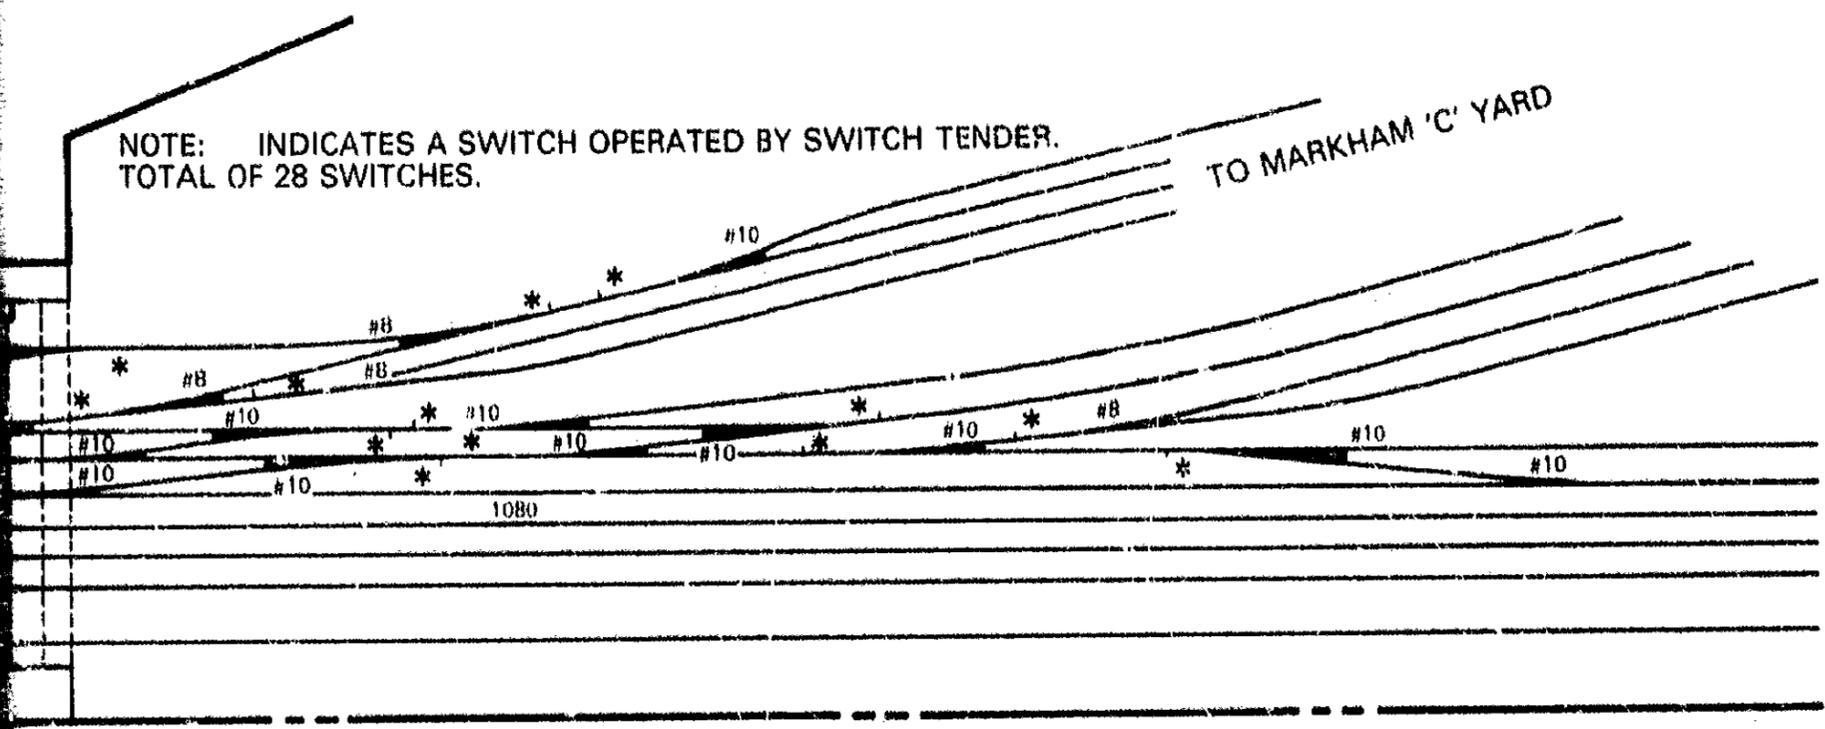
Figure 2. Plan view of accident site.

Seven crossovers permitted trains to cross over from one track to another and to enter and leave Harvey yard. (See figure 2.)

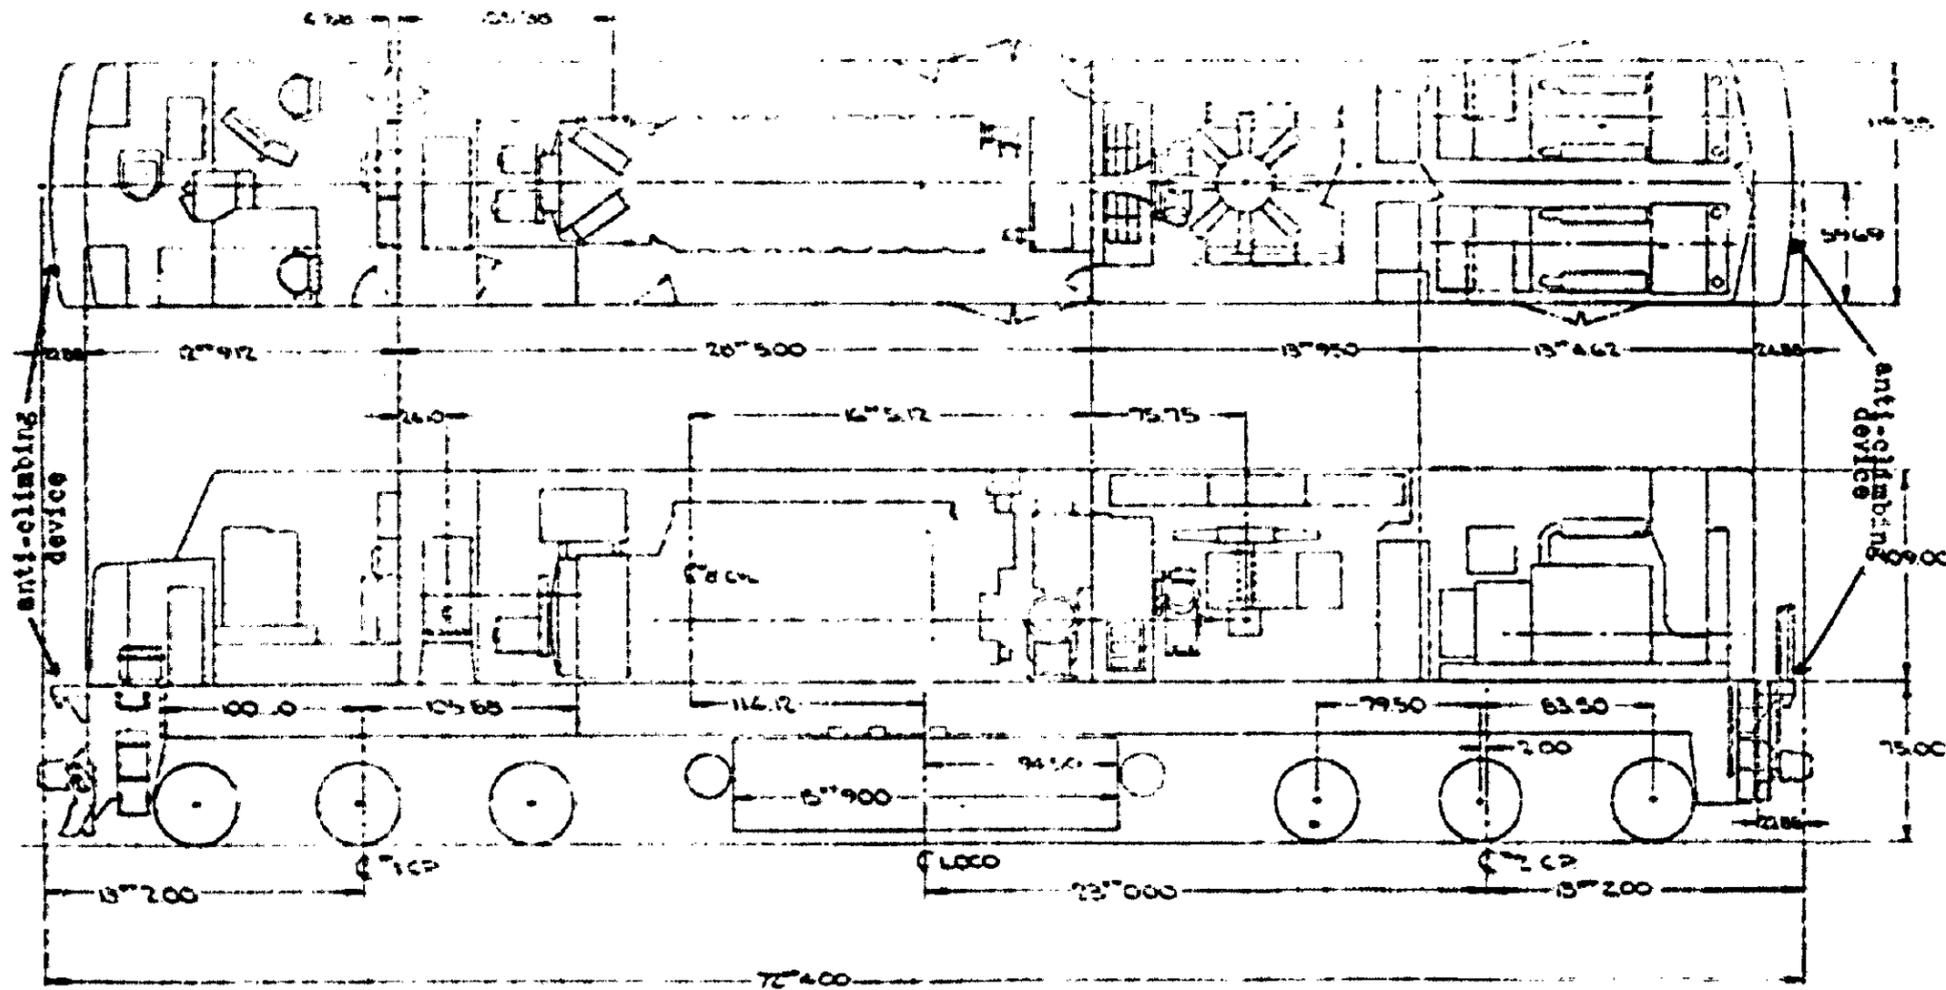
Figure 4.--General Electric Model P30CH diesel-electric locomotive.

Train No. 392 consisted of one General Electric Model P30CH diesel-electric locomotive unit and five superliner coaches. The locomotive unit was equipped with a dual sealed-beam headlight, speed indicator and recorder, overspeed control, alertor safety device, and cab signals with an acknowledging switch. On this class of locomotive, a steel constructed antilimbing device at each end of the platform extends 20 inches outward from the underframe and is 6 feet 3 inches above the top of the rail. The device is strengthened by two steel supports on the underside, which are an extension of the center sill of the underframe and are tapered on the leading end. (See figure 4.)
