NATIONAL TRANSPORTATION SAFETY BOARD

RAILROAD ACCIDENT REPORT

DERAILMENT OF AMTRAK TRAIN NO. 4
THE SOUTHWEST LIMITED
ON THE ATCHISON, TOPEKA
AND SANTA FE RAILWAY COMPANY
LAWRENCE, KANSAS
OCTOBER 2, 1979

NYSB-RAR-80-4

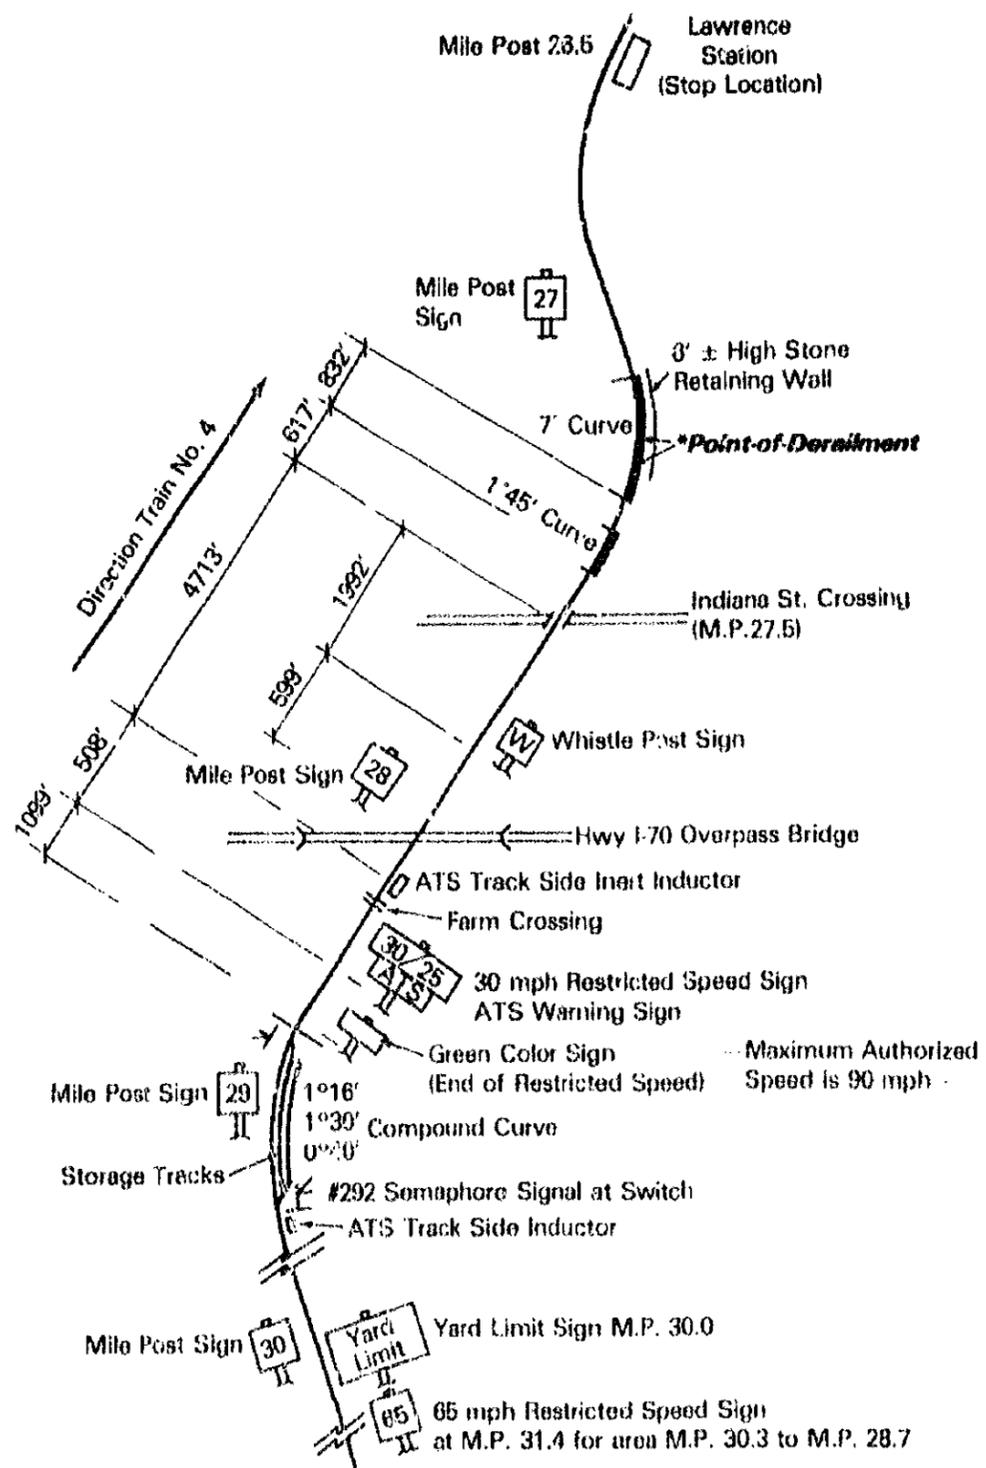
(not to scale)
 Figure 2.--Plan view of track and signs approaching derailment site.

SIGN	DISTANCE BETWEEN
Indiana St. Crossing	1092'
Whistle Post	599'
Mile Post 28	2620'
30/25 mph Sign(missing)	1099'
Green Board	1581'
Mile Post 29	1387'
Signal No. 202	3892'
Yard Limit Sign	1'
Mile Post 30	5280'
Mile Post 31	1700'
Whistle Post	1233'
65/60 mph Sign	340'
Signal No. 312	1748'
Lakeview Station Sign	2093'
Signal No. 314	168'
Mile Post 32	5095'
Station Board	185'
Mile Post 33	1222'
Whistle Post	2396'
Whistle Post	1662'
Mile Post 34	1841'
Green Board	139'
Whistle Post	3300'
Mile Post 35	505'
Signal No. 352	2951'
65/60 mph Sign	1744'
Mile Post 36

9. The location of the resume-speed sign 1,099 ft before the missing 30/25-mph speed-restriction sign gave the engineer a misleading indication of how to operate the train entering Lawrence.

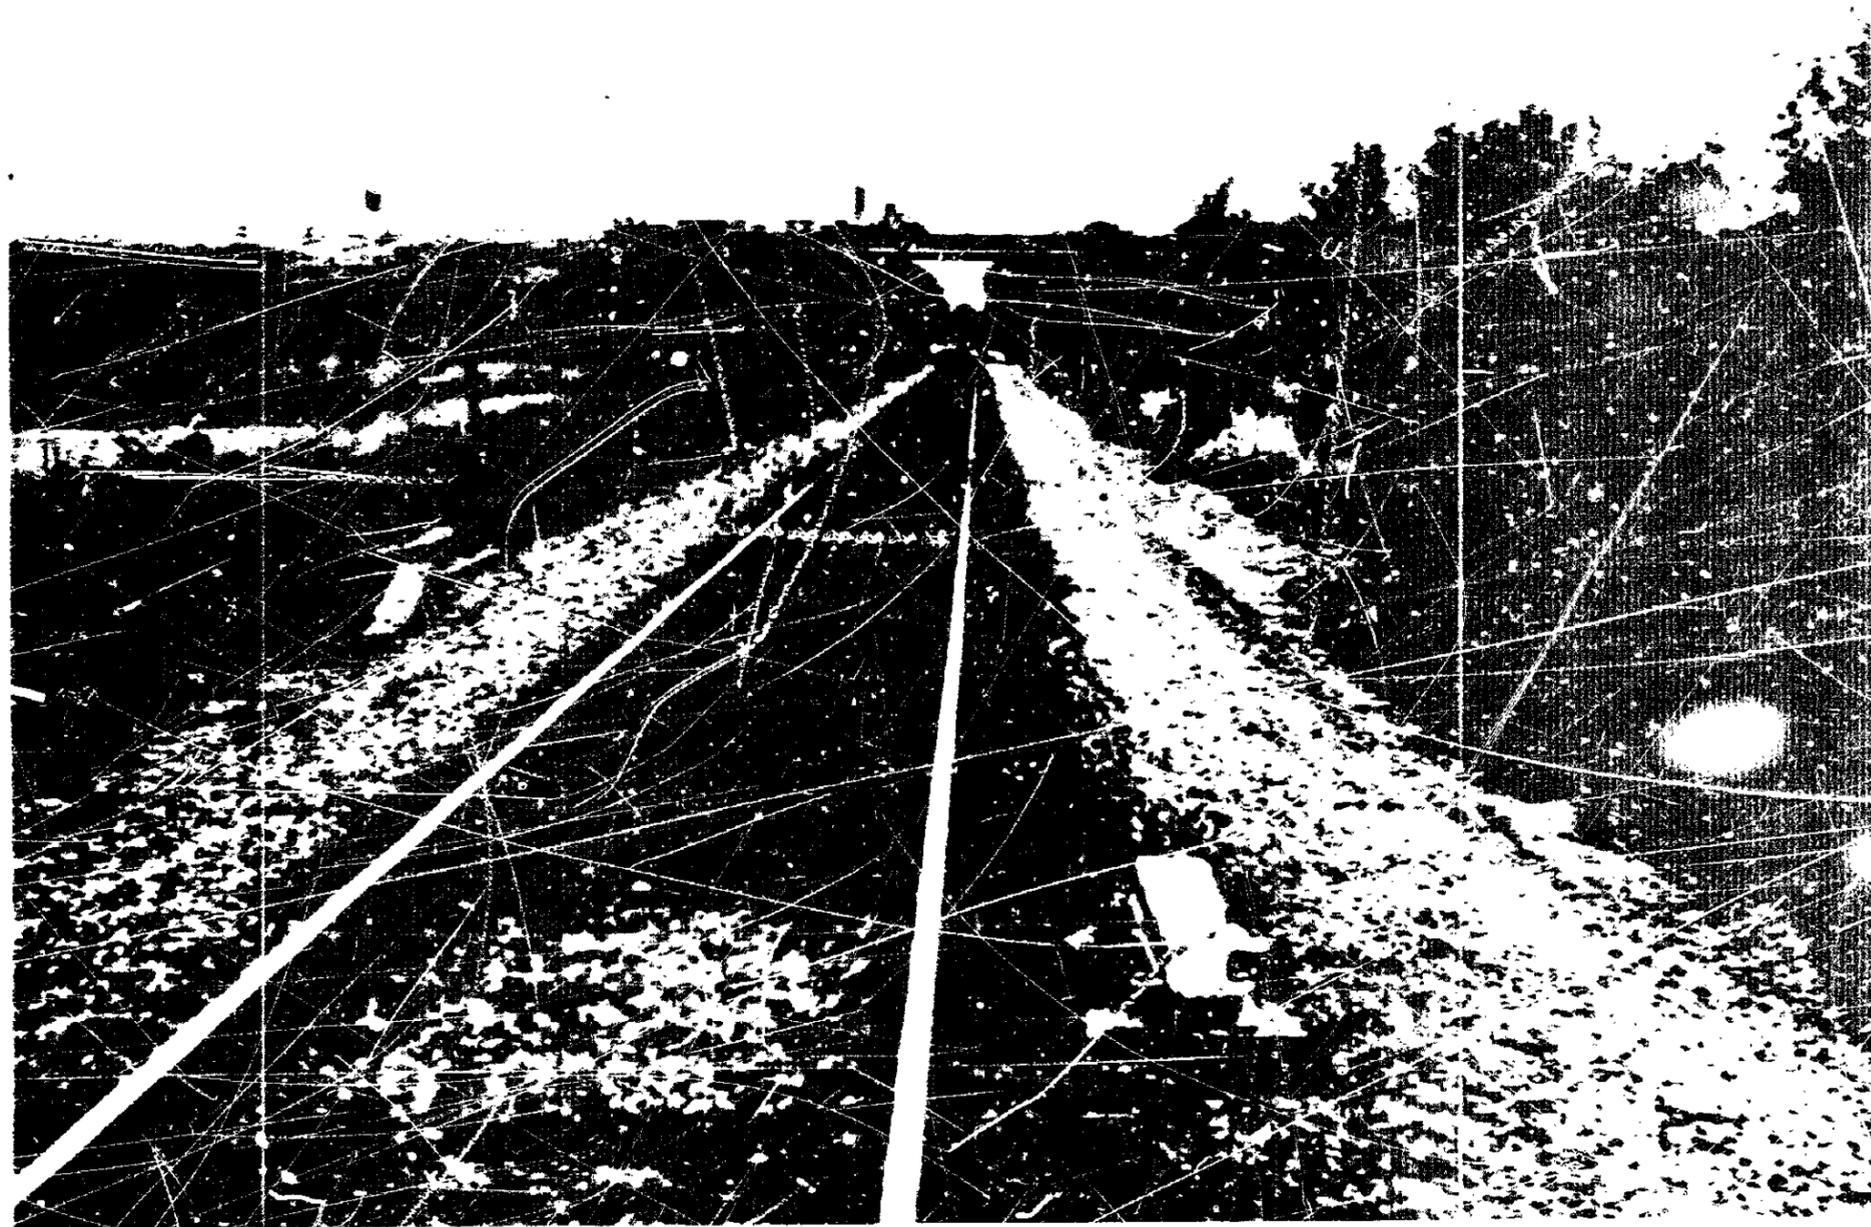
Figure 5.--Inert inductor to outside of right rail on south side of track.

Postaccident inspection of the ATS inert inductor for the six curves at Lawrence indicated that it was in good condition and was properly located. Its height above top-of-rail was 2 7/8 in, which is the proper height according to AT&SF standards.

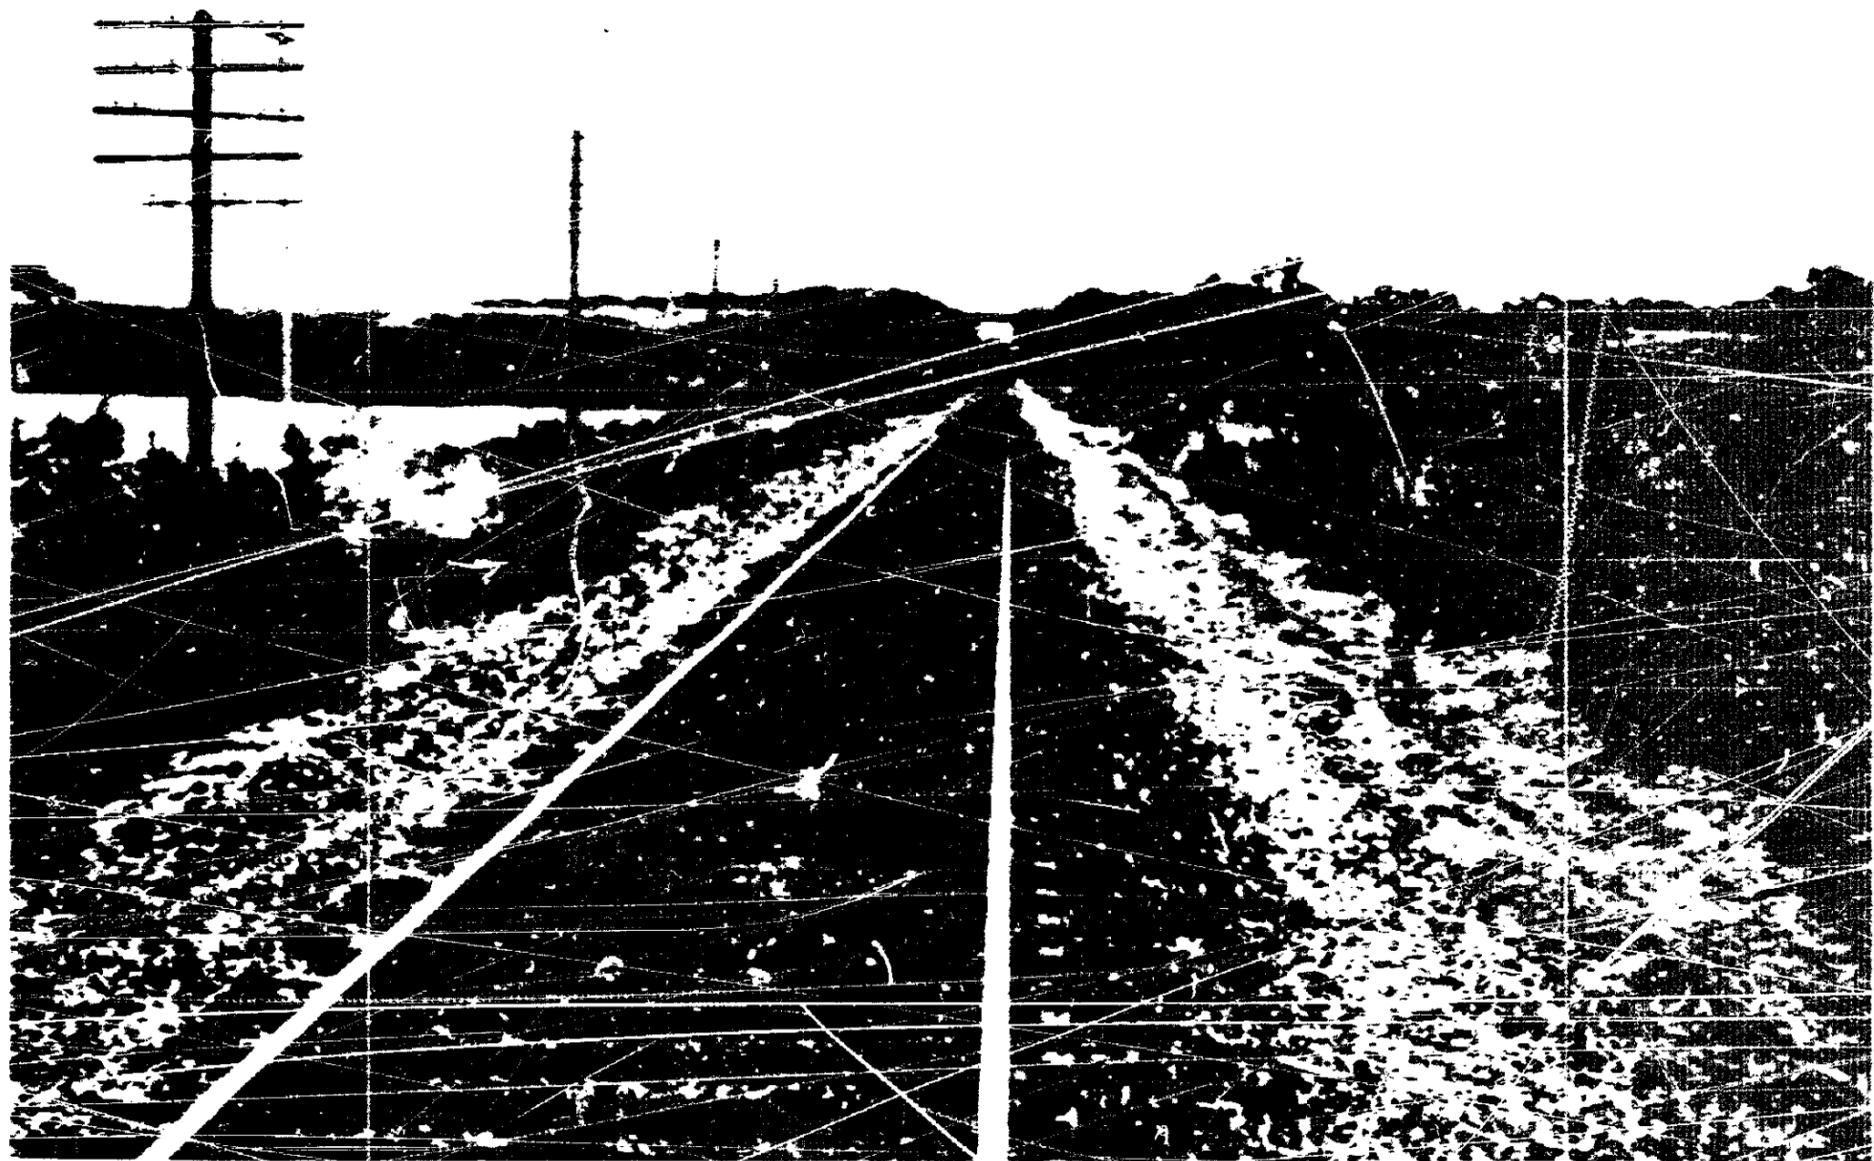
Figure 6.--New 30-mph speed-restriction and ATS signs installed in location of missing 30/25-mph speed-restriction sign on south side of track.

Postaccident inspection of trackside signs approaching Lawrence disclosed that the post with the 30/25-mph speed-restriction and ATS signs that should have been in place 5,838 ft before the first of the curves was not in place. The post with these signs was broken at the ground line and was found lying in the tall grass next to a posthole 14 ft from the south side of the track, 4 ft beyond its proper erected location, about 11 a.m., October 2, 1979, by AT&SF engineering department survey personnel. Investigators could not determine who moved the sign. All other trackside signs in the area were found to be in place except the yard limit sign at milepost 30 which was located about 14 ft rather than the required 10 ft from the track. Track signs 14 ft or more from the track are difficult to see if they are placed in the tall grass of the seldom-maintained edges of the track right-of-way. (See figure 6.)

Since the 30/25-mph and ATS signs and post were found lying in the tall grass near a shallow posthole 14 ft from the track after the accident, and since the engineer of the eastbound train entering Lawrence 20 minutes before train No. 4 did not see the signs, the Safety Board concludes that the 30/25-mph and ATS signs were not standing at the time of the accident and could not be seen by the engineer of train No. 4 who was relying on such signs in the safe operation of his train. Other locomotive engineers and an AT&SF supervisor said the sign had been missing for several weeks before the accident. The sign would have interfered with the crosstie installation and removal in the area, and it is likely that the sign would have been moved to a temporary location or removed to allow passage of equipment when the track gangs and contractor worked in the area. When the track inspector told investigators that the 30/25-mph and ATS signs were in place when he passed the location about 3:30 p.m., on October 1, 1979, it is apparent that he was mistaken or just took no exception to the missing sign.

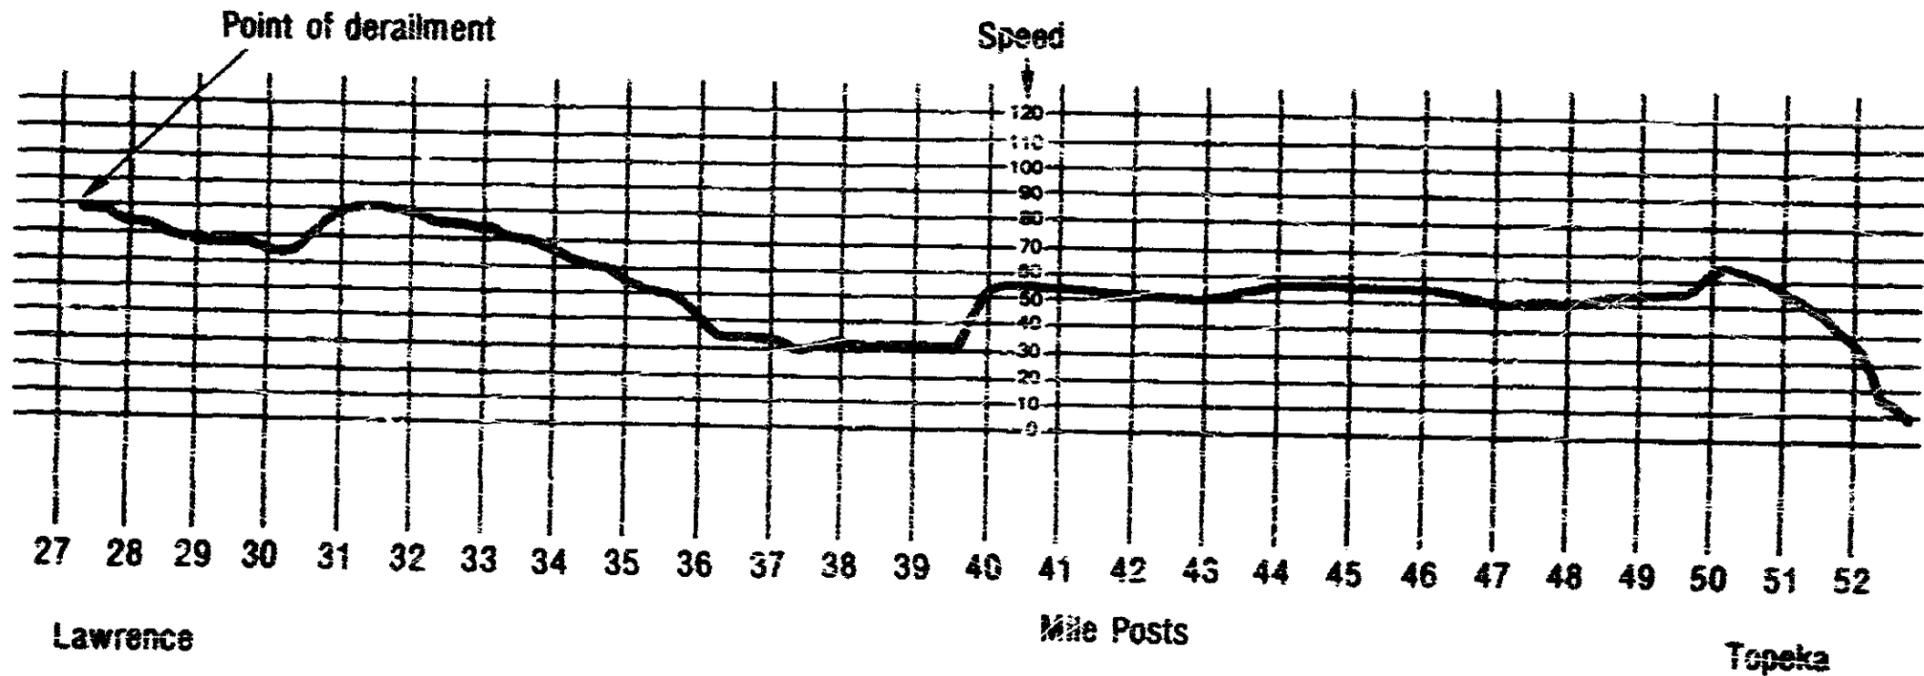
SPEED RECORDER TAPES FROM TRAIN NO. 4

Postaccident inspection of the damaged cars, locomotive units, and pertinent equipment were conducted at both railroad and manufacturer facilities. The inspection of brake equipment on the passenger cars and locomotive units did not disclose any conditions which would have contributed to or caused the brakes to malfunction. Inspection of the trucks and undercarriage of locomotive units did not reveal any defects in the wheels, axles, or suspension systems. The speed recorders on the locomotive units were checked for accuracy; on the lead unit a speed of 78 mph was recorded as 80 mph, and on the second unit a speed of 80 mph was recorded as 75 mph. Examination of the speed recorder tapes indicated the engineer had properly controlled the speed of the train prior to approaching the curve where the accident occurred. (See appendix K.)
